# **PLAY AREA SAFETY INSPECTION REPORT**

**For Walberswick Common Lands Charity/Walberswick PC**

On 6<sup>th</sup> May 2016

Play Area, Common, Church Lane, Walberswick

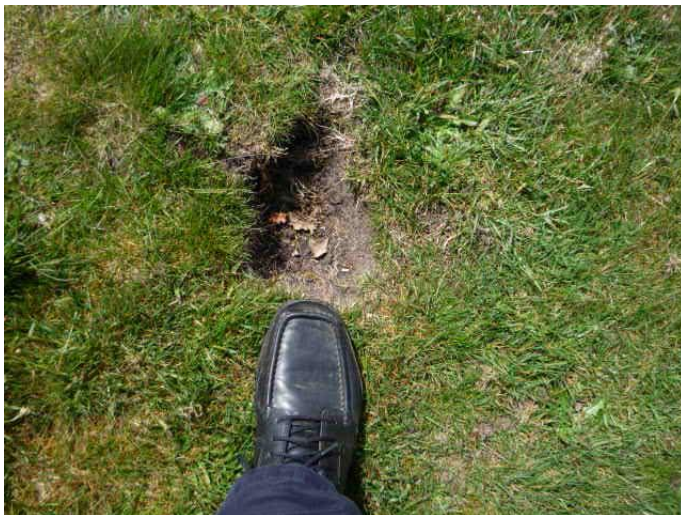
General surface –Grass –Recommend infill Rabbit holes, which are trip hazards (this should be an ongoing operation) –Low to Medium risk.

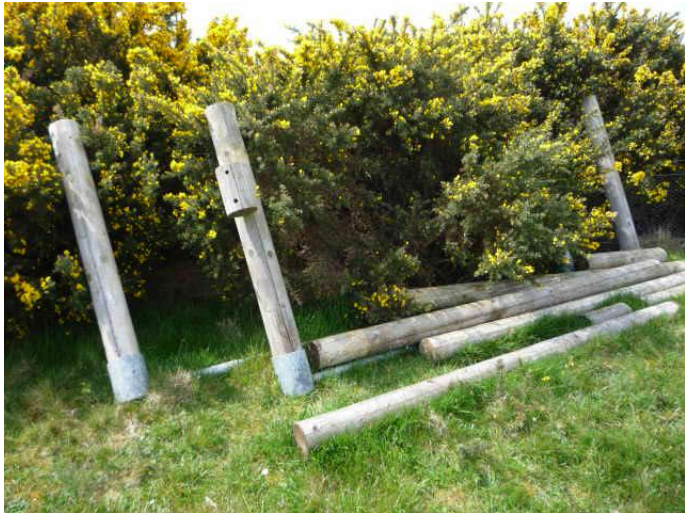
Recommend remove remains of dismantled Log item – Children can play on the logs which are loose, and a hazard – Low to Medium risk.

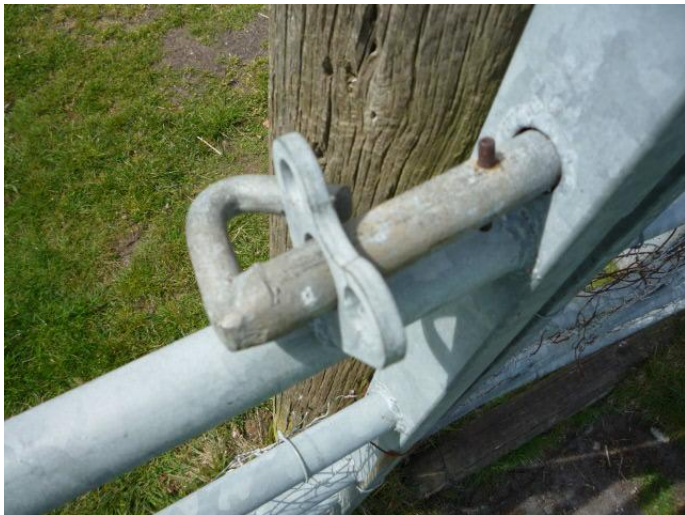
Maintenace gates –Recommend lock

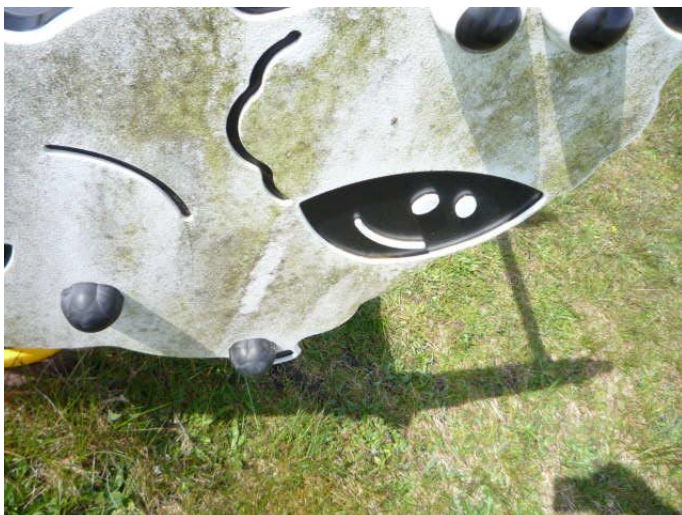
**Item: Springy Sheep - Fahr**

Recommend clean off algae.

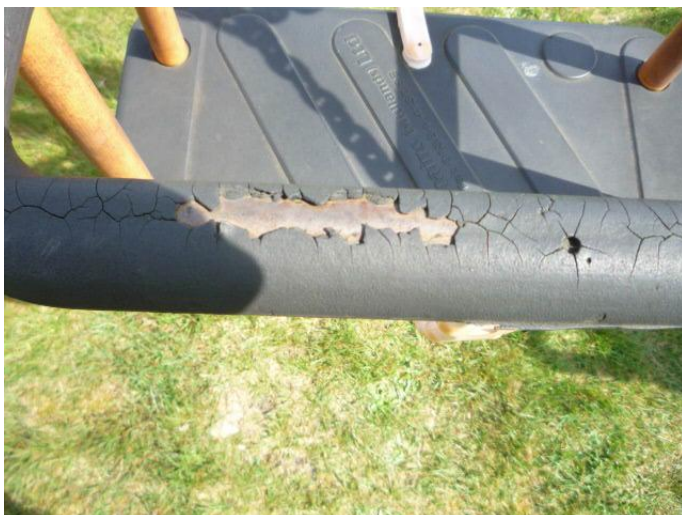
**Item: 1 Bay 2 Cradle Seat Swing (2000mm) - Playquip**

The swing seat has been damaged but does not require immediate replacement. Recommend tape over areas with exposed metal – Low risk.

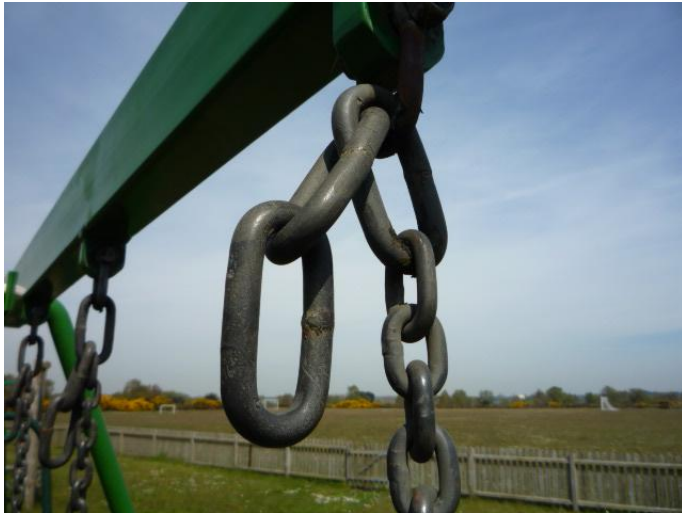
Recommend remove large unused chain links at top of suspensions – Low risk.

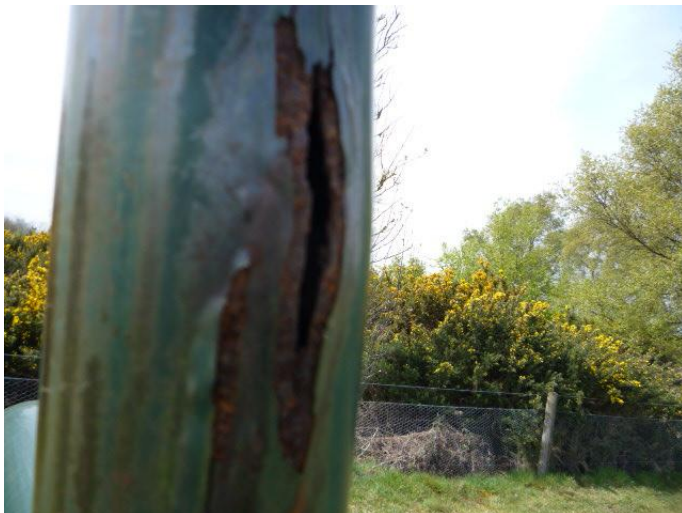
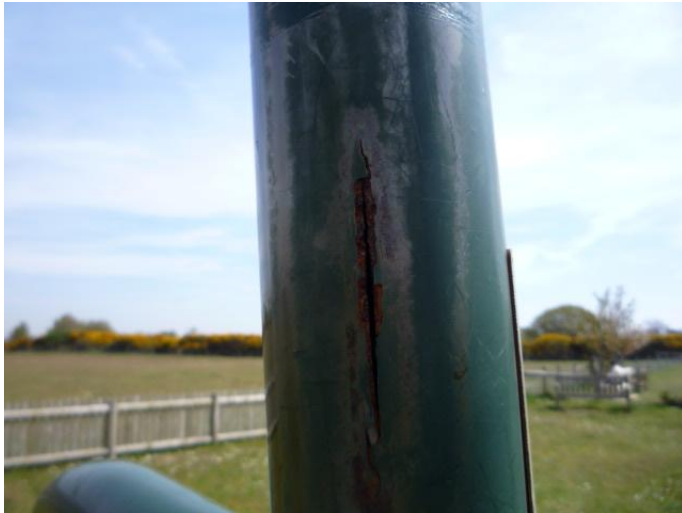
**Item: 1 Bay 2 Flat Seat Swing (2400mm)– Sutcliffe Leisure**

Recommend infill holes in two supports and repaint areas - Low risk.

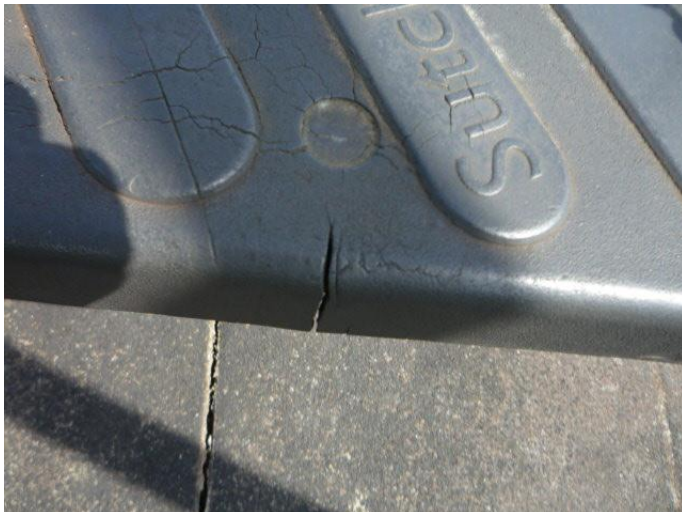
The swing seat has been damaged but does not require immediate replacement. Monitor and replace when hard material is exposed.

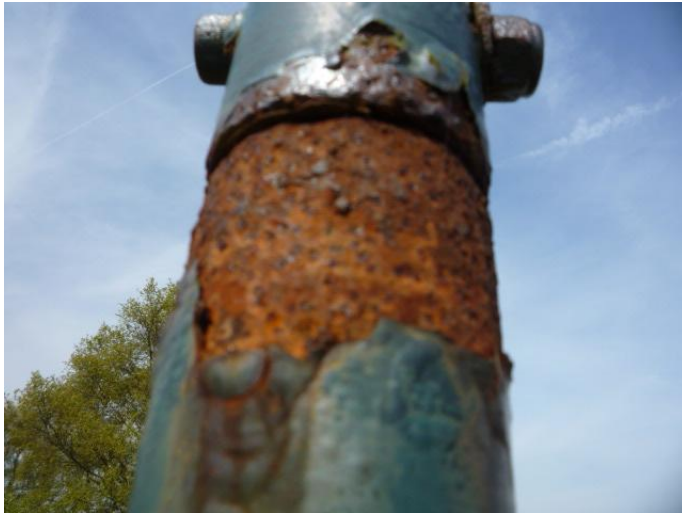
Paintwork is in poor condition. Recommend De-scale and coat with lead free paint, using appropriate precautions.

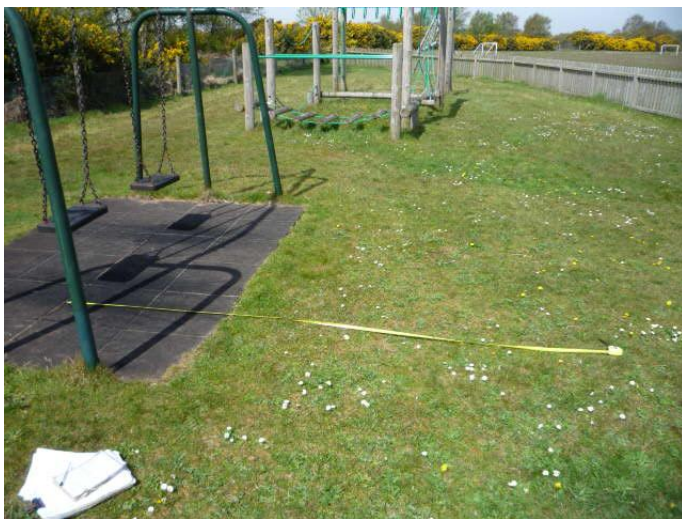
Insufficient protective surfacing has been provided – should have 3220mm, currently 1000mm – Recommend extend in Matting (cost effective) - Low risk.

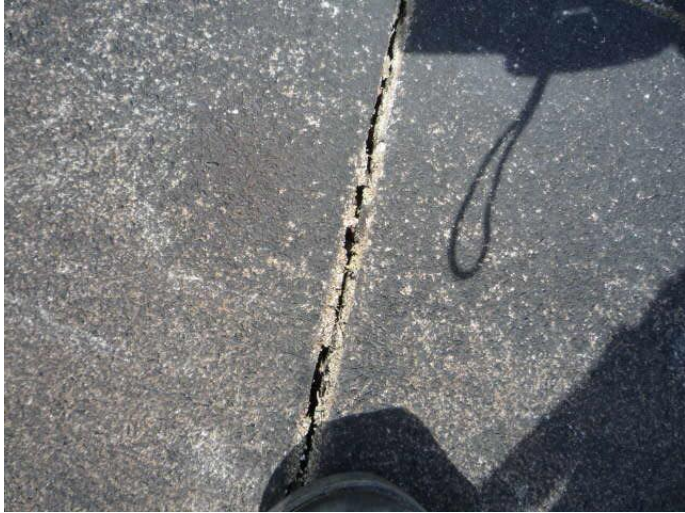
Surface is lifting. Recommend re-glue and fill gaps and joints as necessary - Low risk.

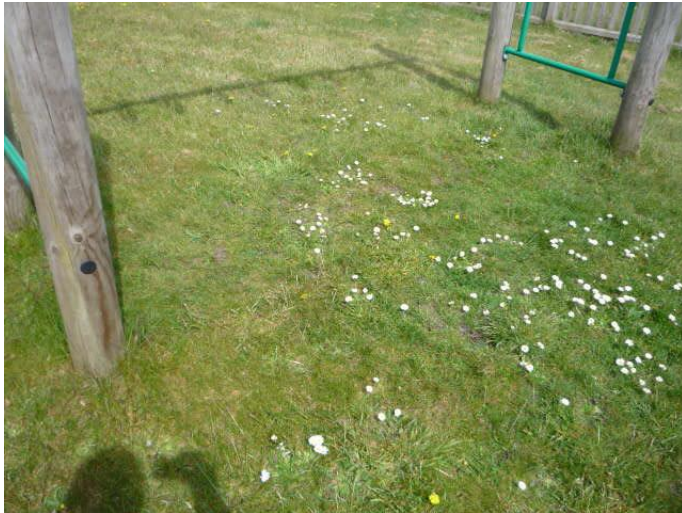
A protective surface is recommended for this item and should be programmed into future development- Recommend Matting to be installed to EN1176 (FFH 1900mm) – Medium risk.

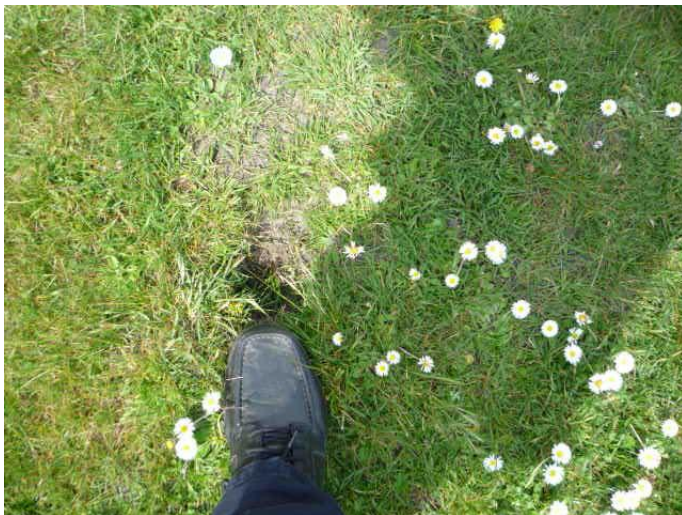
Recommend infill hole in turf – Low to Medium risk.

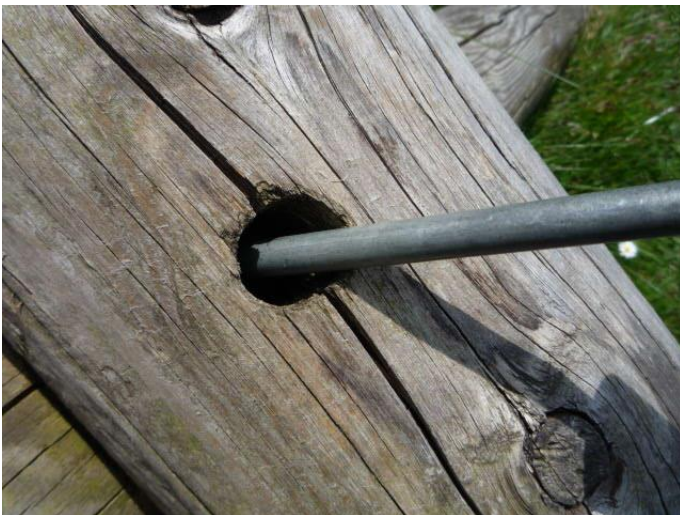
Finger entrapments in holes –Recommend cap off all holes x 24 – Low risk.

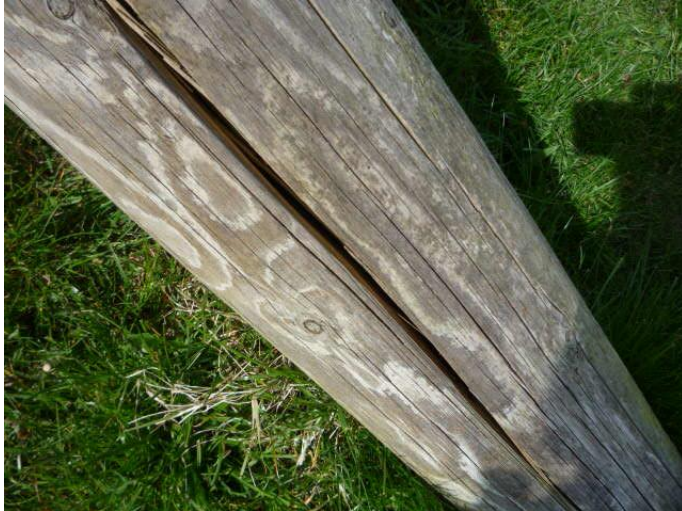
Recommend monitor cracks in timbers, currently 8mm –Low risk.

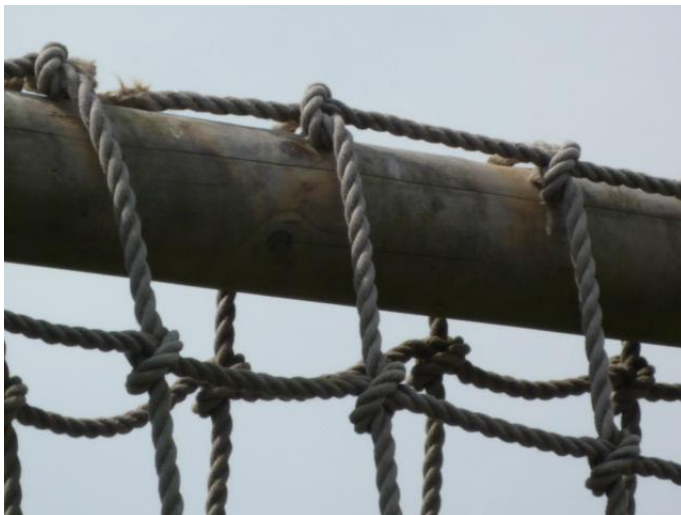
There are 'moving' entrapments at top bar, where the unfixed net can tighten when climbed on – Recommend to refix or renew net to comply with EN1176 – Medium to High Risk.

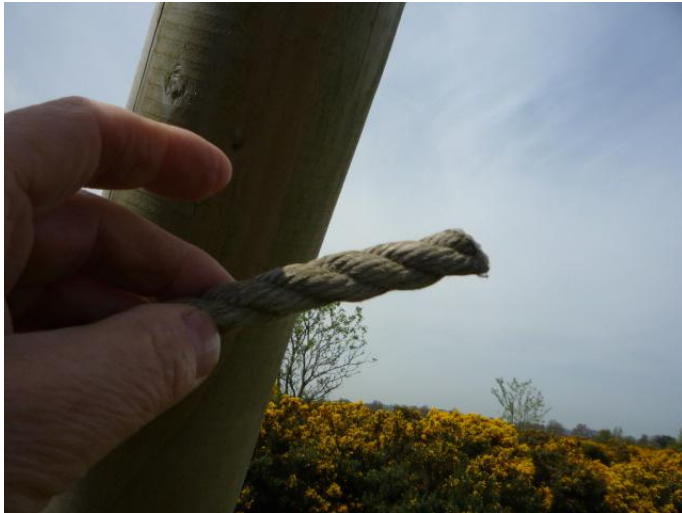
Recommend replace missing eyelets x 2, to allow the tying of two ropes –Low risk.

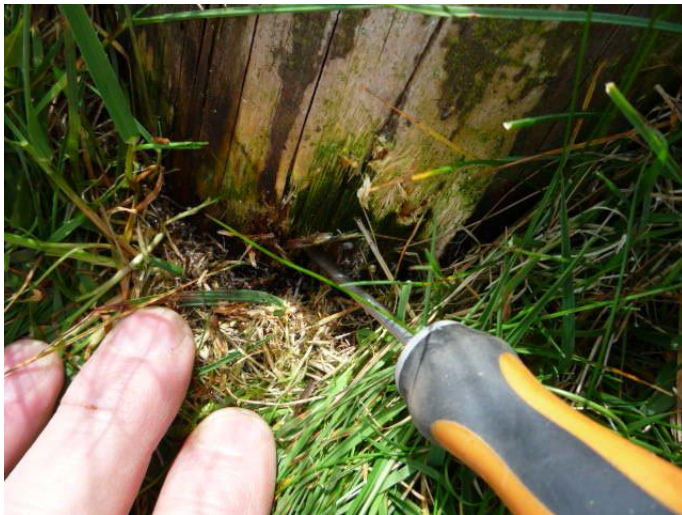
Recommend replace rotten support –Low to Medium risk.

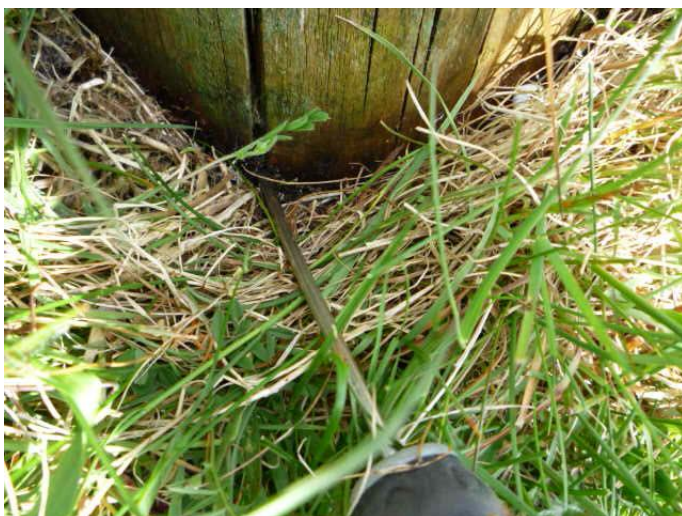
Recommend monitor rot to one other support –Low risk.

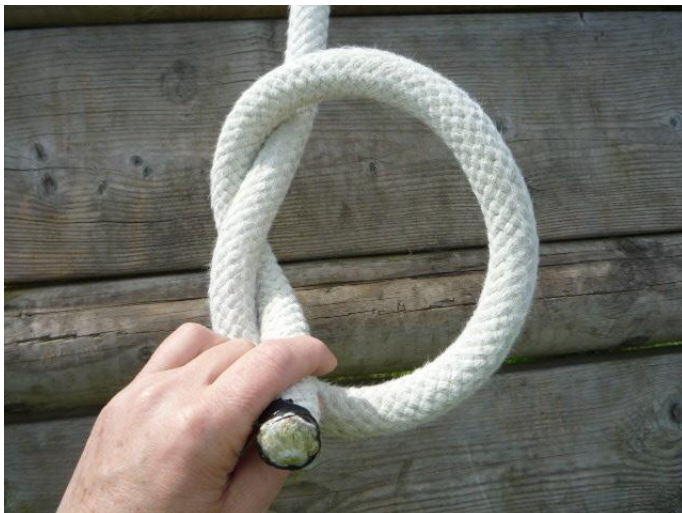
Ropes should be fixed at both ends, to reduce the hazard of rope being shaped into a noose –Recommend secure at both ends - Medium to High Risk.

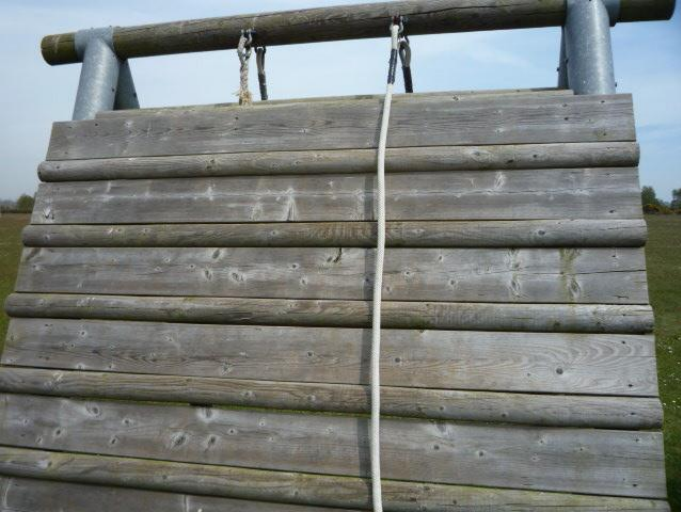
Remove remains of damaged rope and replace to comply with EN1176 –Low risk.

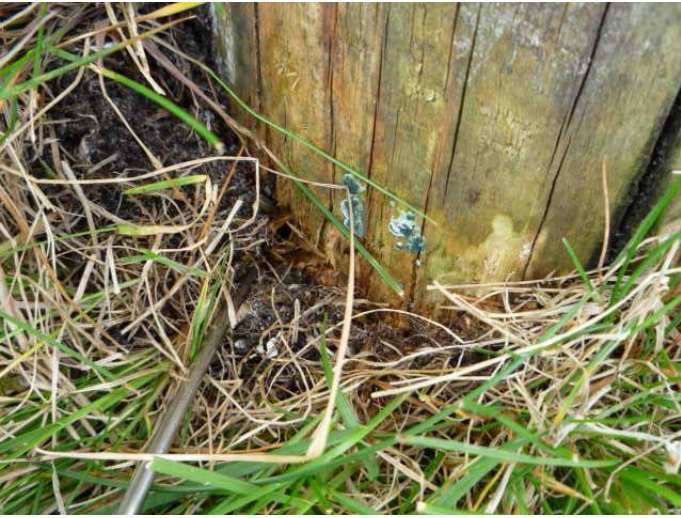
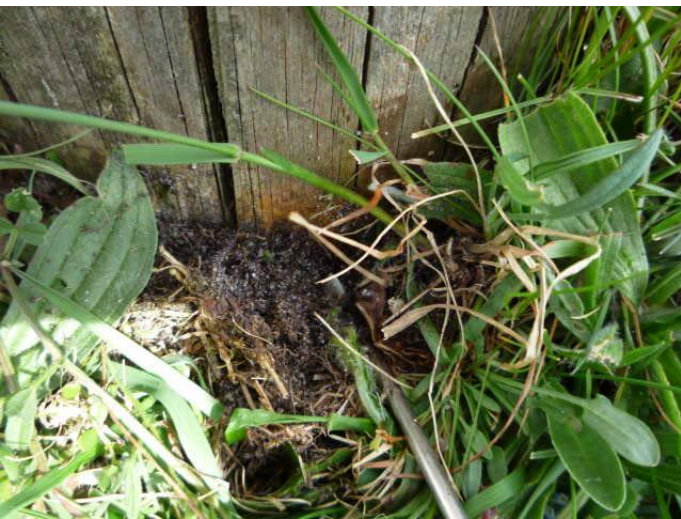
Recommend monitor two supports which show signs of rot –Low risk.

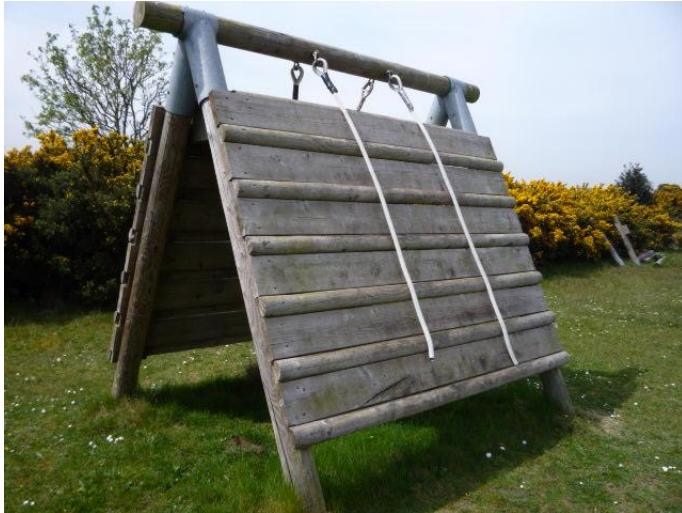
A protective surface is recommended for this item and should be urgently programmed into future development – Medium risk.

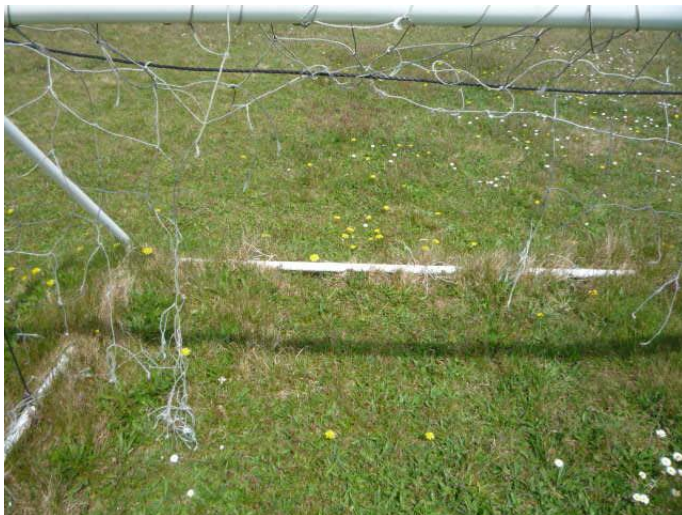
Recommend replace one damaged net –Low risk.

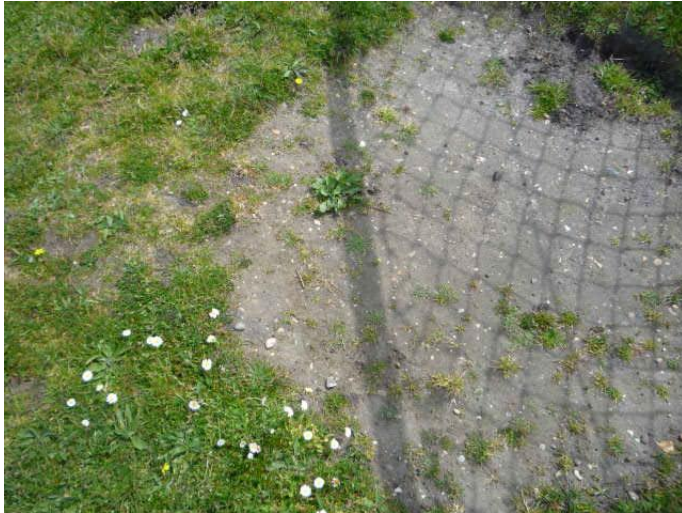
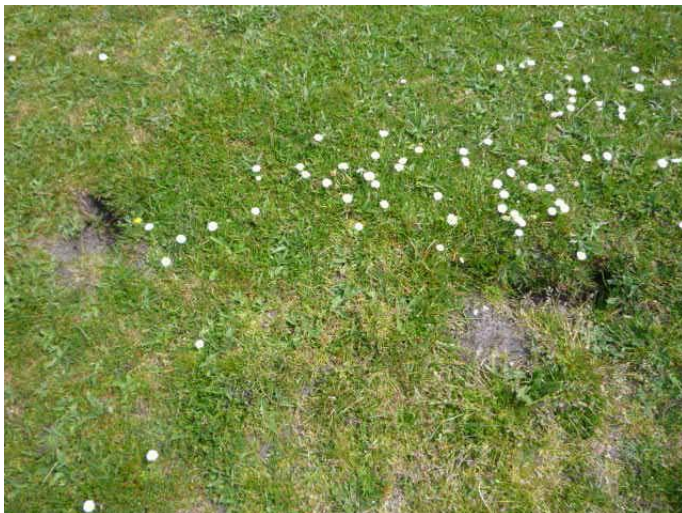
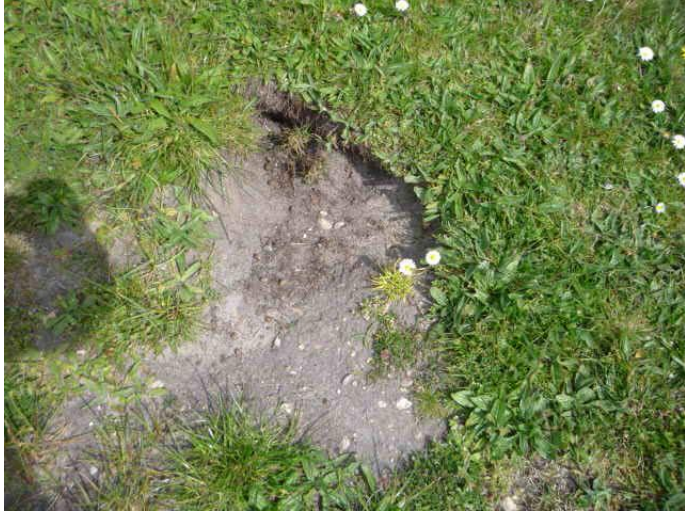
Recommend infill rabbit scrapes and make good worn areas with turf –  
Low risk.

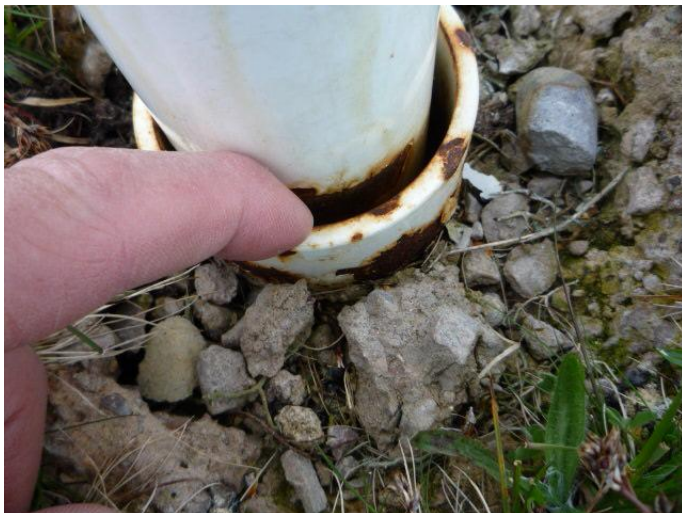
Finger entrapments in sockets x 4 –Recommend add wedges to eliminate entrapments.

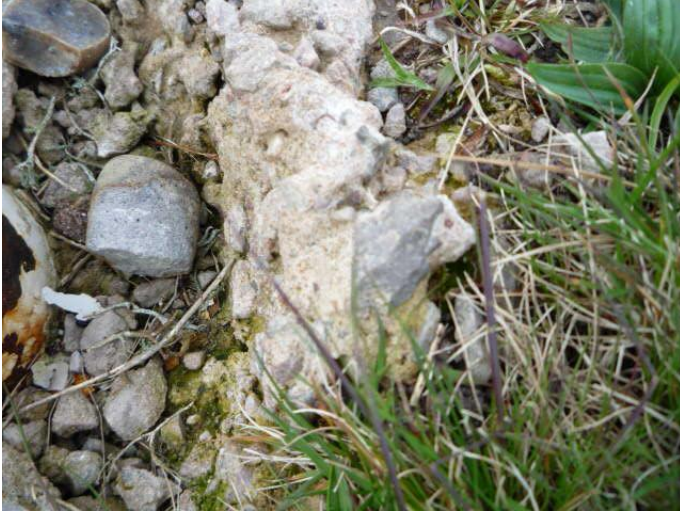
Concrete in fall space –Recommend cover or remove concrete –  
Medium risk.

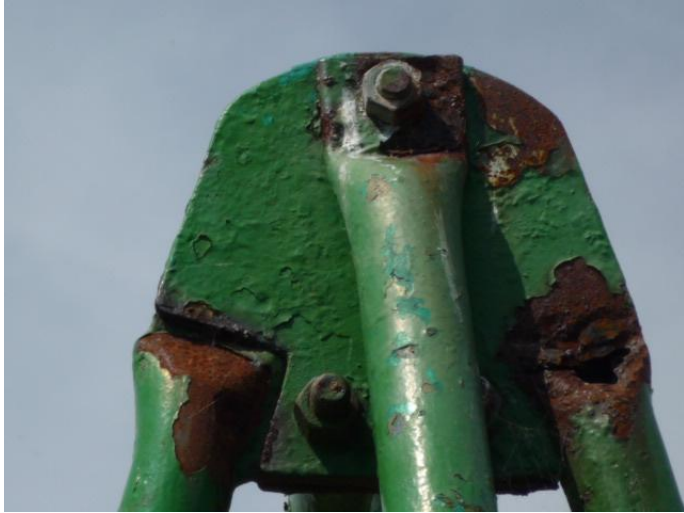
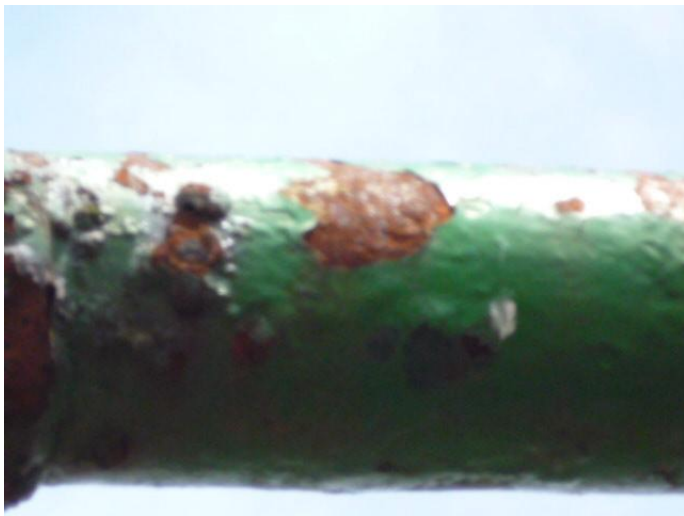
Recommend infill hole at top of support, remove rust and repaint entire item, further repairs may be required/revealed when rust has been removed –Low to Medium risk.

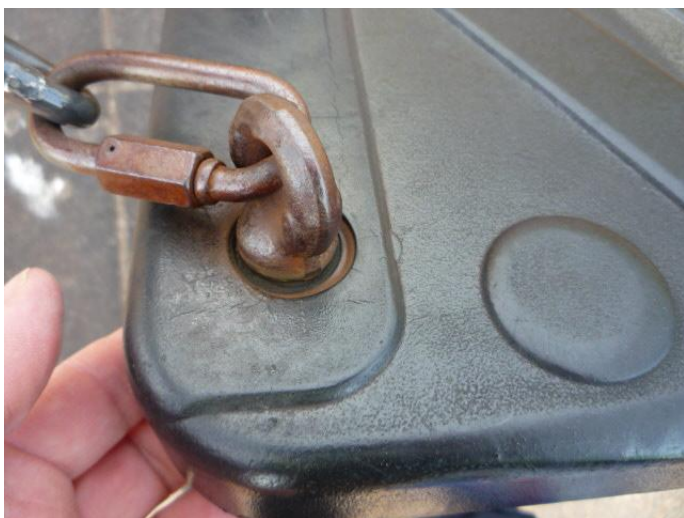
Recommend tighten loose seat bolts x 3 –Low risk.

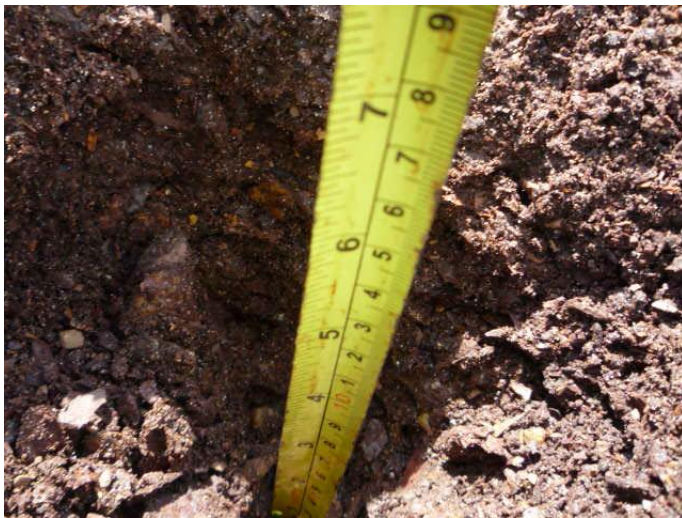
Loose fill levels are too low to provide adequate protection. Recommend fork over and top up (with Bark that complies with EN1176 recommendations) as required to maintain minimum depth (usually 300mm) – currently 180mm –Low risk.

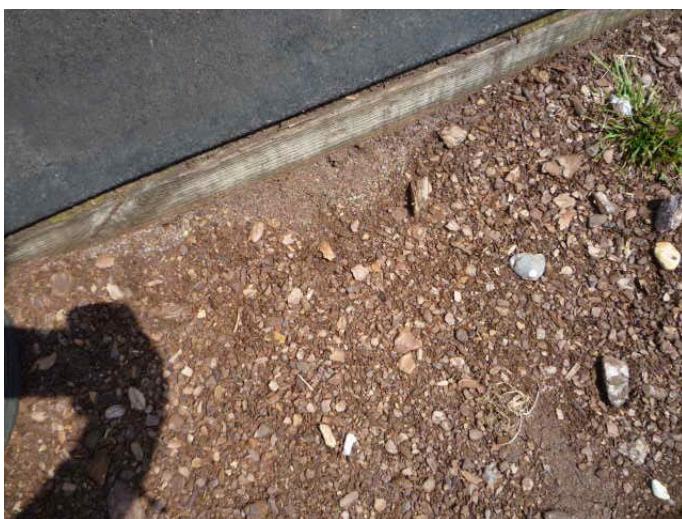
Trip zones found at edge of surface. Recommend build up ground levels to remove trip hazard (see above) - Low to Medium risk.

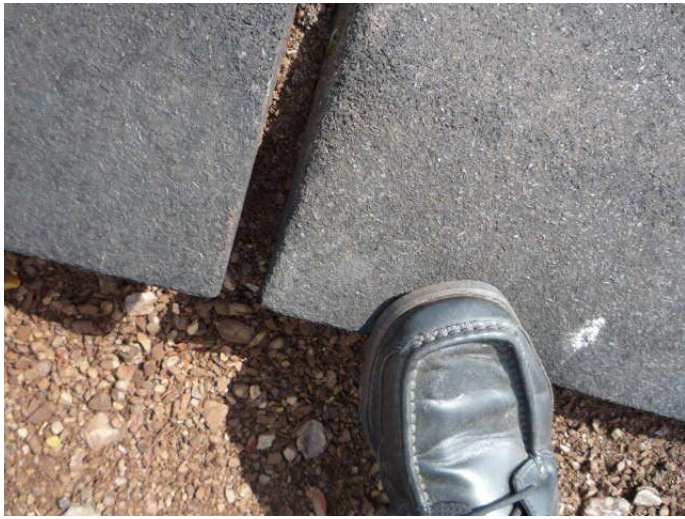
Surface is lifting. Recommend rearrange, re-glue and fill gaps and joints as necessary - Low risk.

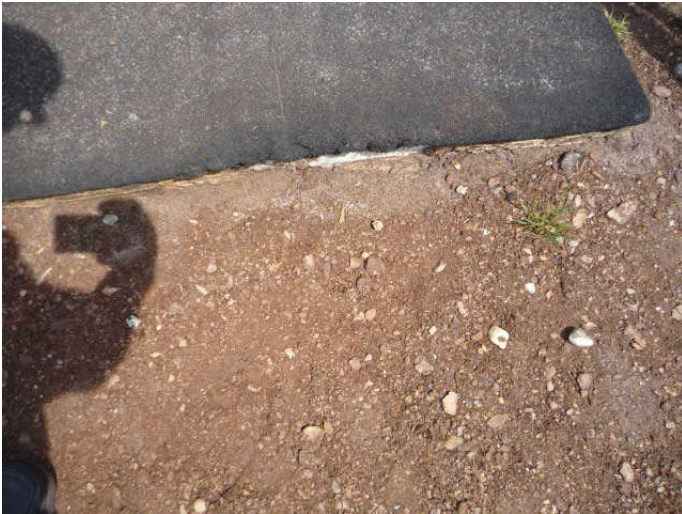
Loose fill levels are too low to provide adequate protection. Recommend fork over and top up (with Bark that complies with EN1176 recommendations) as required to maintain minimum depth (usually 300mm) - currently 180mm Low risk.

Trip zones found at edge of surface. Recommend build up ground levels to remove trip hazard (see above) – Low risk.

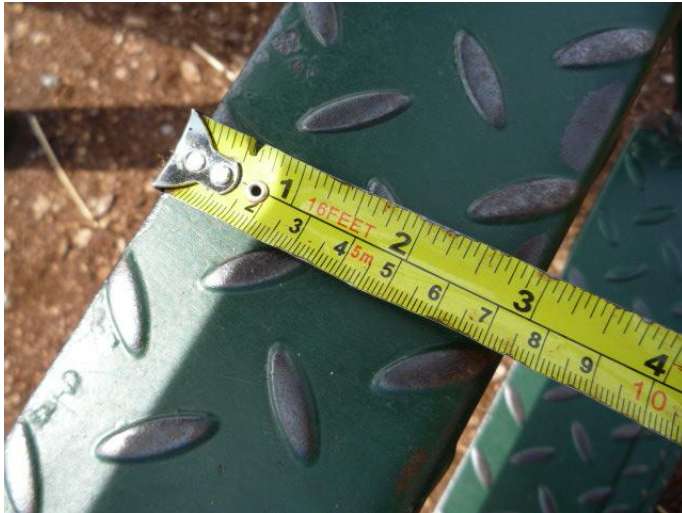
Width of steps fail EN1176 – Recommend monitor only –Low risk.

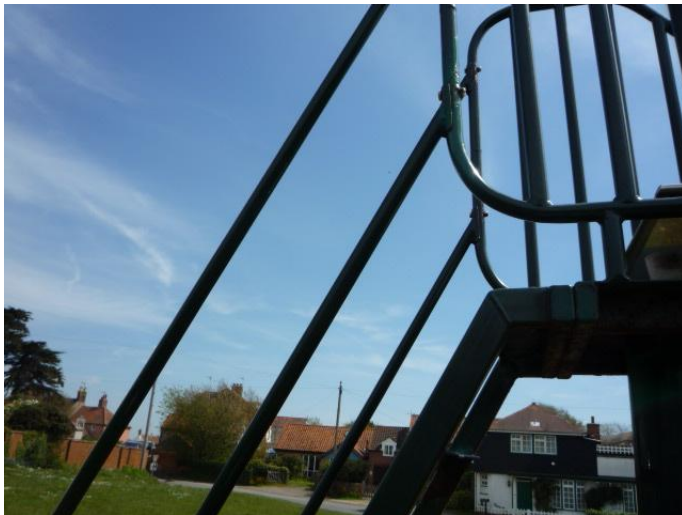
Steps should have infilled barriers –Recommend monitor only – Low risk.

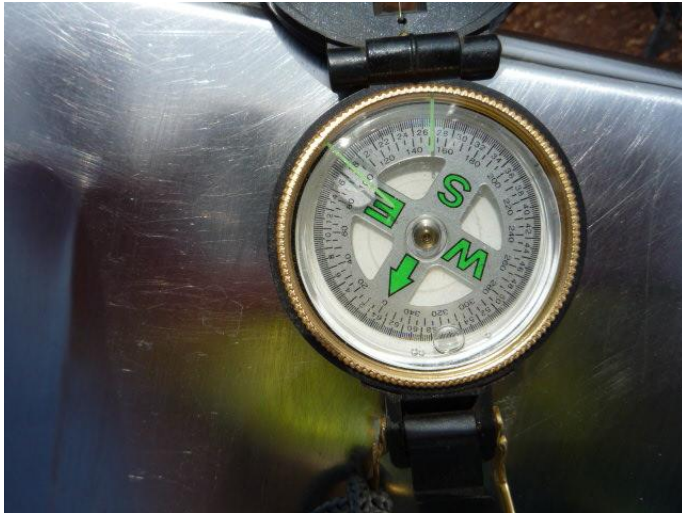
NB Although not part of EN1176 – the slide surface faces south and may suffer from solar gain and get hot during the summer – Recommend monitor –Low risk.

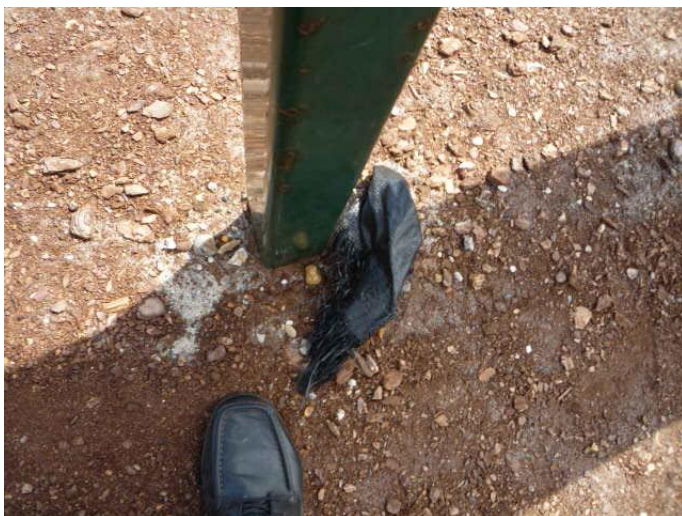
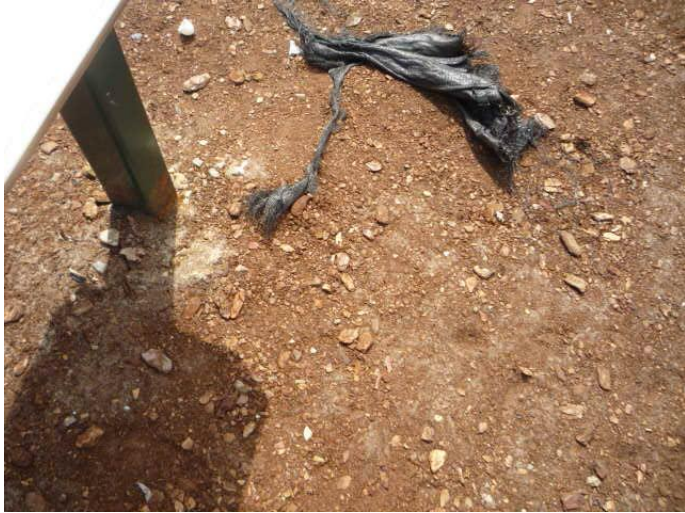
Loose fill levels are too low to provide adequate protection. Recommend fork over and top up (with Bark that complies with EN1176 recommendations) as required to maintain minimum depth (usually 300mm) – currently concrete and geotextile is exposed – Medium risk.
