POST INSTALLATION SAFETY INSPECTION REPORT

For Walberswick Parish Council

31st July 2016

Play Area, Common, Walberswick

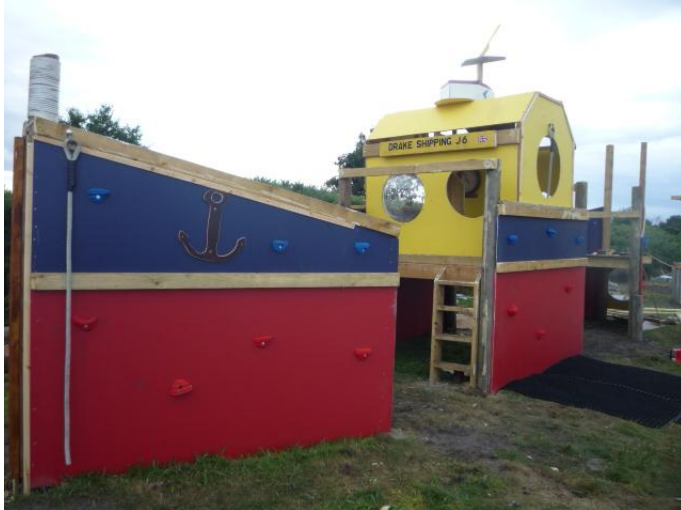
Item 1: Large Ship

EN 1176 Standard Compliance	Yes
Label to EN 1176	No
Other safety failures	No
Installation Correct	Yes
Installation faults	No
Surfacing type	Safergrass and Grass
Dimensions	Correct
Dimension size	-
Random depth	30mm /150mm
Estimated Critical Fall height	1900mm

Additional comments	A Slide has been ordered from Fahr Industries that conforms to EN1176 and will be installed as soon as possible. The area where
---------------------	---

the slide is to be installed has been made safe (blocked off) and conforms to EN1176

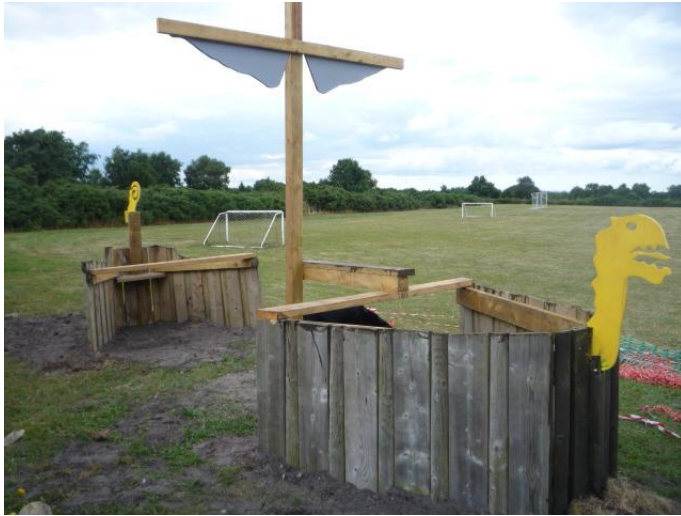
Item 2: Viking Ship

EN 1176 Standard Compliance	Yes
Label to EN 1176	No
Other safety failures	No
Installation Correct	Yes
Installation faults	No
Surfacing type	Grass
Dimensions	Correct
Dimension size	-
Random depth	150mm
Estimated Critical Fall height	1000mm

Surfacing installation	Correct
Additional comments	Shields to be installed on sides to EN1176.

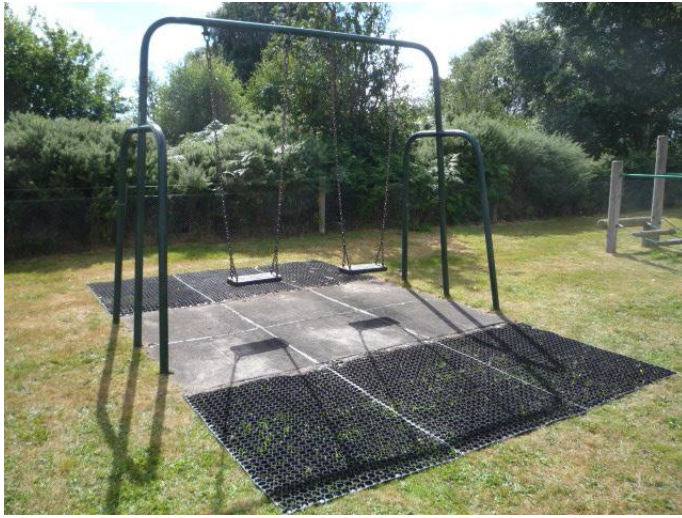
Item 3: 1 Bay 2 Flat Seat Swing (2400mm)

EN 1176 Standard Compliance	Yes
Label to EN 1176	No
Other safety failures	No
Installation Correct	Yes
Installation faults	No
Surfacing type	Tiles (refurbished) / Safergrass (new)
Dimensions	Correct
Dimension size	-
Random depth	30mm
Estimated Critical Fall height	1500mm

Additional comments Refurbishment include infilling holes in metal supports and making good. And infilling gaps between tiles with purpose filler and laying new Safergrass Matting.

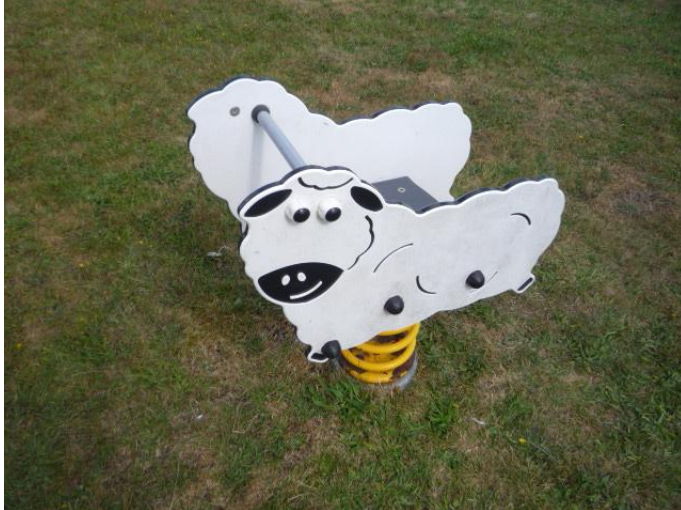
Item 4: Springy Sheep

EN 1176 Standard Compliance	Yes
Label to EN 1176	No
Other safety failures	No
Installation Correct	Yes
Installation faults	No
Surfacing type	Safergrass
Dimensions	Correct
Dimension size	-
Random depth	30mm
Estimated Critical Fall height	400mm

Surfacing installation	Correct
Additional comments	Algae removed from item, and left in a clean condition.

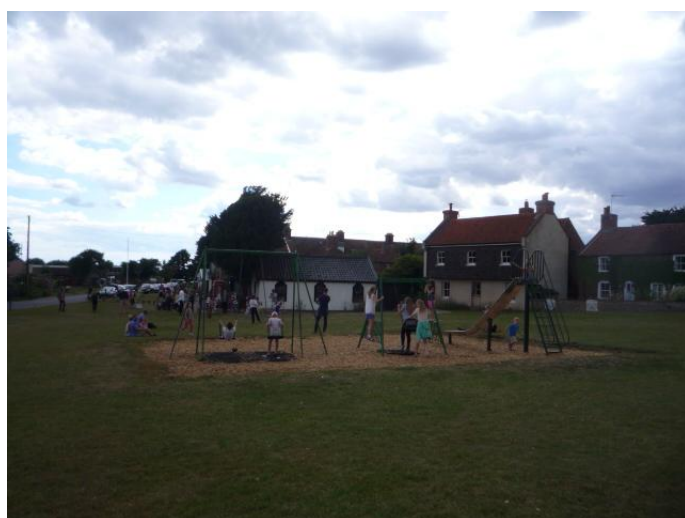
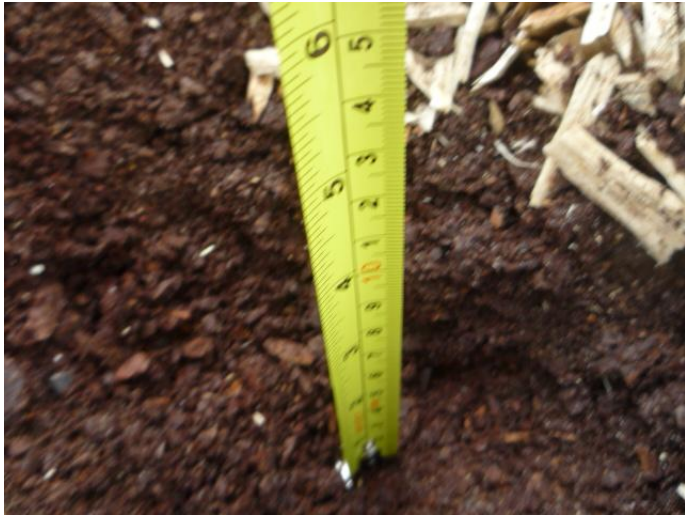
The inspection included checking the depth of woodchip at the play area (not provided by Marriot Play and Leisure). The woodchip was tested at 150mm deep, which is 150mm less than recommended (300mm). However, it is thought that the surfacing will be replaced by Safergrass Matting when funds allow (6 months?). The surface currently is Low risk, and is acceptable for use at the present time but it is recommended to rake the woodchip weekly (?) towards and under the major fall areas under the Slide and Swings, to ensure that maximum impact absorption possible is given.
