# **PLAY AREA SAFETY INSPECTION REPORT**

**For Walberswick Common Lands Charity/Walberswick PC**

On 23rd March 2018

Play Area, Common, Church Lane, Walberswick

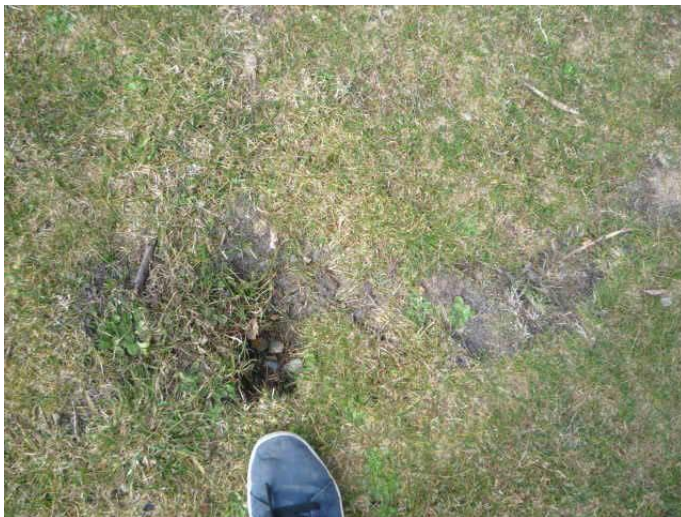
General surface –Grass –Recommend infill Rabbit holes, which are trip hazards (this should be an ongoing operation) –Low to Medium risk.

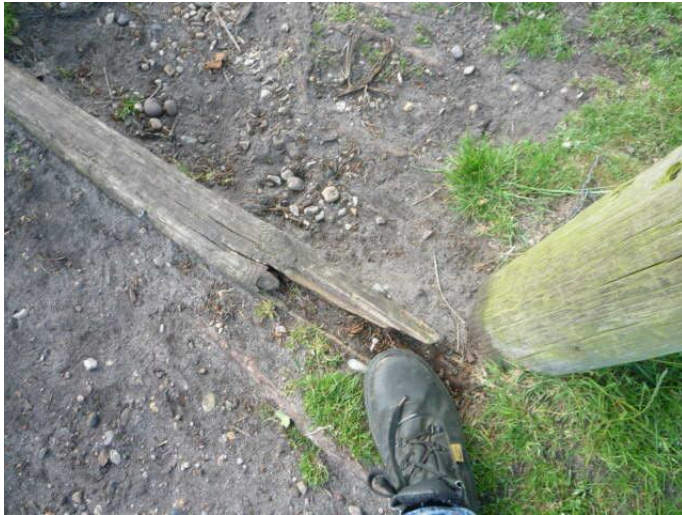
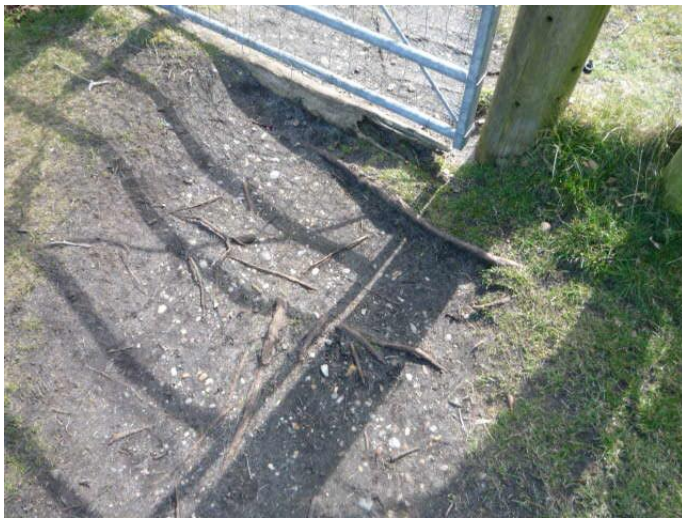
Access –Recommend removed damaged log under pedestrian gate, and remove /cover roots which are a trip hazard –Low to Medium risk.

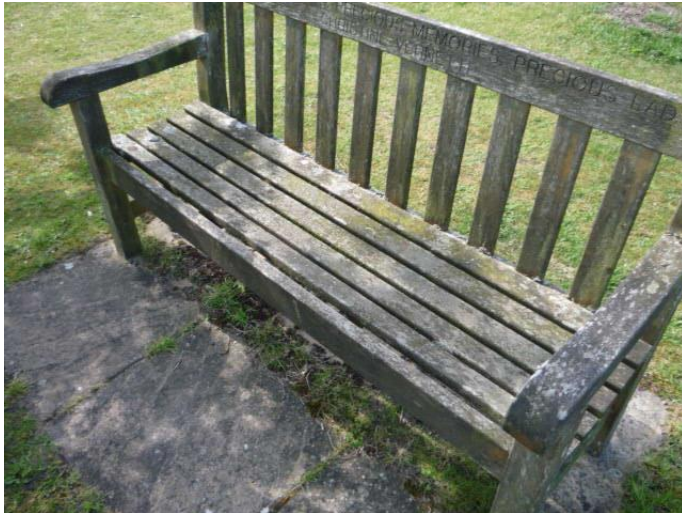
Seats x 3 – Timber preservation is in poor condition to one seat. Recommend Rub Down and Stain with appropriate preservative. Most preservatives sold as child friendly by major DIY chains meet these standards.

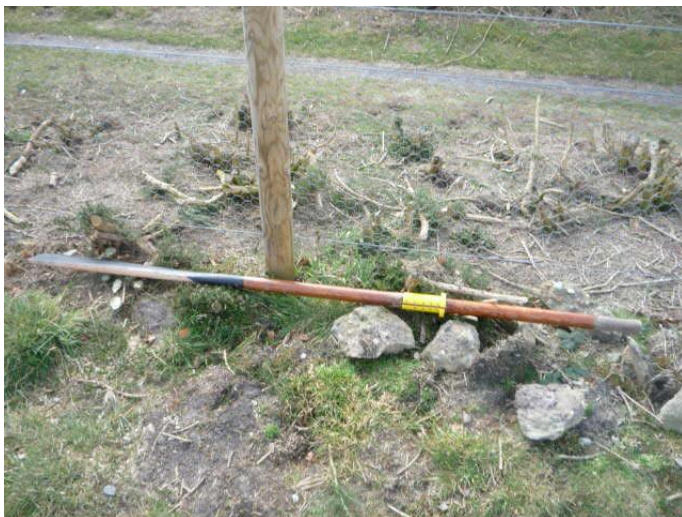
Recommend remove Oar from site, as it can be played with –Low risk.

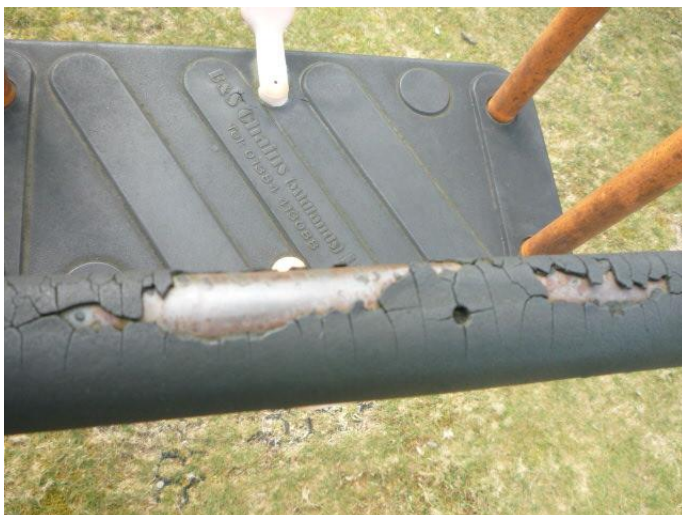
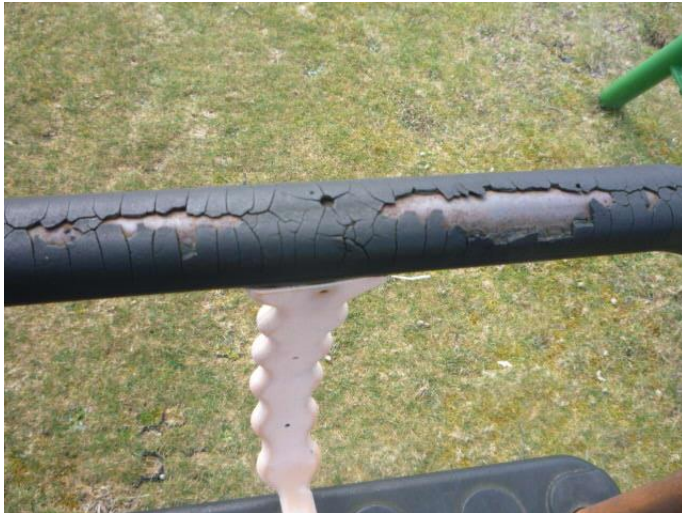
Recommend replace two seats with metal exposed –Low risk.

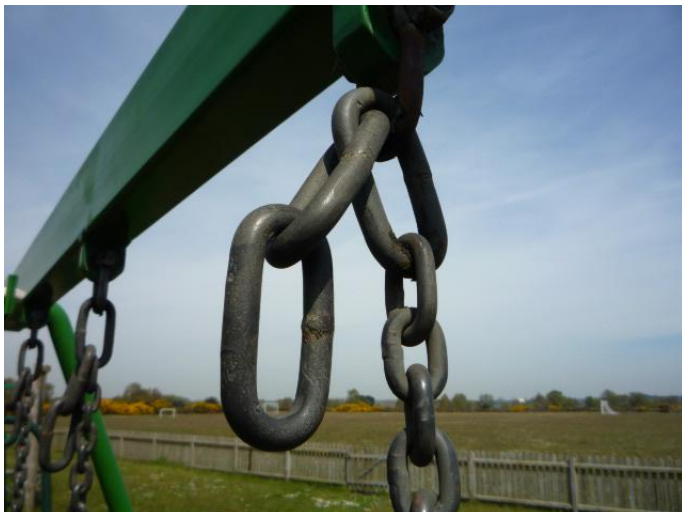
Recommend remove large unused chain links at top of suspensions –  
Low risk.

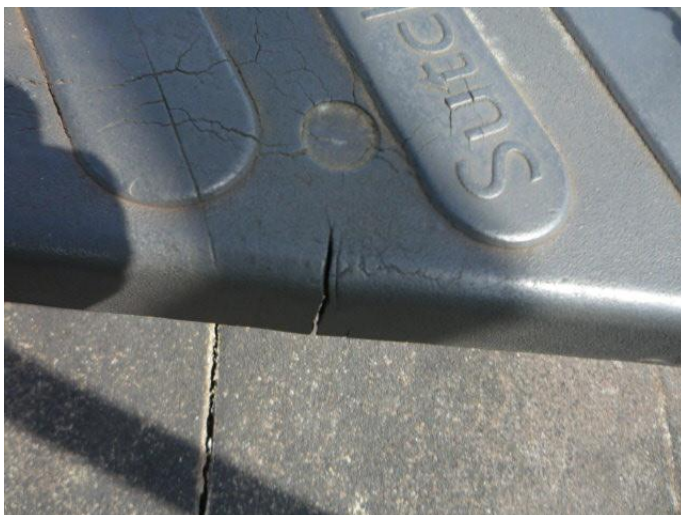
The swing seat has been damaged but does not require immediate replacement. Monitor and replace when hard material is exposed.

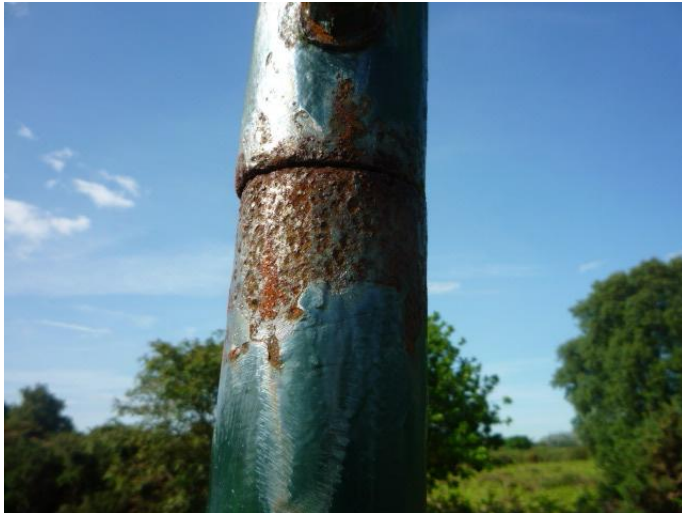
Paintwork is in poor condition. Recommend De-scale and coat with lead free paint, using appropriate precautions.

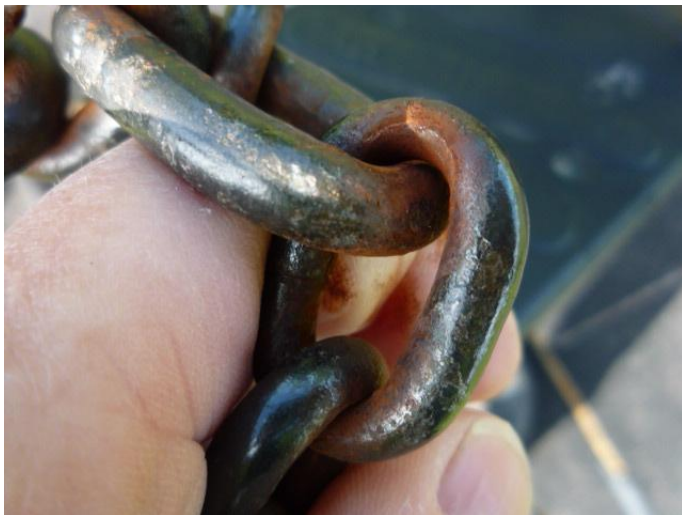
Some chain wear. Recommend Monitor for further deterioration and replace at 40% wear.

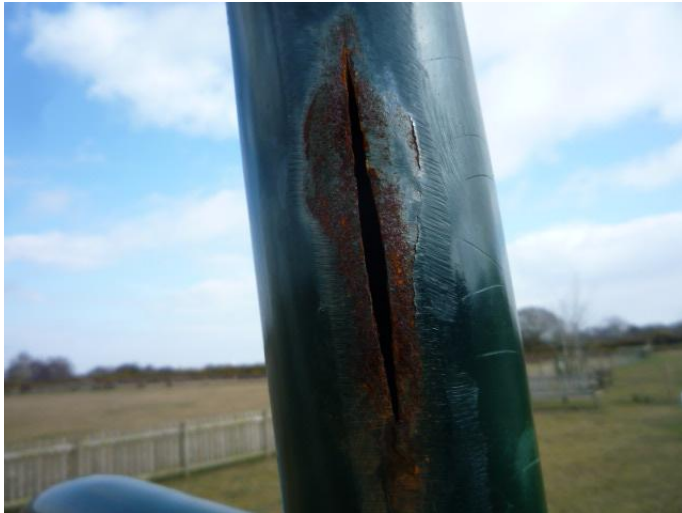
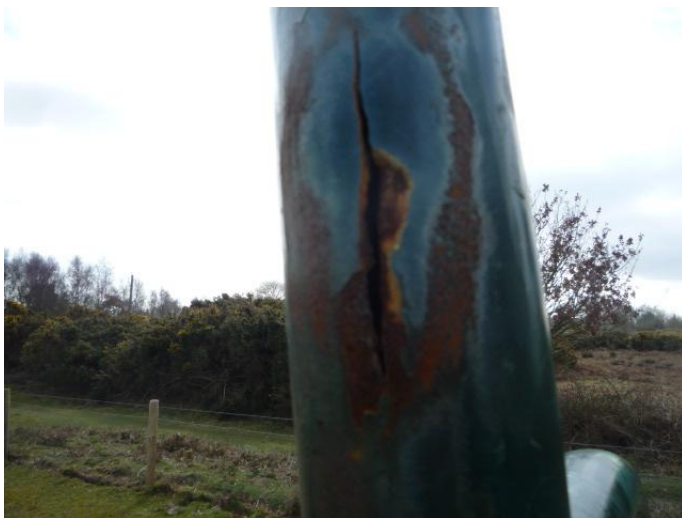
Recommend repair two supports that have splits –Low risk.

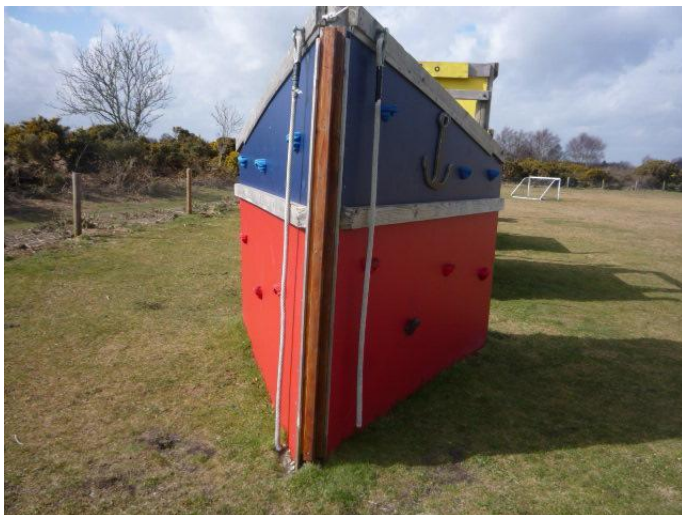
Recommend that the two climbing ropes should be secured (clamped) at each end, and should not be loose to make a loop, which could be an entrapment risk. When securing the ropes, it must be ensured that the space between rope and panel is greater than 230mm at one point to eliminate entrapment – Medium risk.

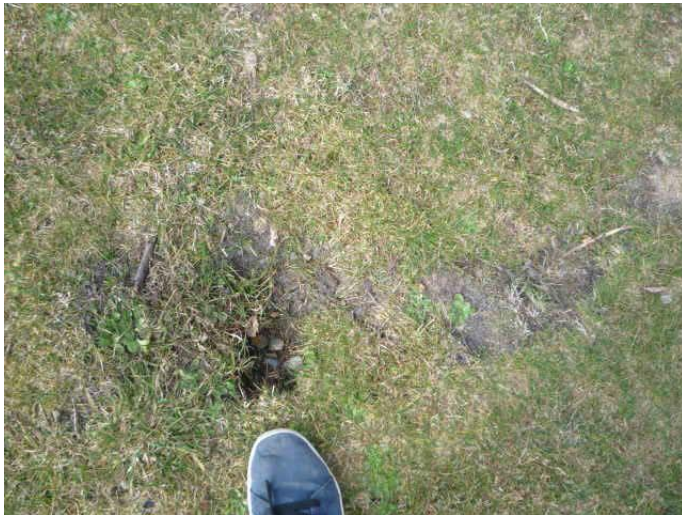
Recommend infill rabbit holes, which are trip hazards –Low to Medium risk.

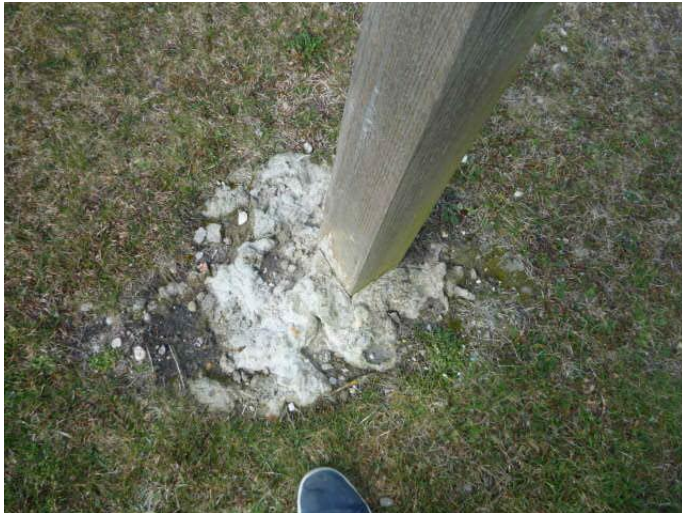
Recommend cover concrete at bottom of mast –Low risk.

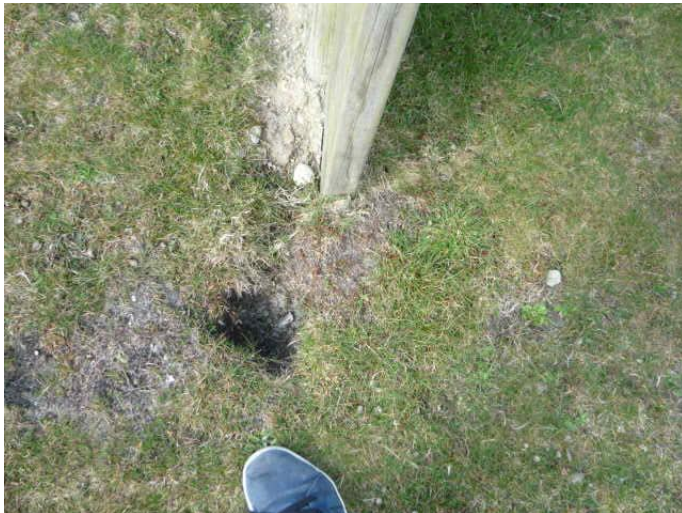
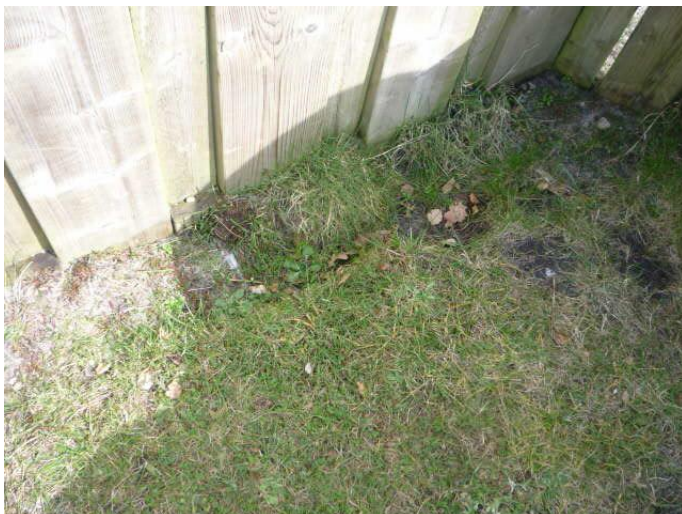
Recommend infill rabbit holes, which are trip hazards –Low to Medium risk.

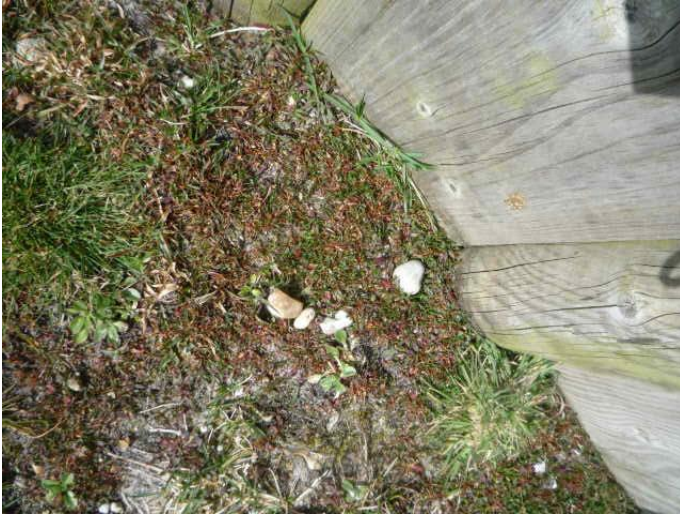
Recommend remove loose stones –Low risk.

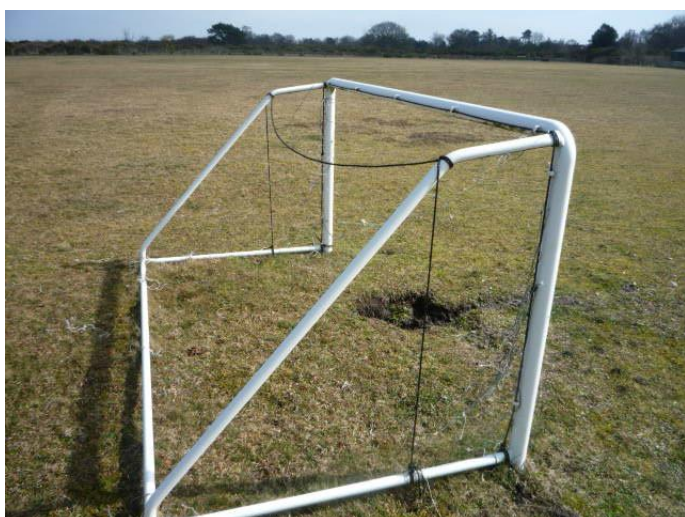
Recommend replace one missing net –Low risk.

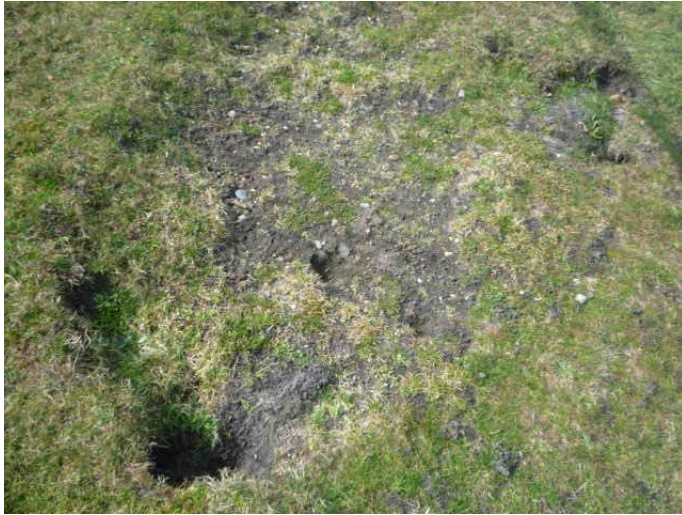
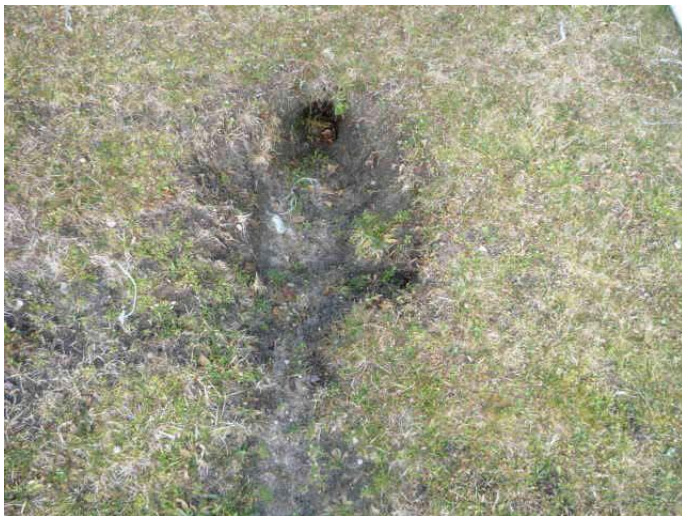
Recommend infill rabbit scrapes and make good worn areas with turf –  
Medium risk.

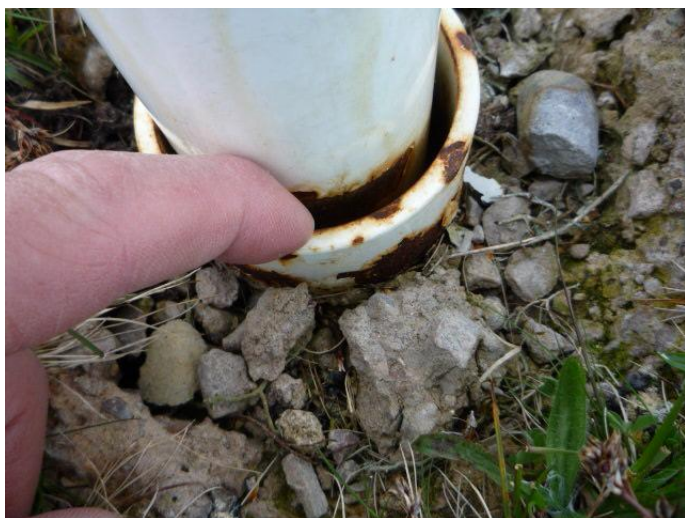
Finger entrapments in sockets x 4 –Recommend add wedges to eliminate entrapments.

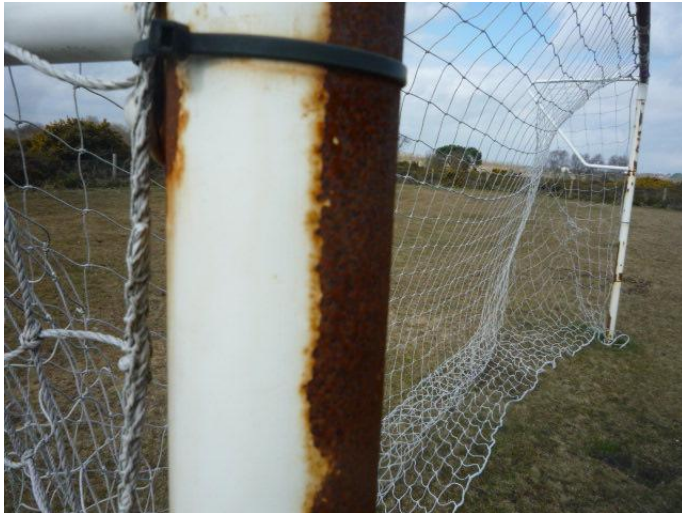
Paintwork is in poor condition. Recommend De-scale and coat with lead free paint, using appropriate precautions.

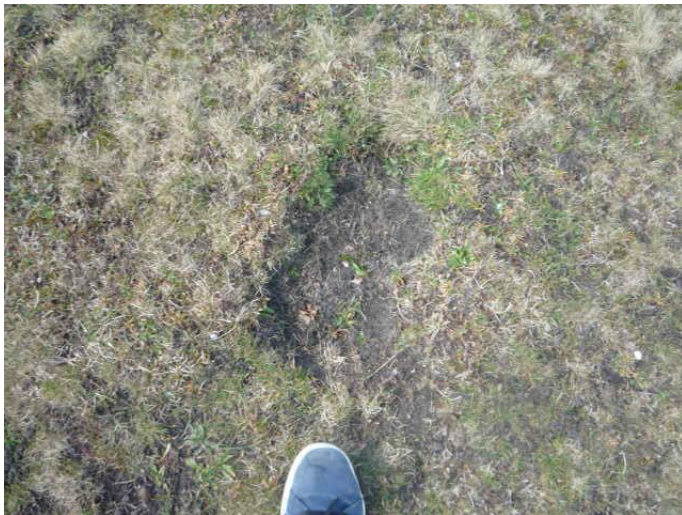
Recommend infill rabbit scrapes to eliminate trip hazards =Low to Medium risk.

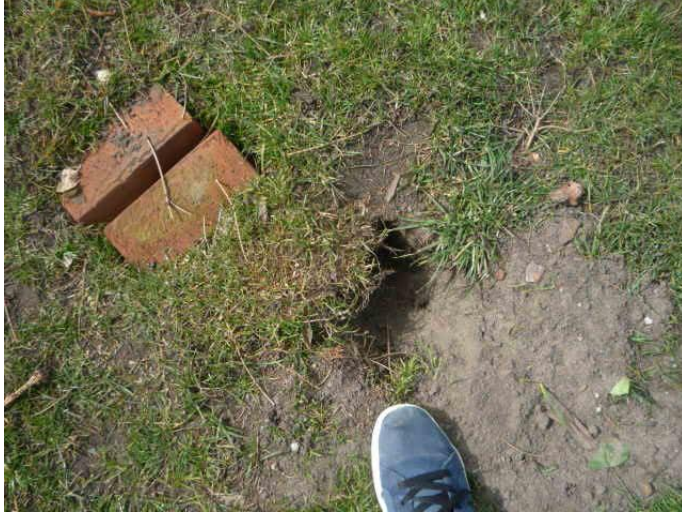
General surface – Grass –Recommend infill rabbit holes to eliminate trip hazards (ongoing) –Low to Medium risk.

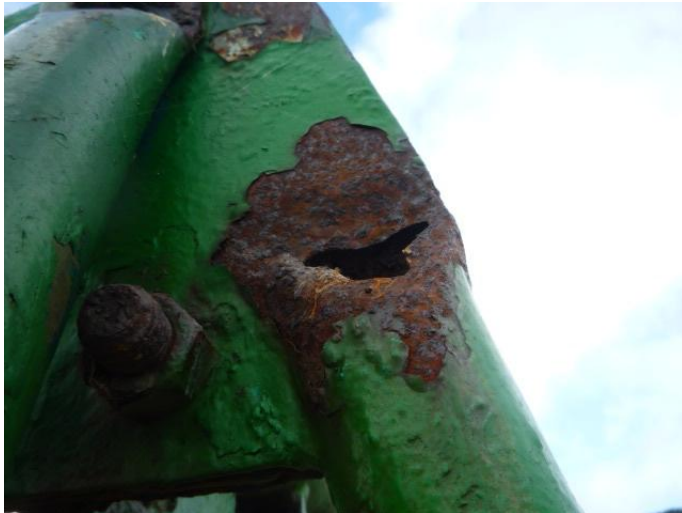
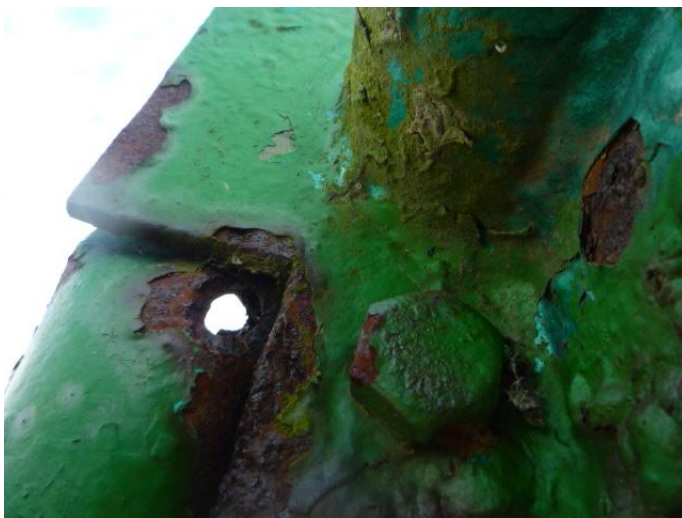
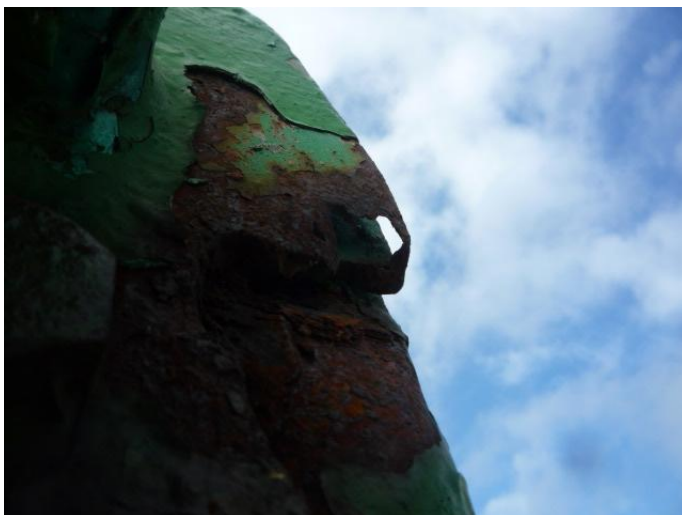
Recommend infill holes at top of support, remove rust and repaint entire item, further repairs may be required/revealed when rust has been removed – Medium risk.

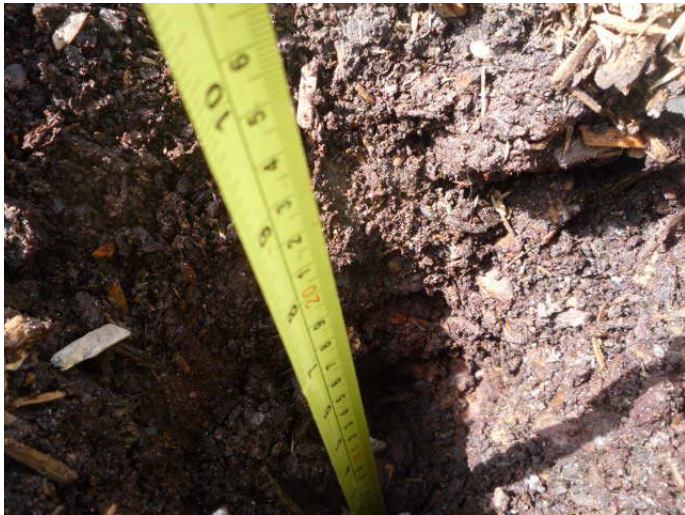
Loose fill levels are too low to provide adequate protection. Recommend fork over and top up (with Bark that complies with EN1176 recommendations) as required to maintain minimum depth (usually 300mm) – currently 240mm –Low risk.

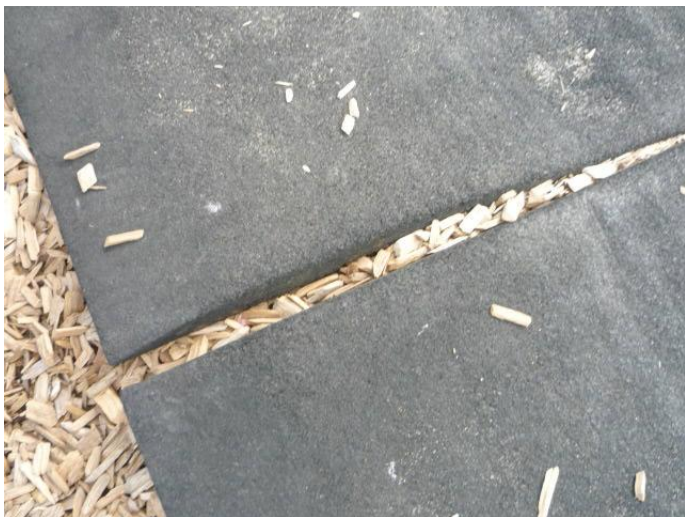
Surface is lifting. Recommend rearrange, re-glue and fill gaps and joints as necessary - Low risk.

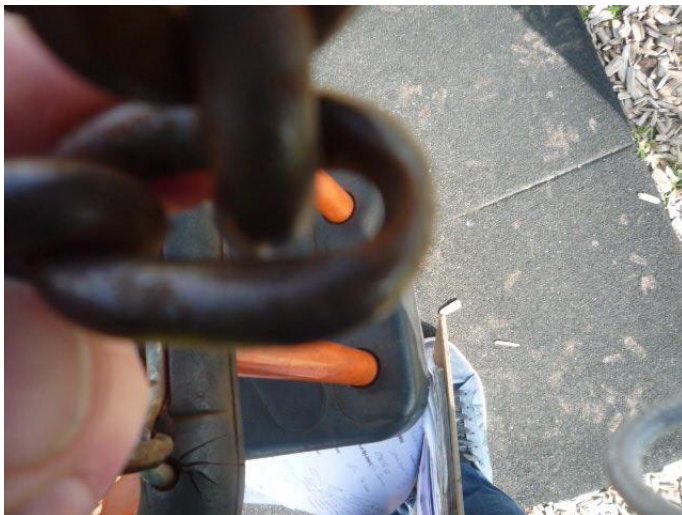
Chains worn, recommend monitor and replace when 40% worn –Low risk.

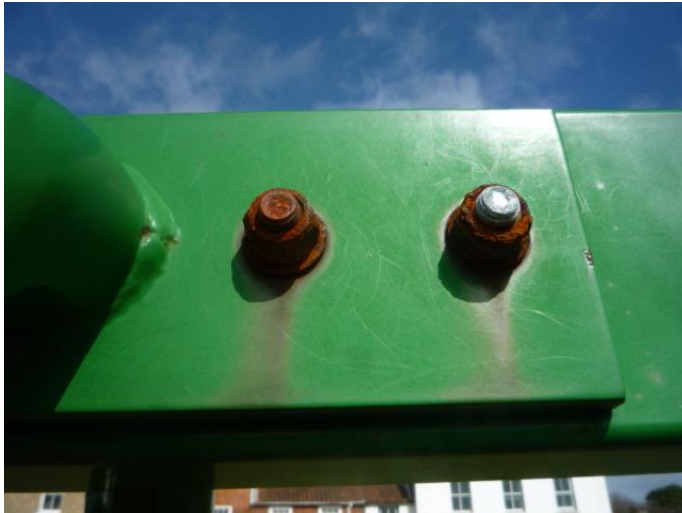
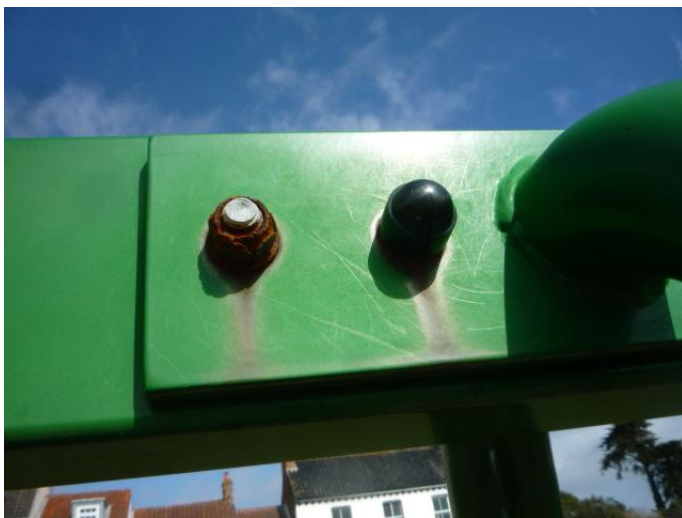
Recommend replace missing caps x 3 –Low risk.

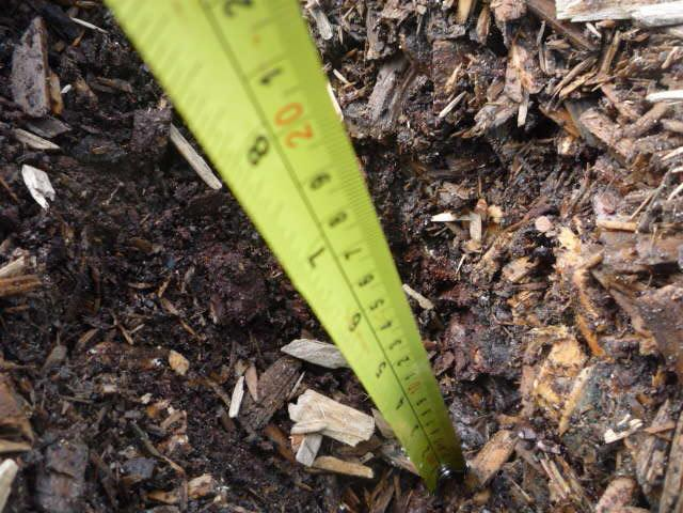
Loose fill levels are too low to provide adequate protection. Recommend fork over and top up (with Bark that complies with EN1176 recommendations) as required to maintain minimum depth (usually 300mm) - currently 200mm - Low risk.

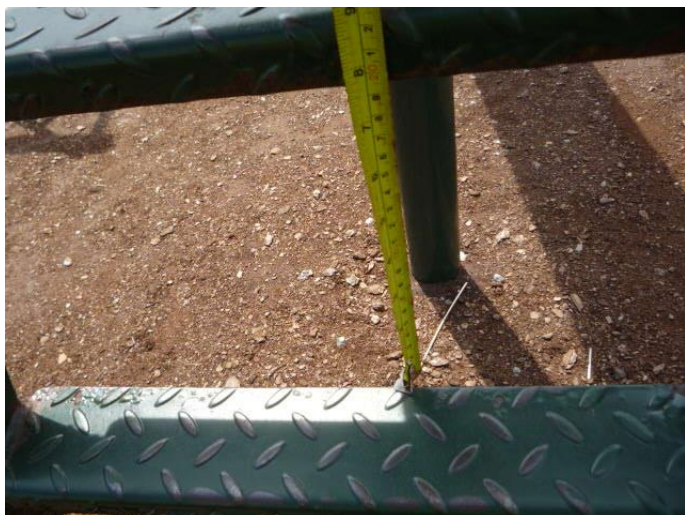
Access fails entrapment requirements (at steps) - Recommend monitor only – Low Risk.

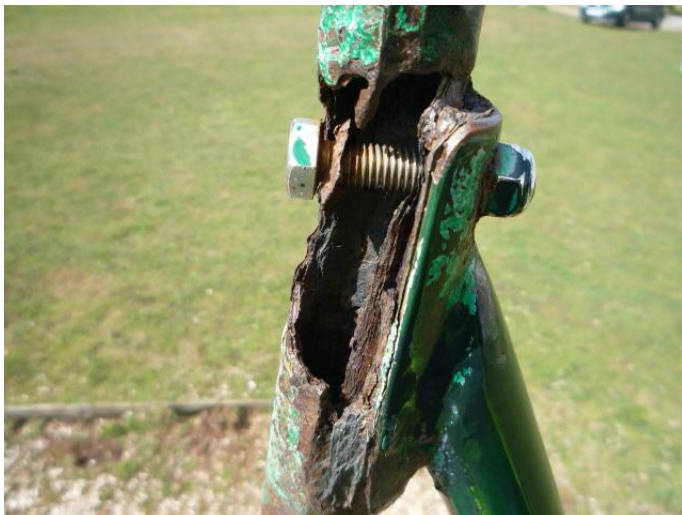
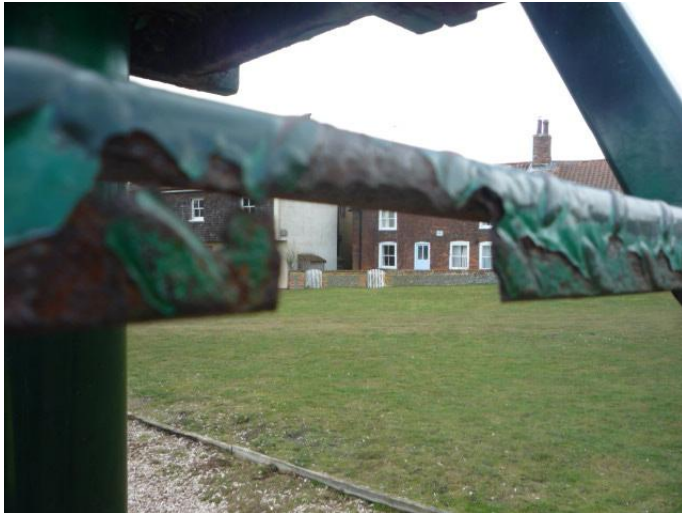
Recommend repair/replace rotten sections at slide barrier and at step (sharp edges) –Medium risk.

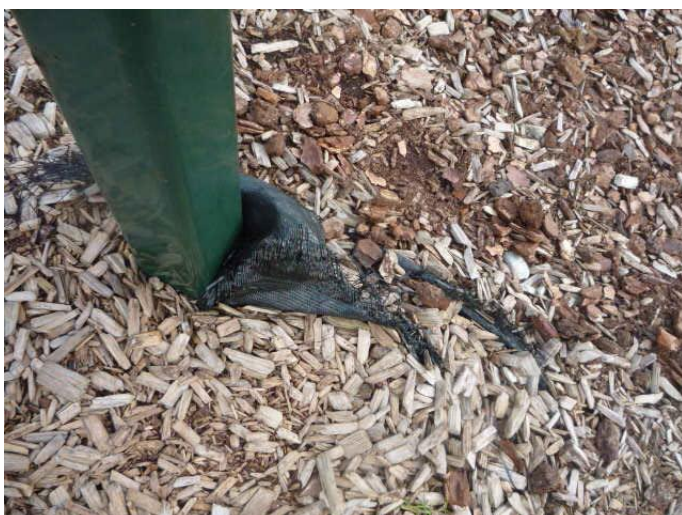
Loose fill levels are too low to provide adequate protection. Recommend fork over and top up (with Bark that complies with EN1176 recommendations) as required to maintain minimum depth (usually 300mm) – currently 170mm and geotextile is exposed – Low to Medium risk.
