PLAY AREA SAFETY INSPECTION REPORT

For Walberswick Common Lands Charity/Walberswick PC

On 31st May 2017

Play Area, Common, Church Lane, Walberswick

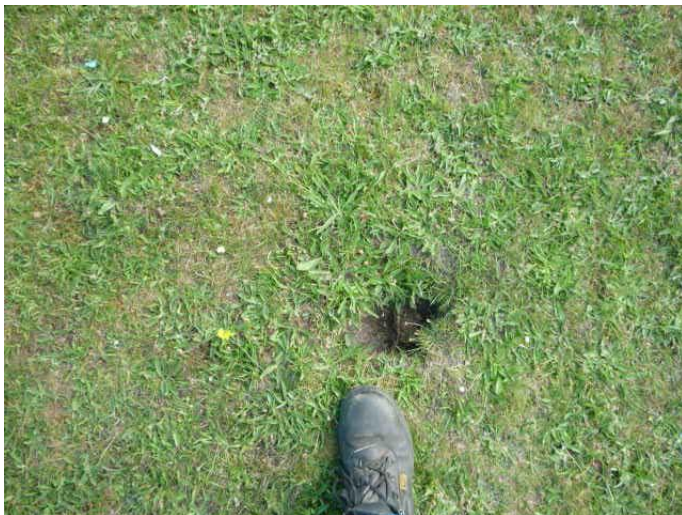
General surface –Grass –Recommend infill Rabbit holes, which are trip hazards (this should be an ongoing operation) –Low to Medium risk.

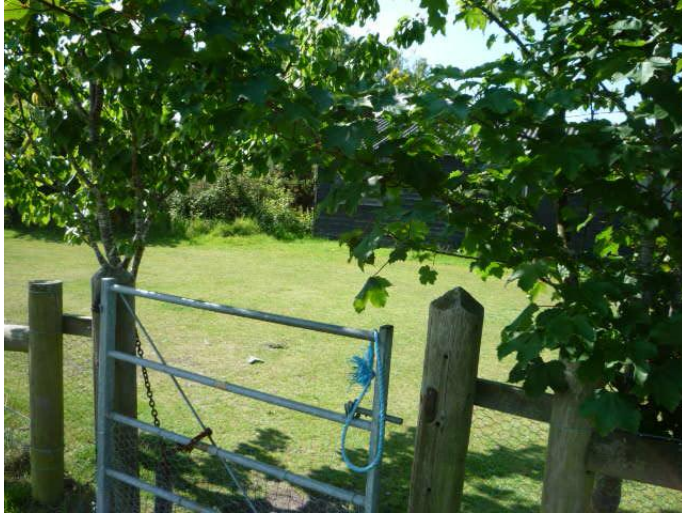
Planting –Recommend prune back from gate and access to seats – Low to Medium risk.

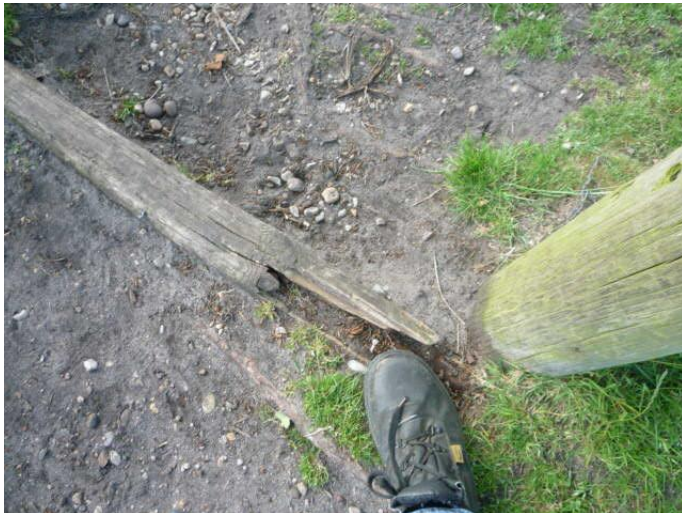
Access –Recommend removed damaged log under pedestrian gate, which is a trip hazard –Low to Medium risk.

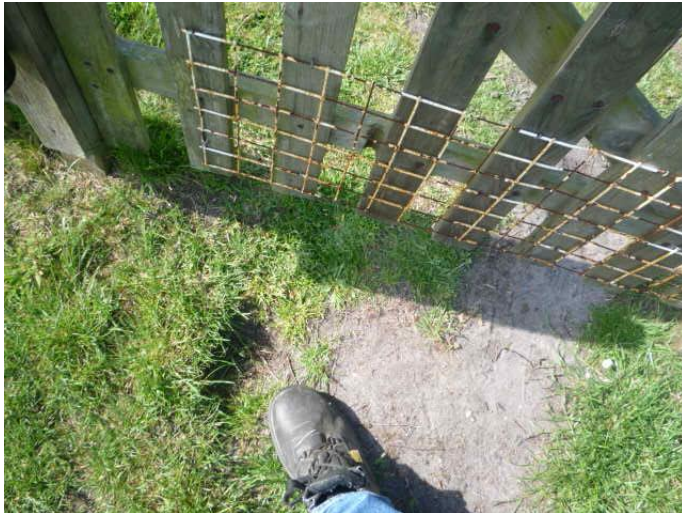
Recommend infill hole at gate –which is a trip hazard –Low to Medium risk.

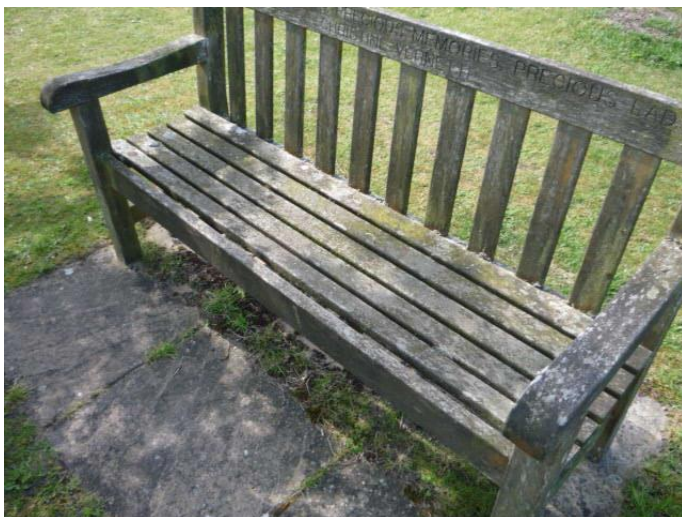
Seats x 3 –Timber preservation is in poor condition to one seat.
Recommend Rub Down and Stain with appropriate preservative. Most preservatives sold as child friendly by major DIY chains meet these standards.

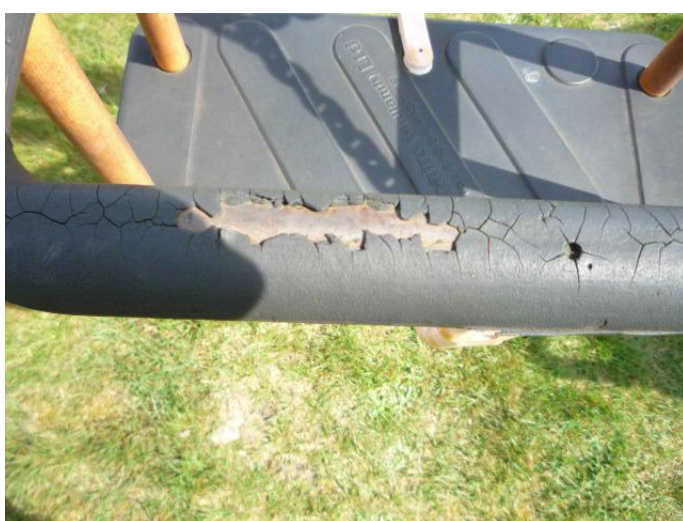
The swing seats have been damaged but do not require immediate replacement. Recommend tape over areas with exposed metal – Low risk.

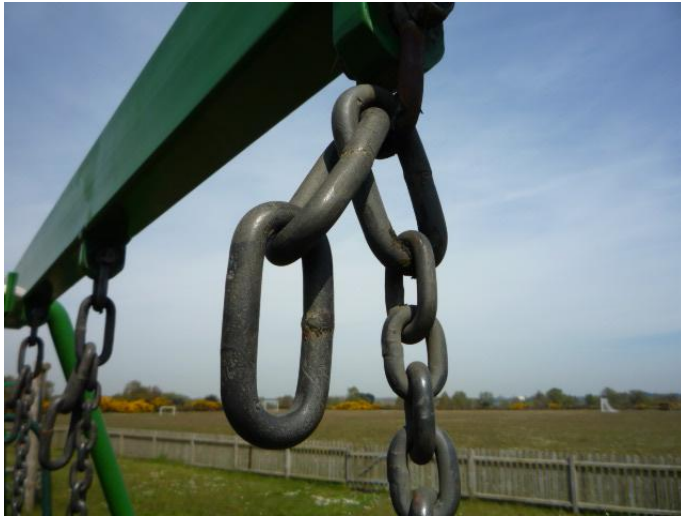
Recommend remove large unused chain links at top of suspensions –

Low risk.

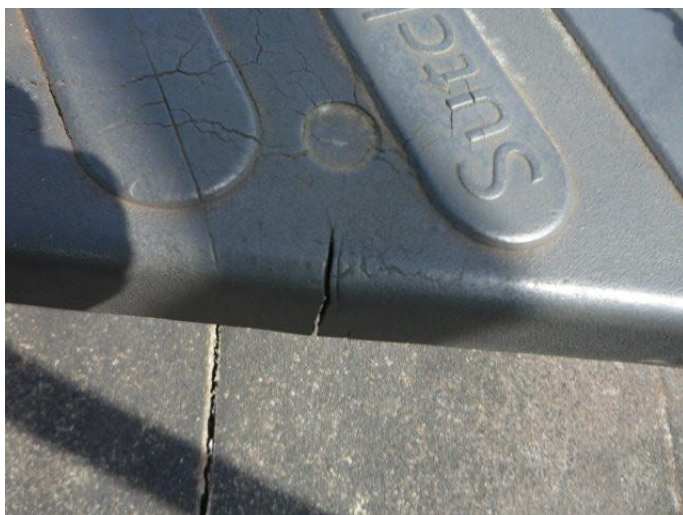
The swing seat has been damaged but does not require immediate replacement. Monitor and replace when hard material is exposed.

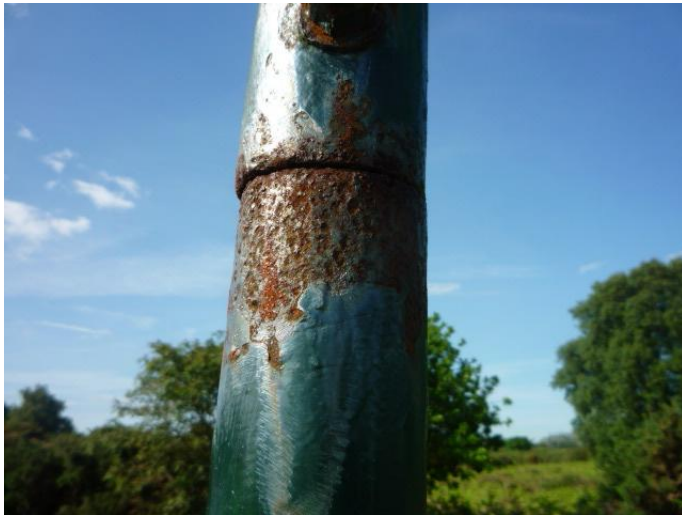
Paintwork is in poor condition. Recommend De-scale and coat with lead free paint, using appropriate precautions.

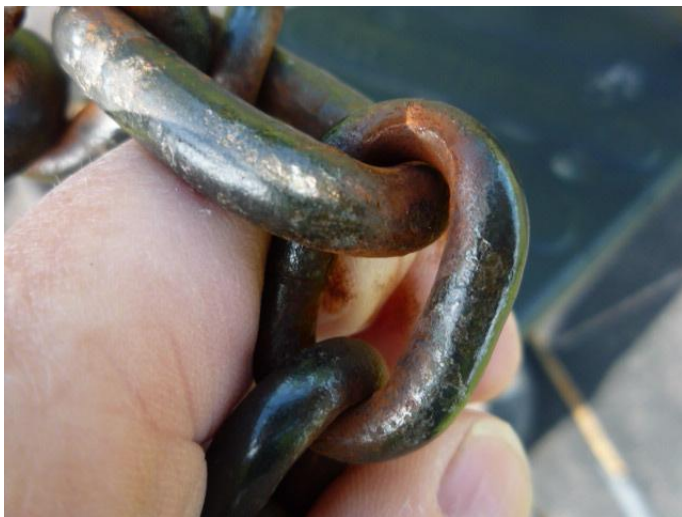
Some chain wear. Recommend Monitor for further deterioration and replace at 40% wear.

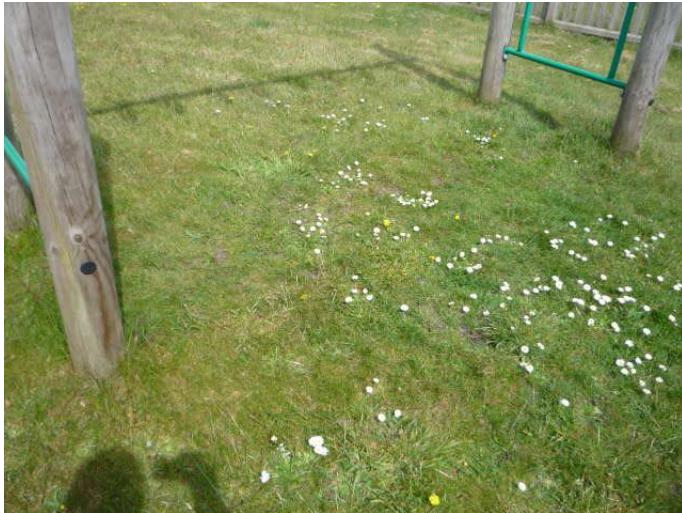
A protective surface is recommended for this item and should be programmed into future development- Recommend Matting to be installed to EN1176 (FFH 1900mm) – Low to Medium risk.

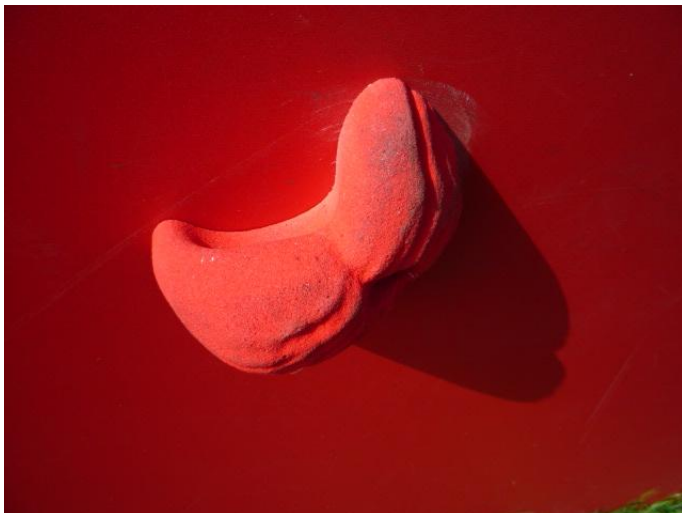
Recommend tighten loose climbing block (red) – Low to Medium risk.

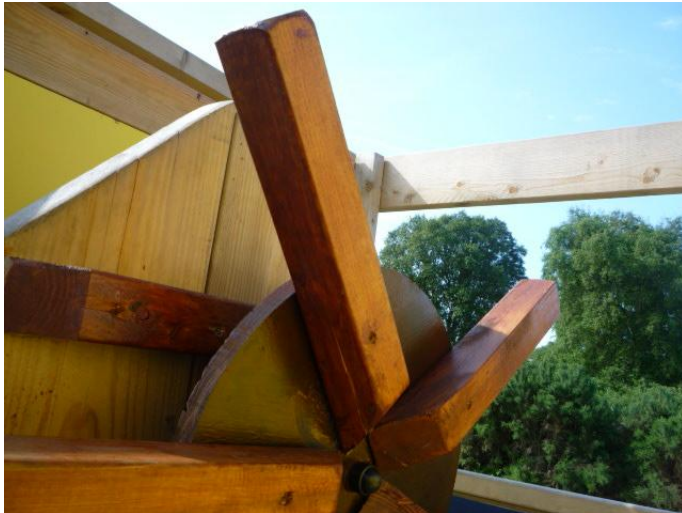
Recommend replace damaged wheel spoke –Low risk.

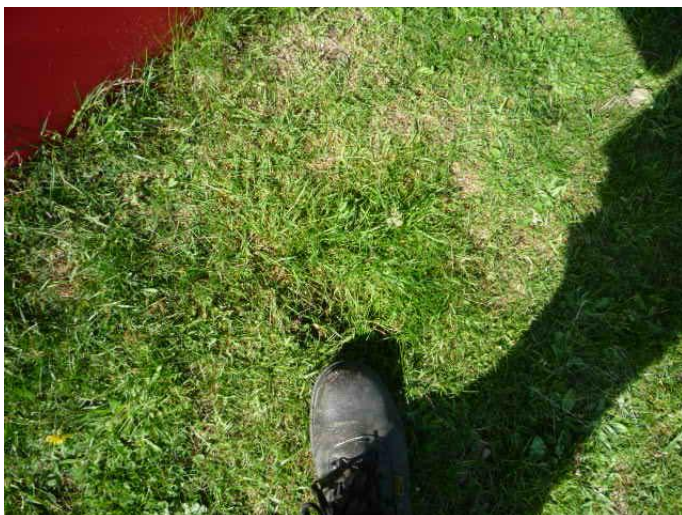
Recommend infill rabbit holes, which are trip hazards –Low to Medium risk.

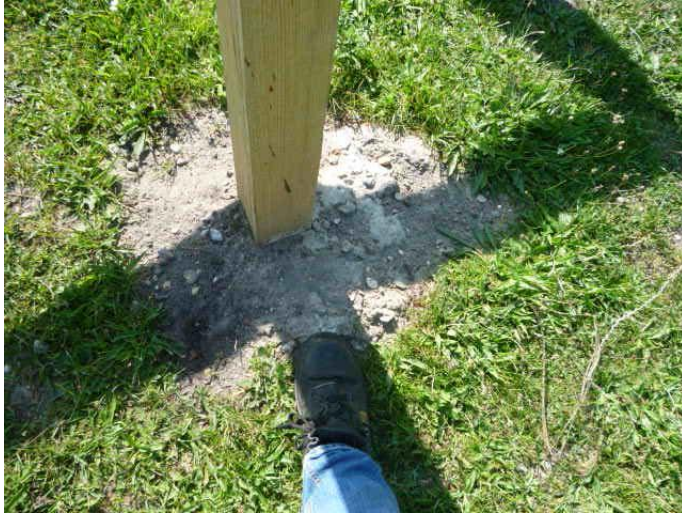
Recommend cover concrete at bottom of mast –Low risk.

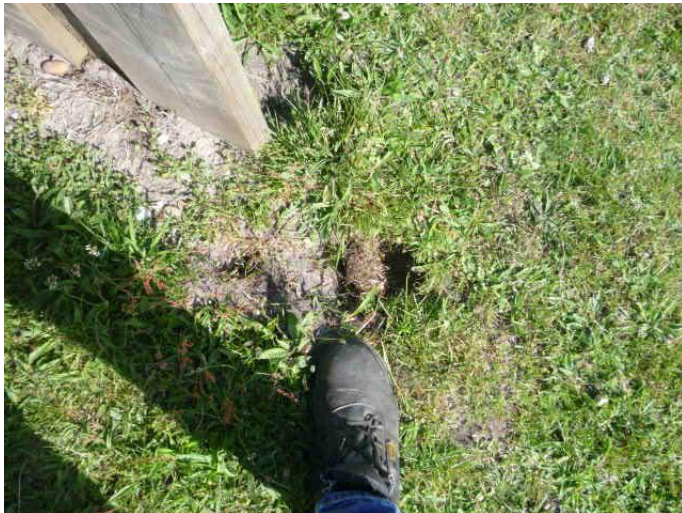
Recommend infill rabbit holes, which are trip hazards –Low to Medium risk.

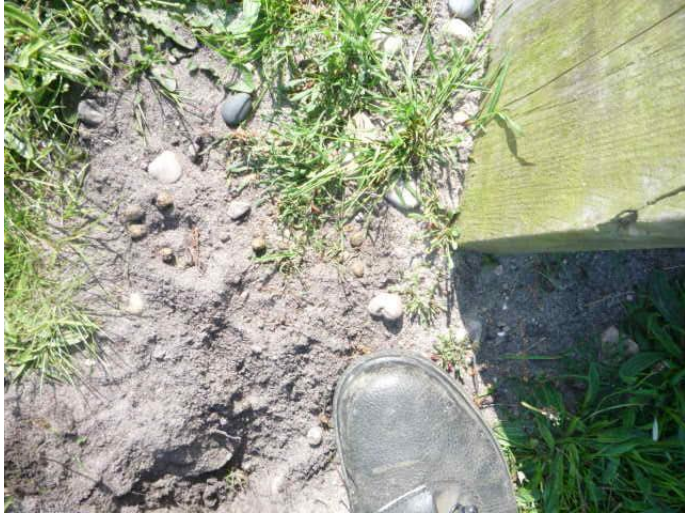
Recommend remove loose stones –Low risk.

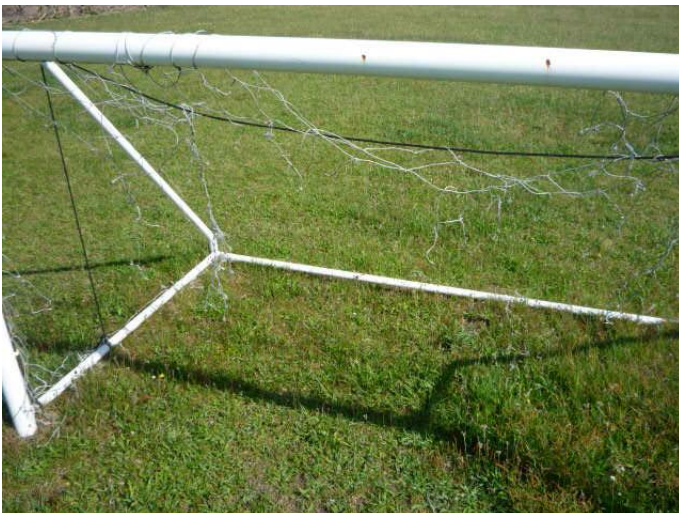
Recommend replace one damaged net –Low risk.

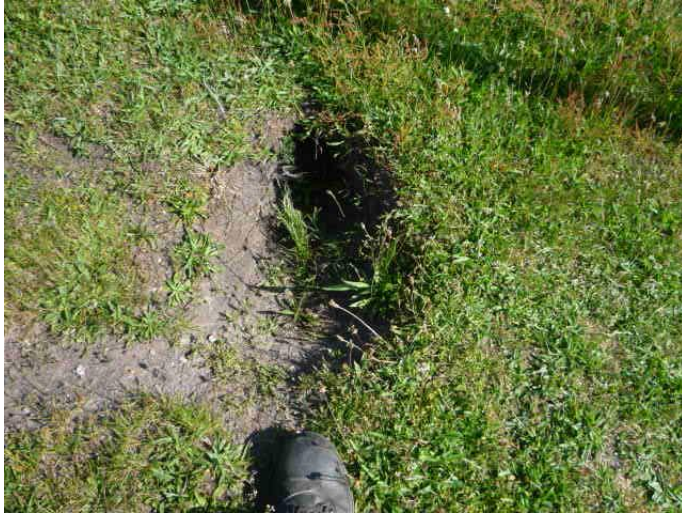
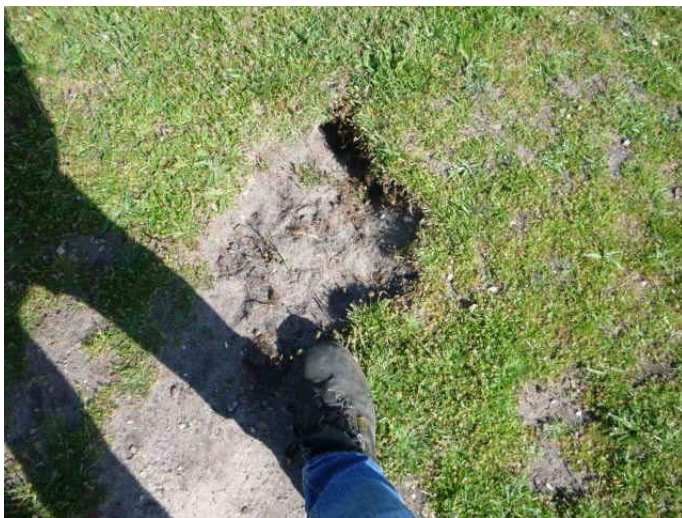
Recommend infill rabbit scrapes and make good worn areas with turf –
Low to Medium risk.

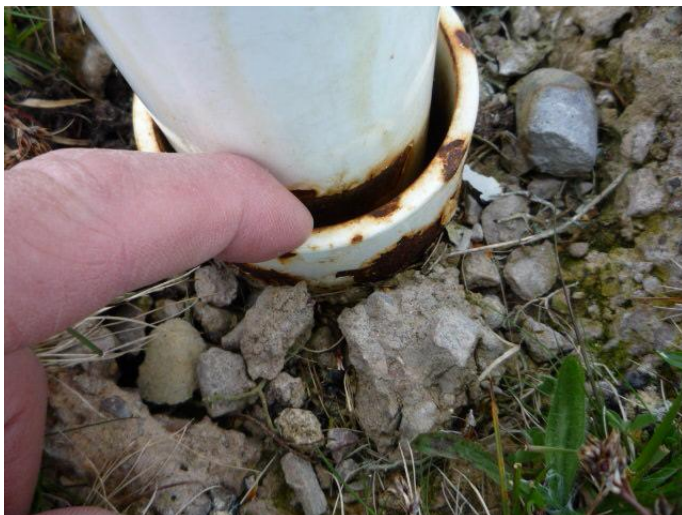
Finger entrapments in sockets x 4 –Recommend add wedges to eliminate entrapments.

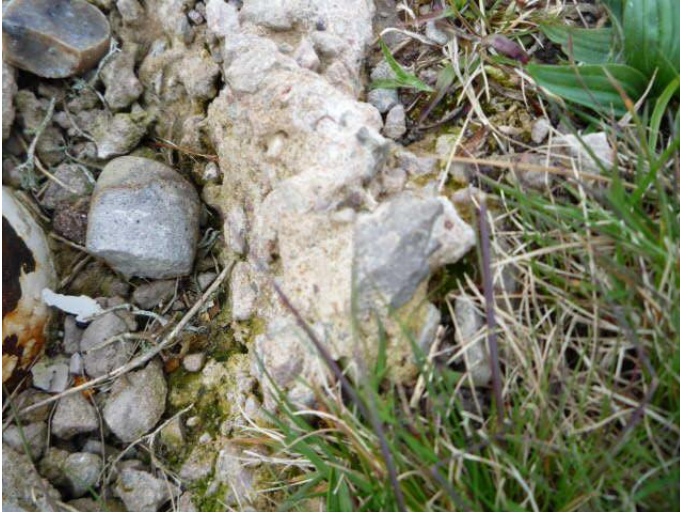
Concrete in fall space –Recommend cover or remove concrete –
Medium risk.

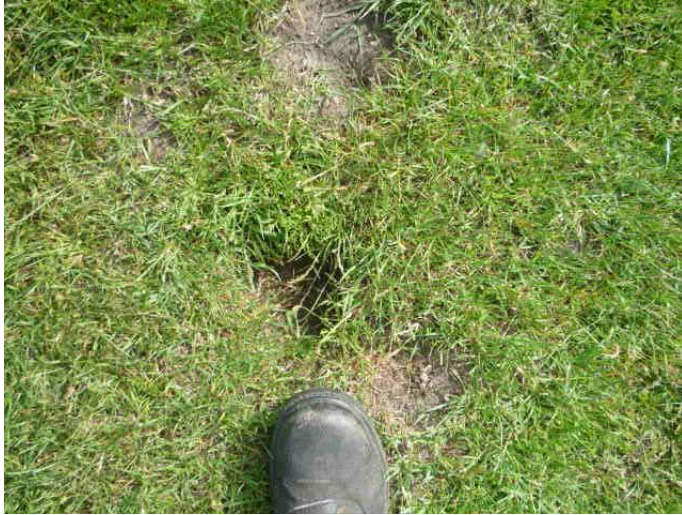
General surface – Grass –Recommend infill rabbit holes to eliminate trip hazards (ongoing) –Low to Medium risk.

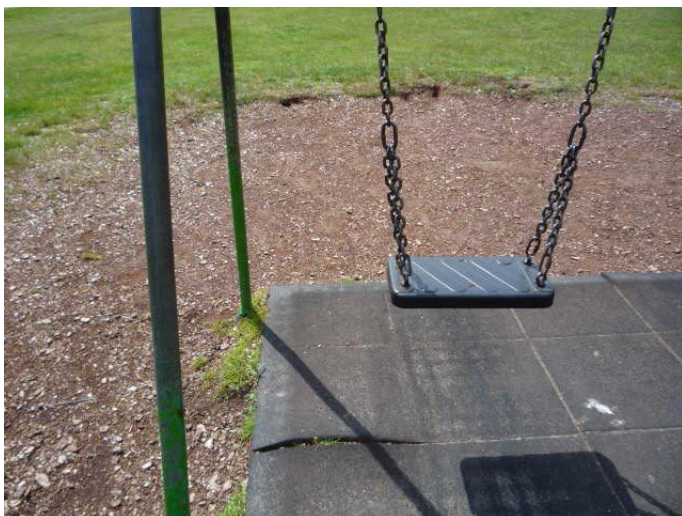
The distance between the seat side and the support is insufficient – Recommend Monitor – Low Risk.

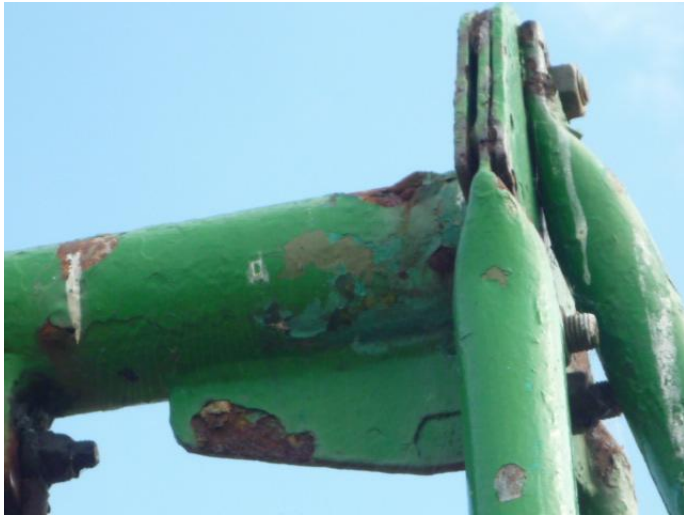
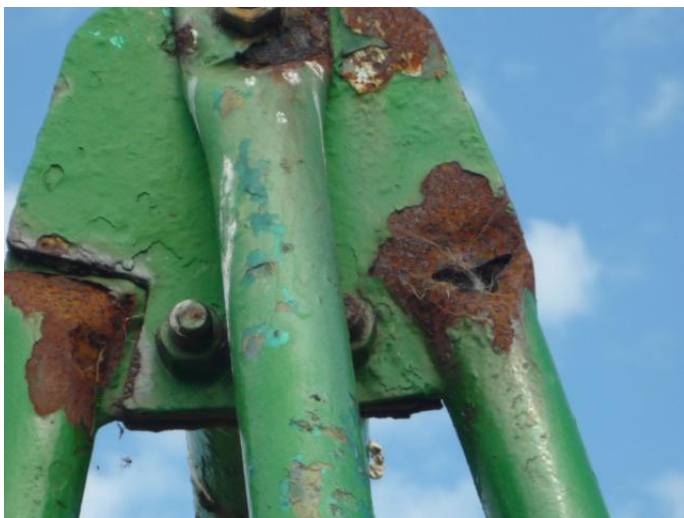
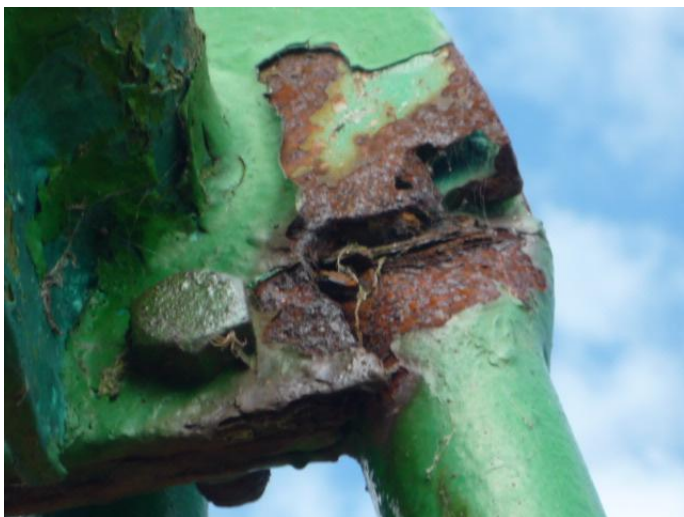
Recommend infill holes at top of support, remove rust and repaint entire item, further repairs may be required/revealed when rust has been removed –Low to Medium risk.

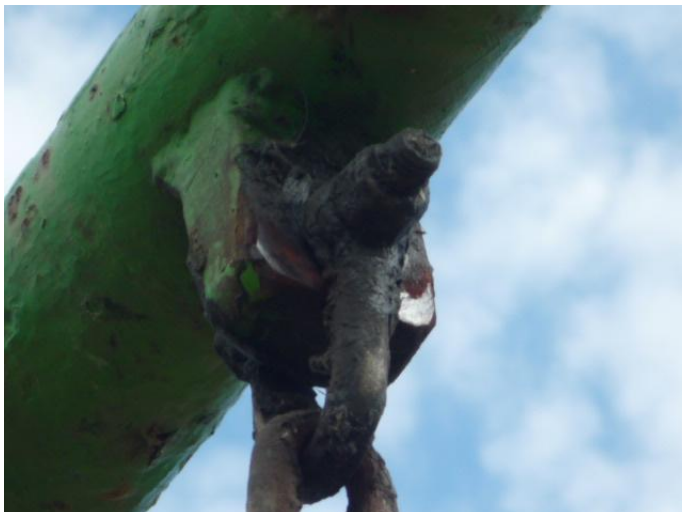
Recommend to remove shackle bolt and check bush and shackle pin wear, replacing if necessary.

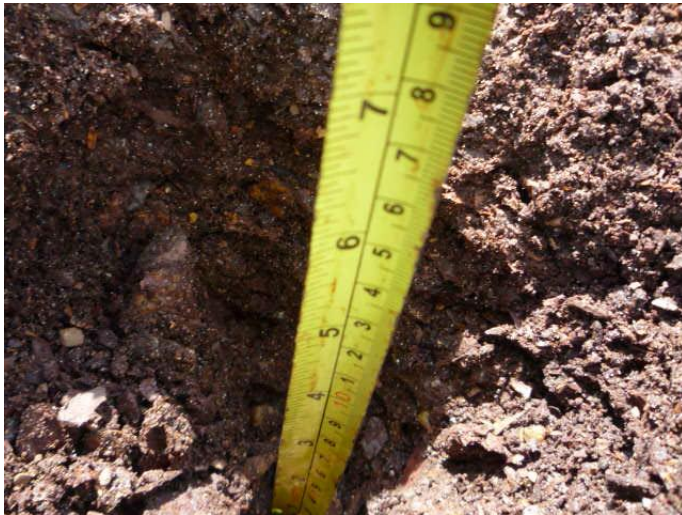
Loose fill levels are too low to provide adequate protection. Recommend fork over and top up (with Bark that complies with EN1176 recommendations) as required to maintain minimum depth (usually 300mm) – currently 180mm –Low risk.

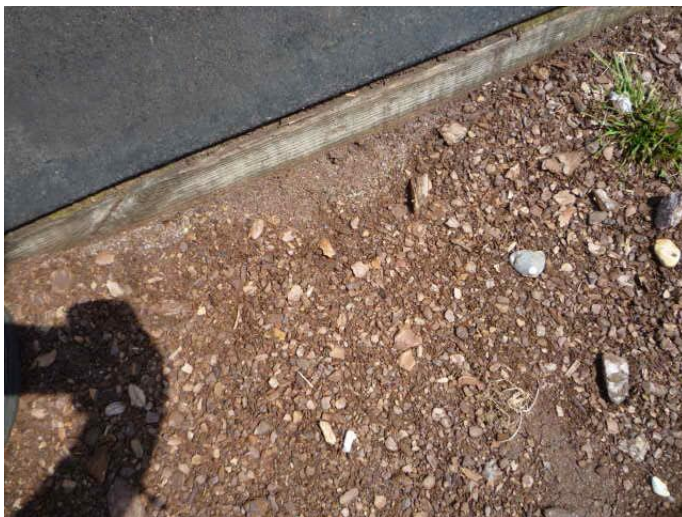
Trip zones found at edge of surface. Recommend build up ground levels to remove trip hazard (see above) - Low to Medium risk.

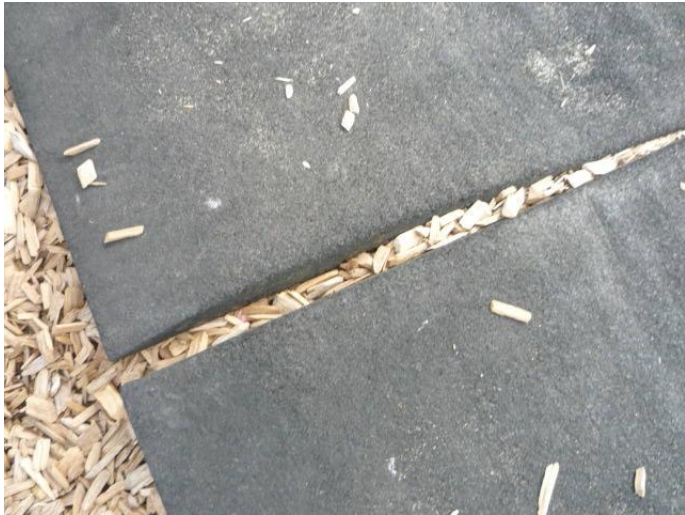
Surface is lifting. Recommend rearrange, re-glue and fill gaps and joints as necessary - Low risk.

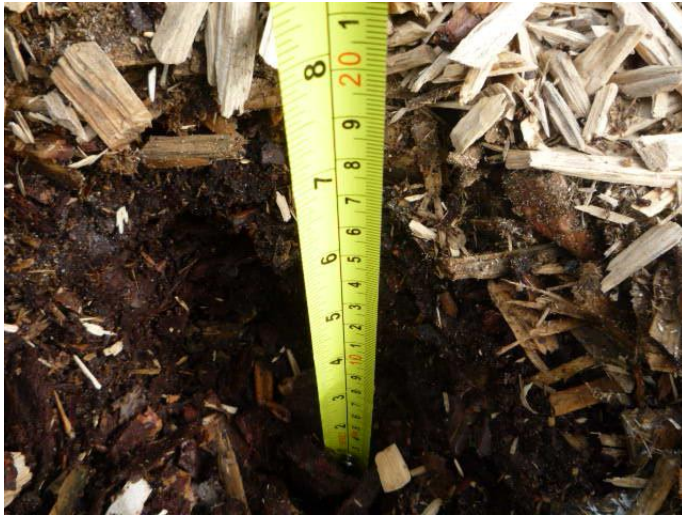
Loose fill levels are too low to provide adequate protection. Recommend fork over and top up (with Bark that complies with EN1176 recommendations) as required to maintain minimum depth (usually 300mm) - currently 180mm Low risk.

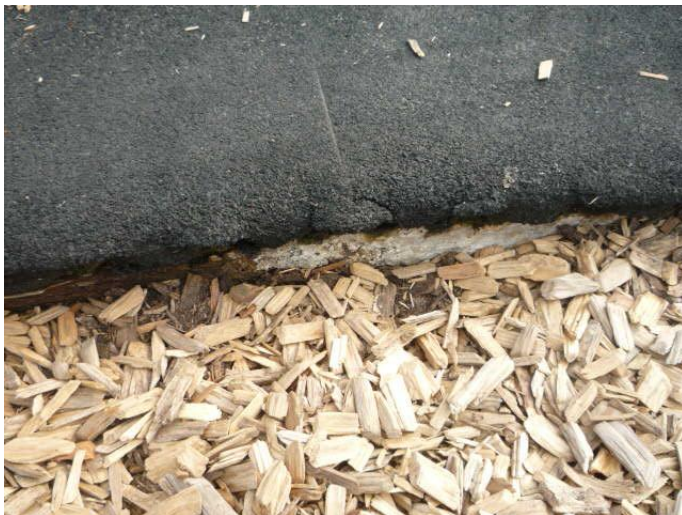
Trip zones found at edge of surface. Recommend build up ground levels to remove trip hazard (see above) – Low risk.

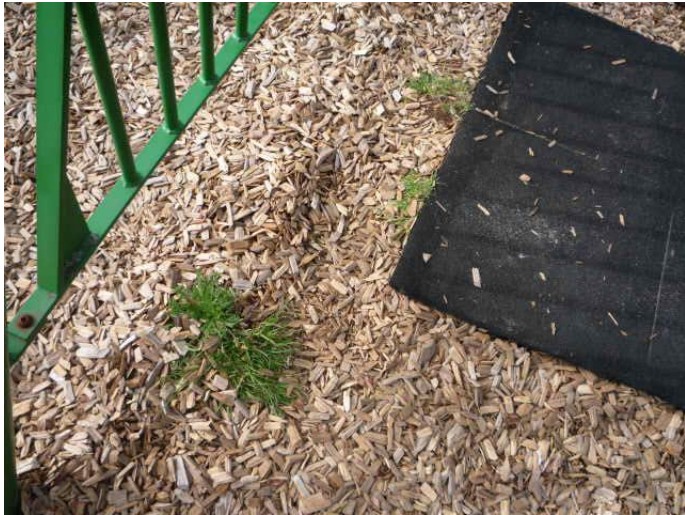
Recommend remove weed –Low risk.

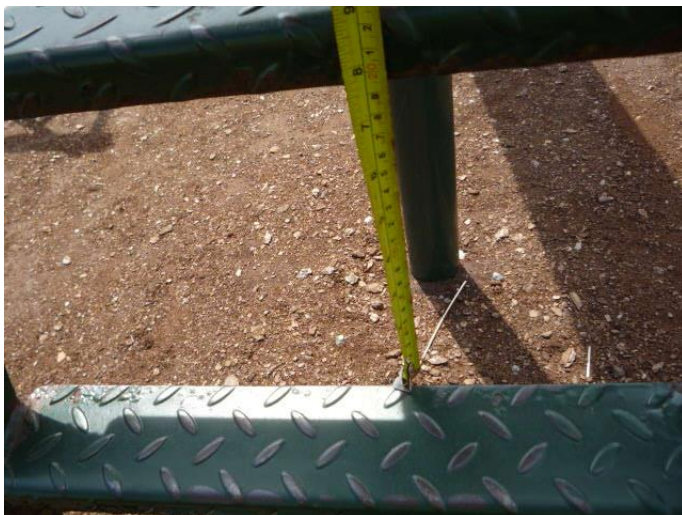
Access fails entrapment requirements (at steps) - Recommend monitor only – Low Risk.

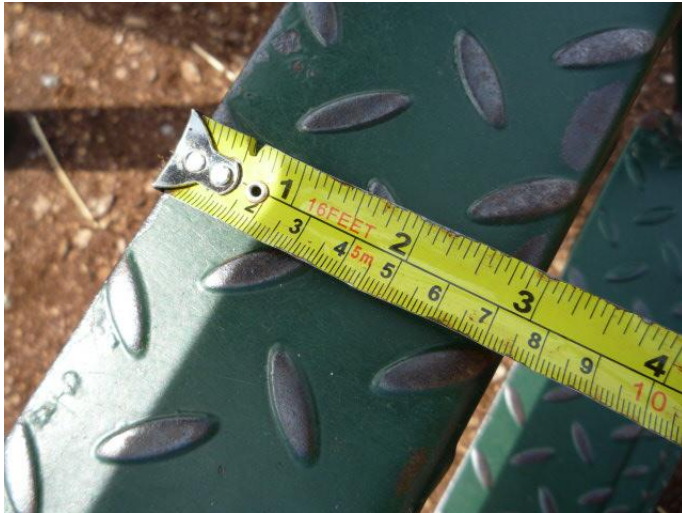
Width of steps fail EN1176 – Recommend monitor only –Low risk.

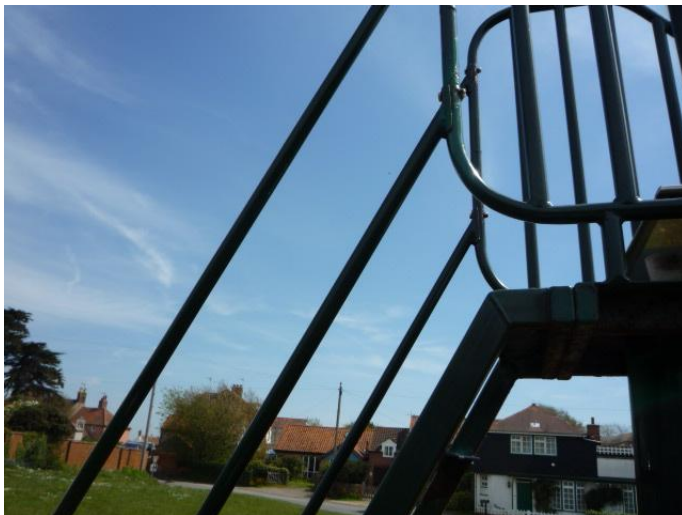
Steps should have infilled barriers –Recommend monitor only – Low risk.

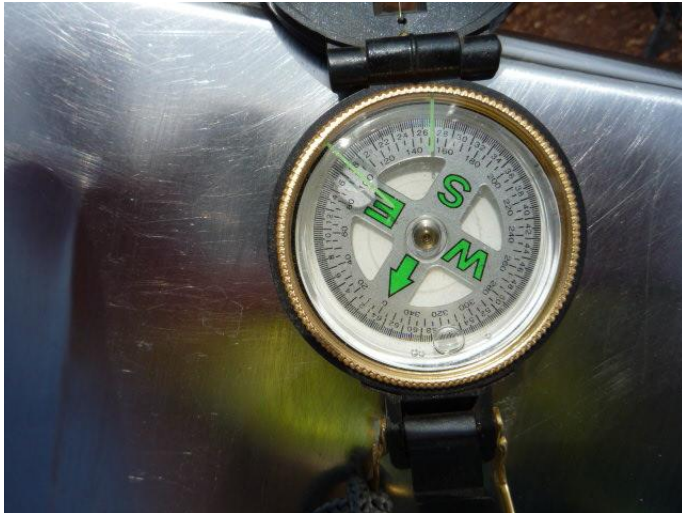
NB Although not part of EN1176 – the slide surface faces south and may suffer from solar gain and get hot during the summer – Recommend monitor –Low risk.

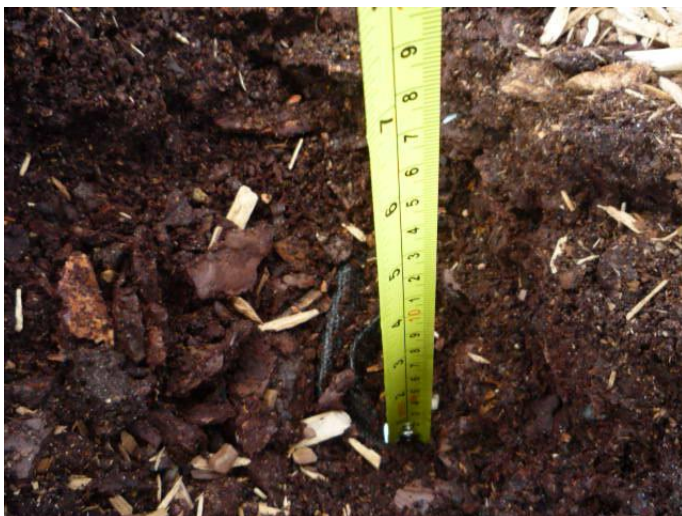
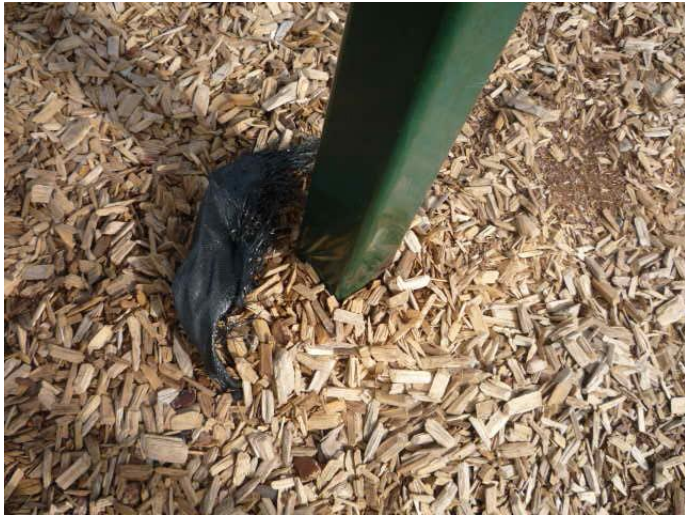
Loose fill levels are too low to provide adequate protection. Recommend fork over and top up (with Bark that complies with EN1176 recommendations) as required to maintain minimum depth (usually 300mm) – currently concrete and geotextile is exposed – Medium risk.
