# **PLAY AREA SAFETY INSPECTION REPORT**

**For Walberswick Common Lands Charity/Walberswick PC**

On 6<sup>th</sup> May 2016

Play Area, Common, Church Lane, Walberswick

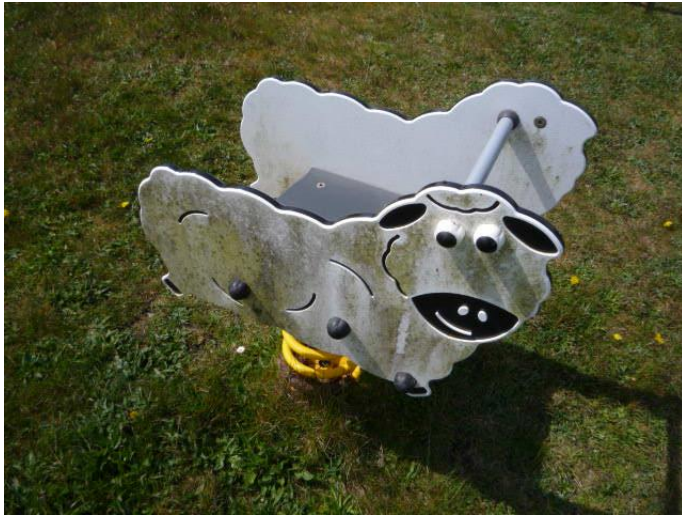
**Item: Springy Sheep - Fahr**

The item meets the requirements of EN1176 where this may be tested on site without dismantling or destruction.

Recommend clean off algae.

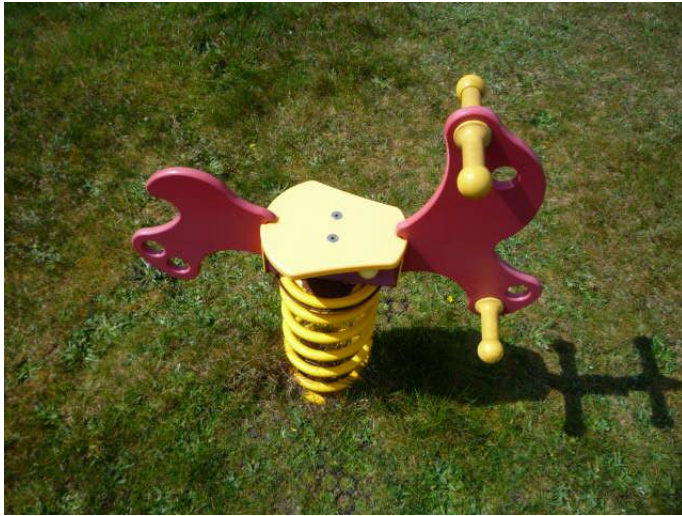
**Item: Spriny Racer - Playquip**

The item meets the requirements of EN1176 where this may be tested on site without dismantling or destruction.

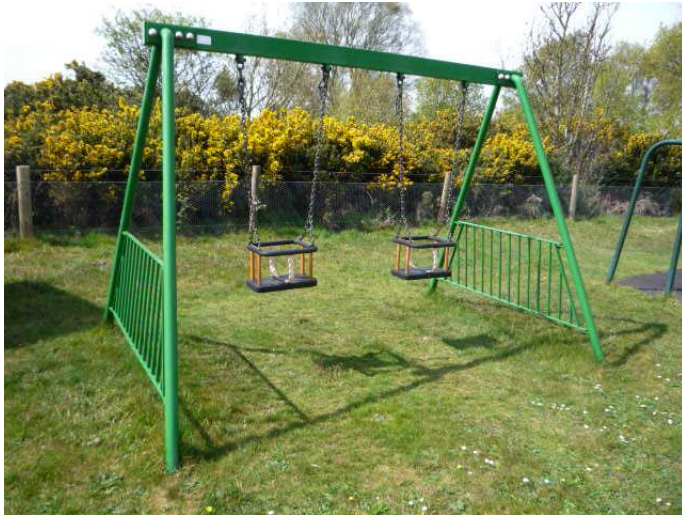
**Item: 1 Bay 2 Cradle Seat Swing (2000mm) - Playquip**

The item meets the requirements of EN1176 where this may be tested on site without dismantling or destruction.

The swing seat has been damaged but does not require immediate replacement. Recommend tape over areas with exposed metal – Low risk.

Recommend remove large unused chain links at top of suspensions – Low risk.

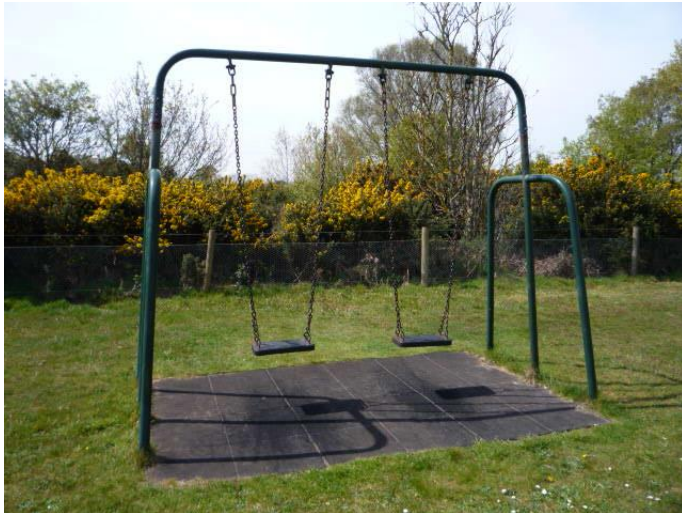
**Item: 1 Bay 2 Flat Seat Swing (2400mm)– Sutcliffe Leisure**

The item meets the requirements of EN1176 where this may be tested on site without dismantling or destruction.

The swing seat has been damaged but does not require immediate replacement. Monitor and replace when hard material is exposed.

Recommend infill holes in two supports and repaint areas - Low risk.

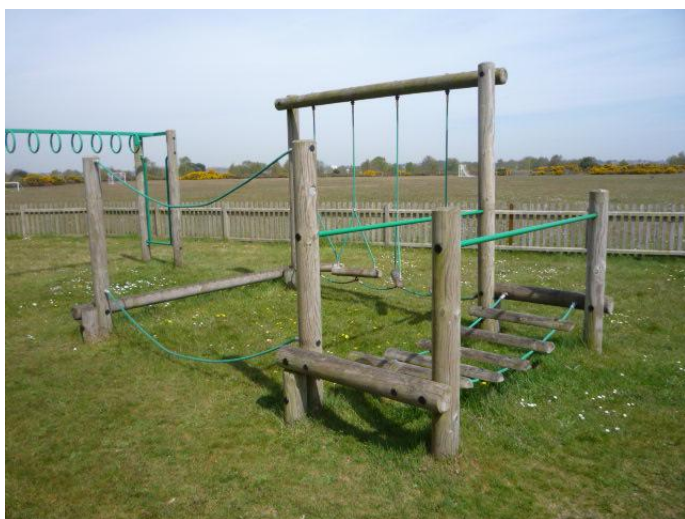
## **Adventure Cube – Evans**

The item meets the requirements of EN1176 where this may be tested on site without dismantling or destruction.

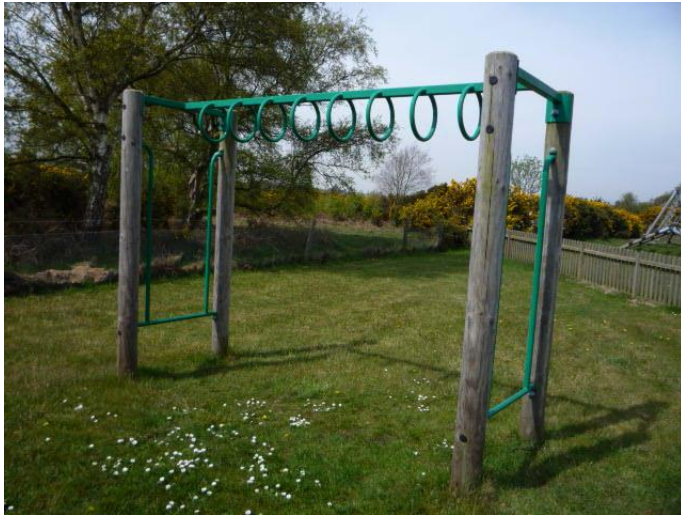
## **Item: Ring Ladder - Evans**

The item meets the requirements of EN1176 where this may be tested on site without dismantling or destruction.

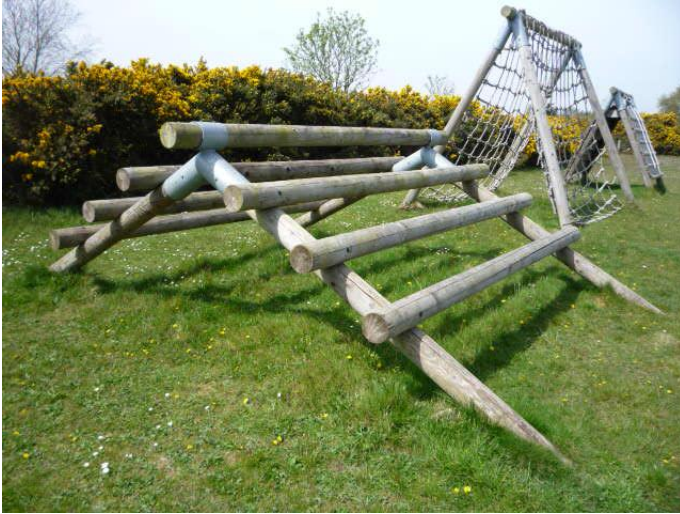
## **Item: Log Climber – Evans?**

The item fails to meet the requirements of EN1176 in the following respects:

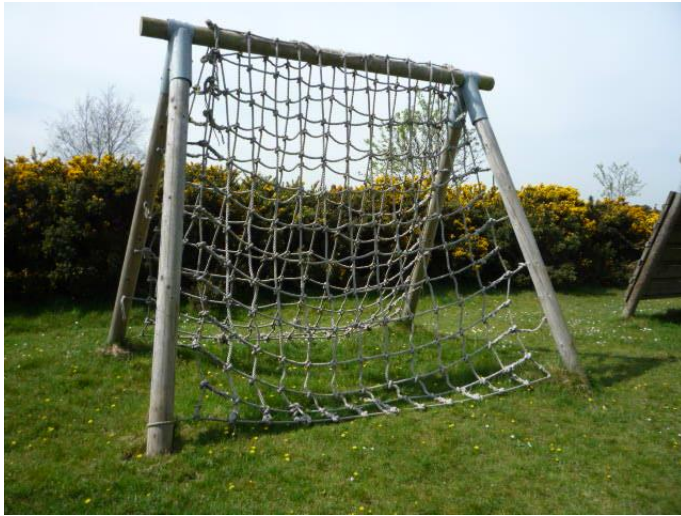
## Item: Net Climber – Evans?

The item fails to meet the requirements of EN1176 in the following respects:

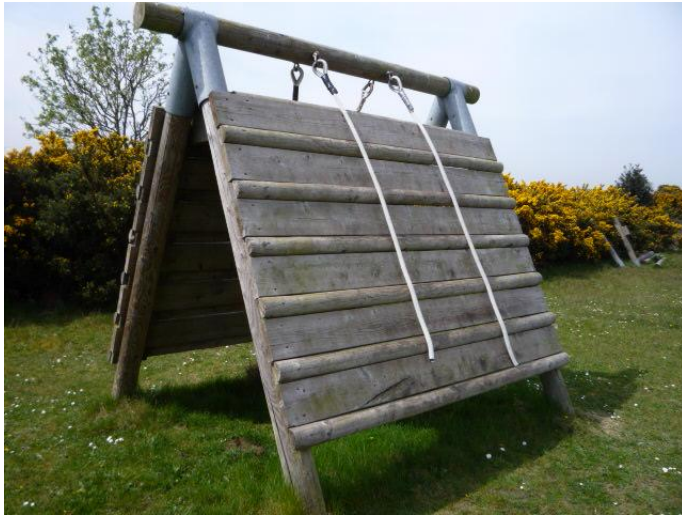
## Item: Ramp –Evans?

The item fails to meet the requirements of EN1176 in the following respects:

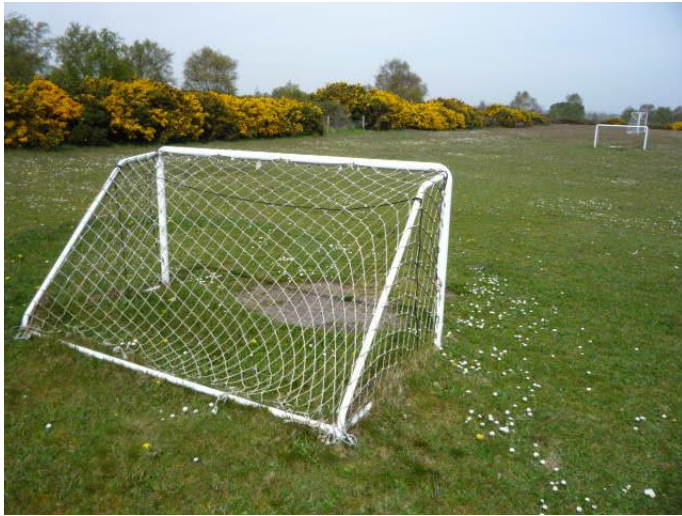
## **Item: 2 Small Size Goals**

The item meets the requirements of BSEN 748 where this may be tested on site without dismantling or destruction.

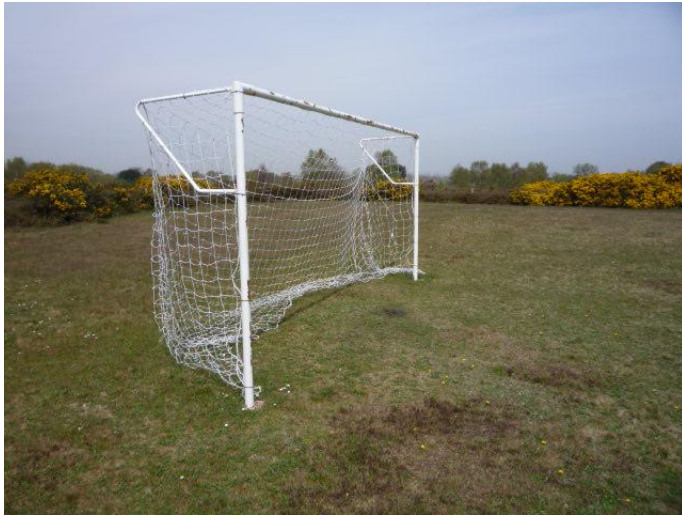
## **Item: Two Full Size Goals**

Full size goals fail to conform to BSEN 748 in the following:

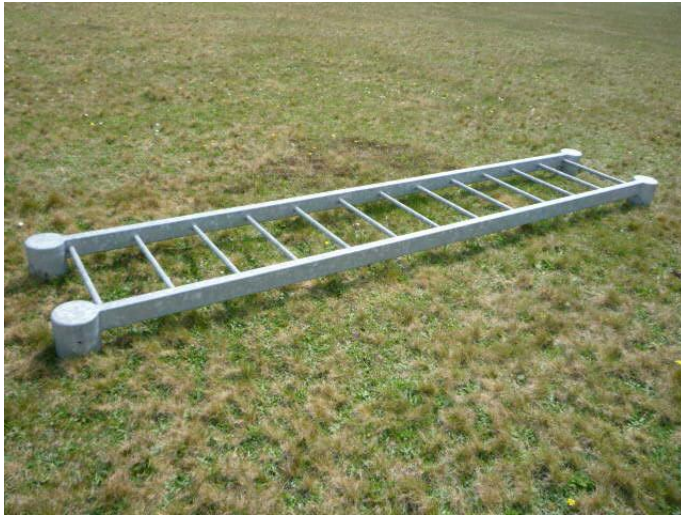
## **Item: Ladder –Evans?**

The item meets the requirements of EN1176 where this may be tested on site without dismantling or destruction.

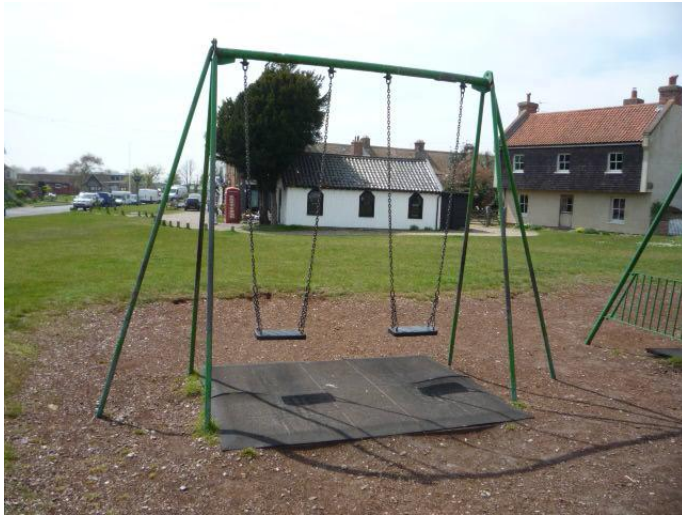
**Item: 1 Bay 2 Flat Seat Swing (2700mm)**

The distance between the seat side and the support is insufficient – Recommend Monitor – Low Risk.

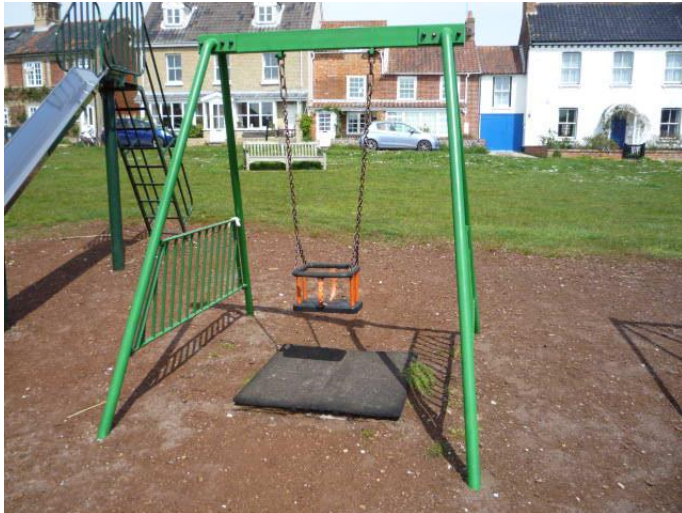
**Item: 1 Bay 1 Cradle Seat Swing (2000mm) - Playquip**

The item meets the requirements of EN1176 where this may be tested on site without dismantling or destruction.

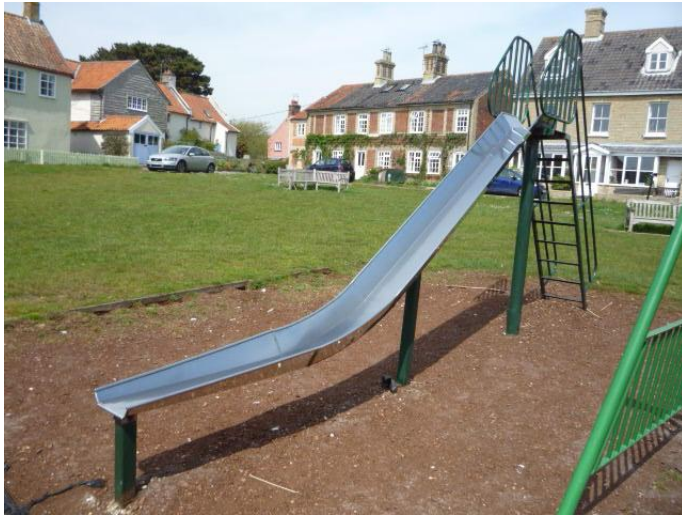
**Item: Slide (2000mm) – Wicksteed Leisure**

The item fails to meet the requirements of EN1176 in the following respects:
