# **PLAY AREA SAFETY INSPECTION REPORT**

**For Walberswick Common Lands Charity/Walberswick PC**

On 23rd March 2018

Play Area, Common, Church Lane, Walberswick

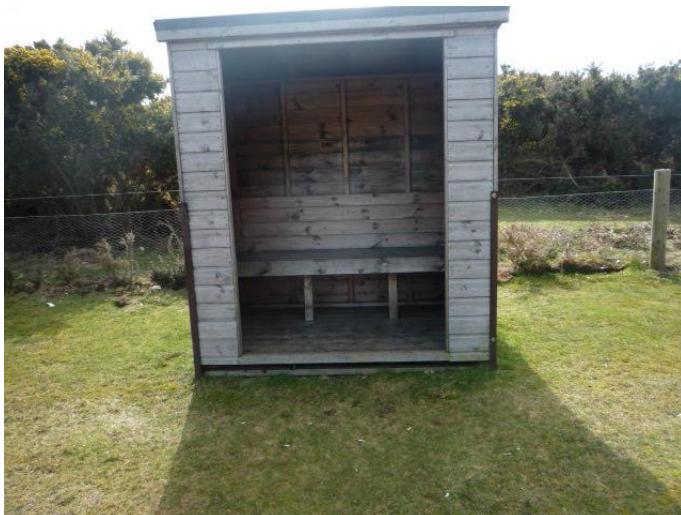
General surface –Grass –Recommend infill Rabbit holes, which are trip hazards (this should be an ongoing operation) –Low to Medium risk.

Access –Recommend removed damaged log under pedestrian gate, and remove /cover roots which are a trip hazard –Low to Medium risk.

Seats x 3 – Timber preservation is in poor condition to one seat. Recommend Rub Down and Stain with appropriate preservative. Most preservatives sold as child friendly by major DIY chains meet these standards.

Dog Ban and Ownership signs recommended.

Pictogram 'No Dog' signs are also strongly recommended

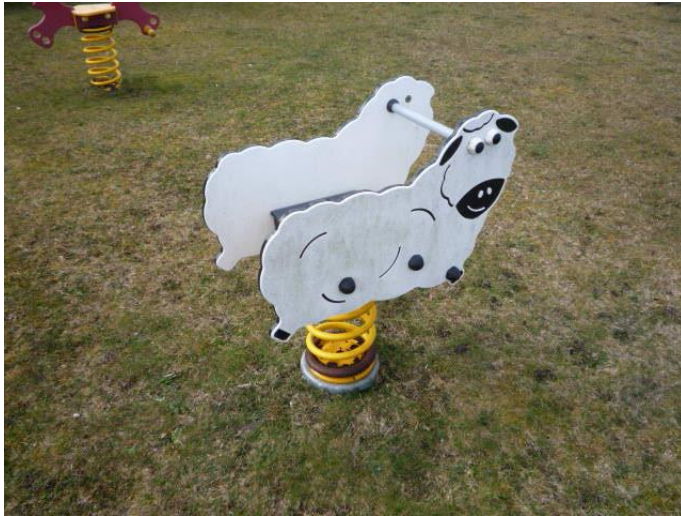
## **Item: Springy Sheep - Fahr**

The item meets the requirements of EN1176 where this may be tested on site without dismantling or destruction.

The surfacing is in satisfactory condition and no work is required at this time.

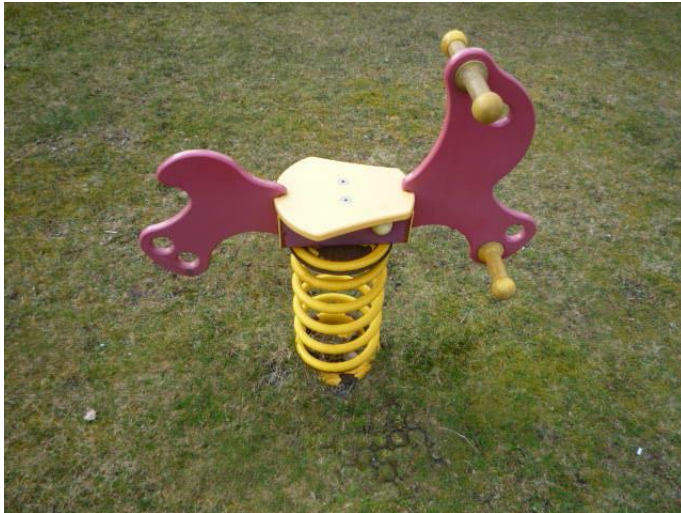
**Item: Springy Racer - Playquip**

The item meets the requirements of EN1176 where this may be tested on site without dismantling or destruction.

The surfacing is in satisfactory condition and no work is required at this time.

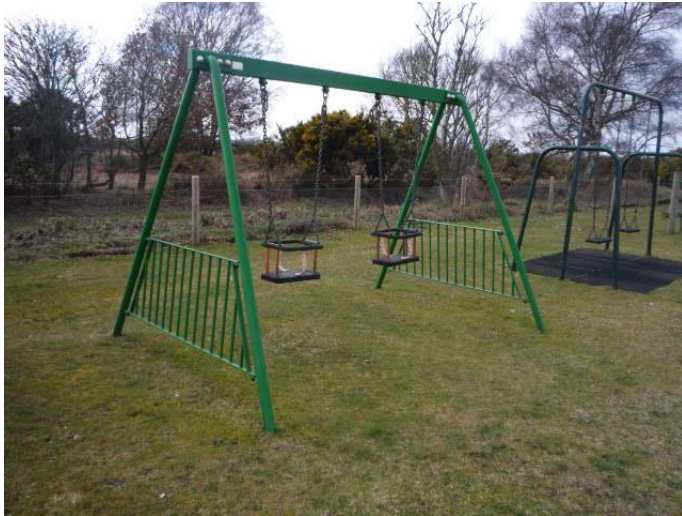
**Item: 1 Bay 2 Cradle Seat Swing (2000mm) - Playquip**

The item meets the requirements of EN1176 where this may be tested on site without dismantling or destruction.

The surfacing is in satisfactory condition and no work is required at this time.

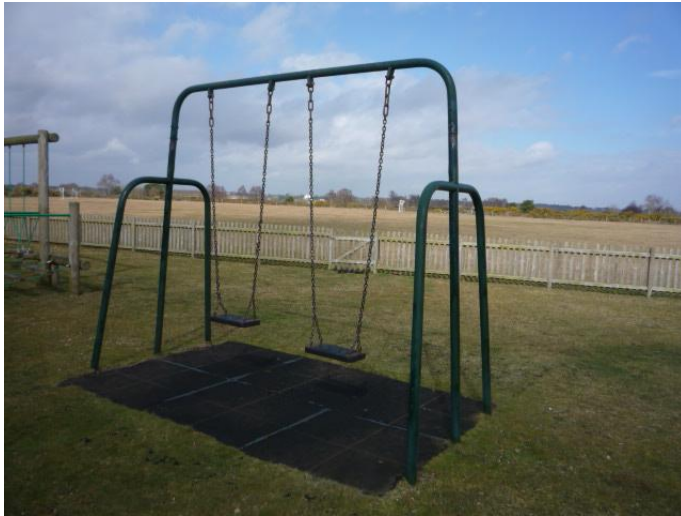
**Item: 1 Bay 2 Flat Seat Swing (2400mm)– Sutcliffe Leisure**

The item meets the requirements of EN1176 where this may be tested on site without dismantling or destruction.

The surfacing is in satisfactory condition and no work is required at this time.

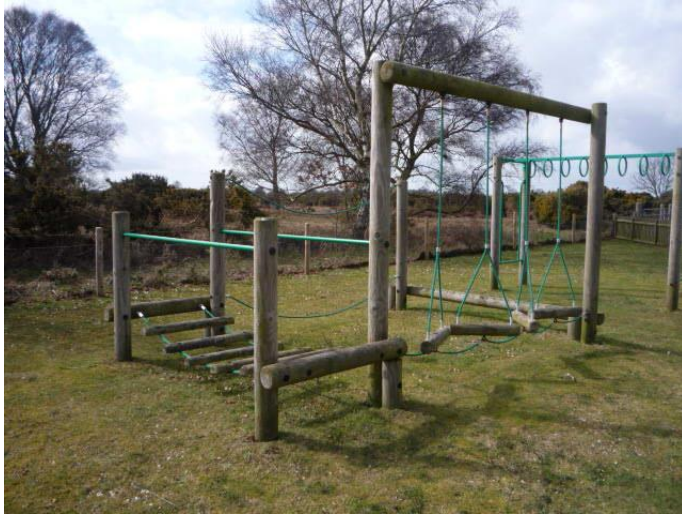
## **Adventure Cube – Evans**

The item meets the requirements of EN1176 where this may be tested on site without dismantling or destruction.

The surfacing is in satisfactory condition and no work is required at this time.

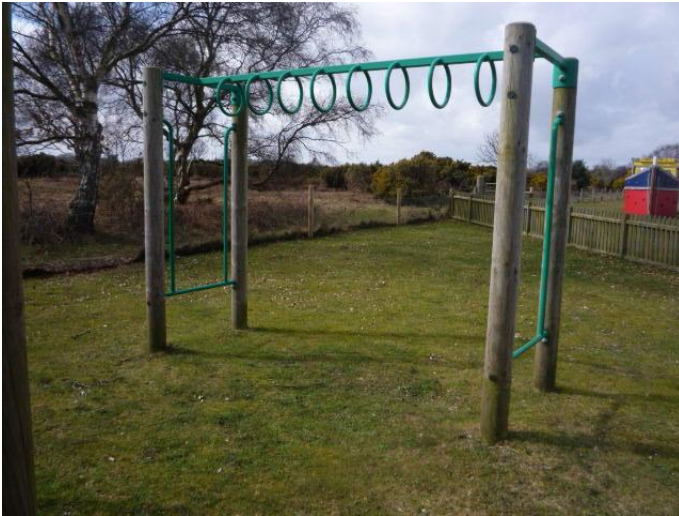
## **Item: Ring Ladder - Evans**

The item meets the requirements of EN1176 where this may be tested on site without dismantling or destruction.

The surfacing is in satisfactory condition and no work is required at this time.

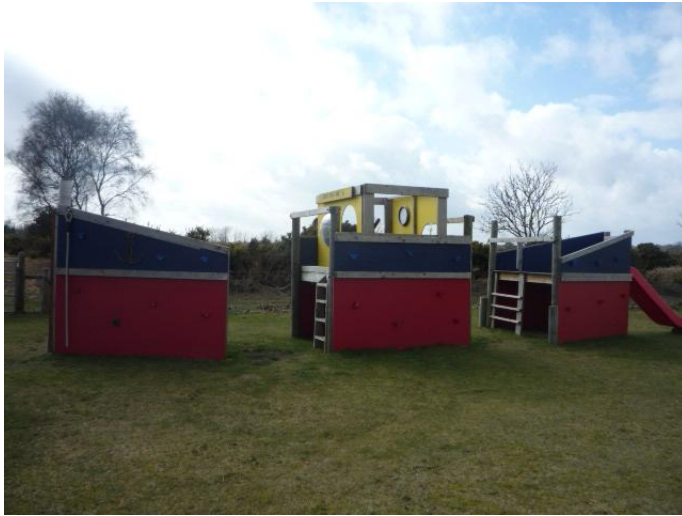
## **Large Boat – Marriot Play and Leisure**

The item fails to meet the requirements of EN1176 in the following respects:

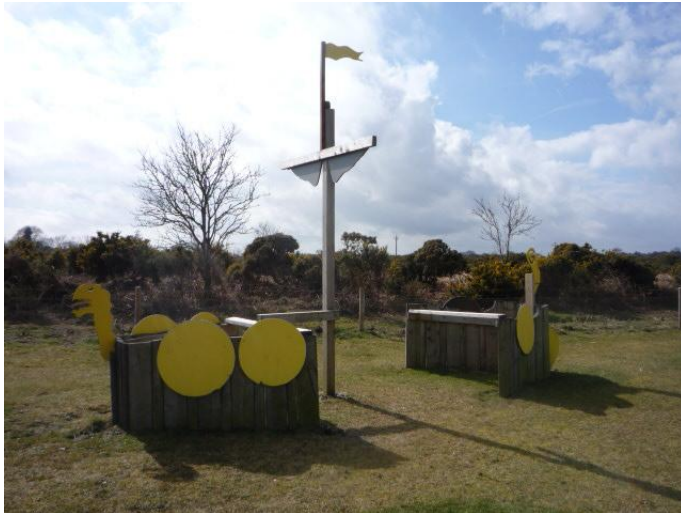
## **Small Boat – Marriot Play and Leisure**

The item meets the requirements of EN1176 where this may be tested on site without dismantling or destruction.

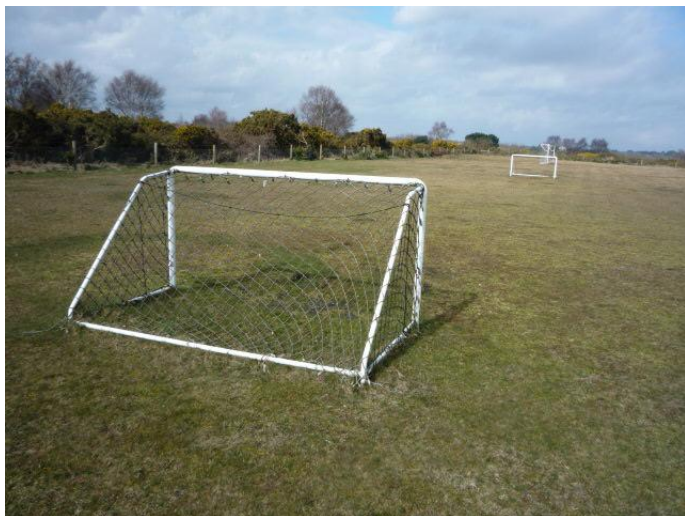
## **Small Goals**

The item meets the requirements of BSEN 748 where this may be tested on site without dismantling or destruction.

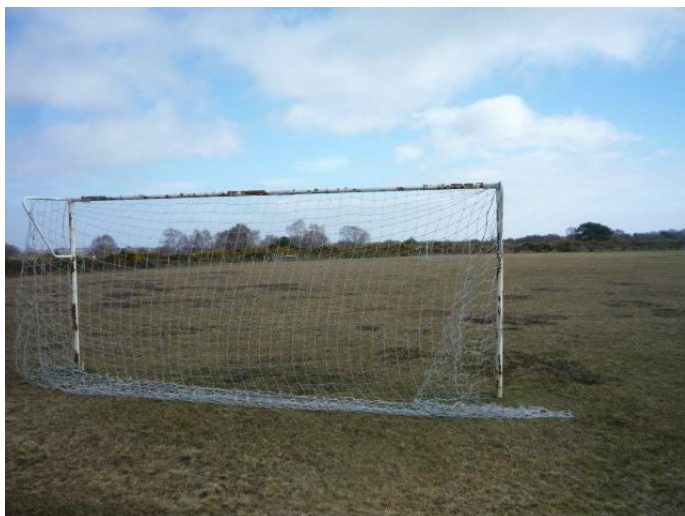
## **Item: Two Full Size Goals**

Full size goals fail to conform to BSEN 748 in the following:

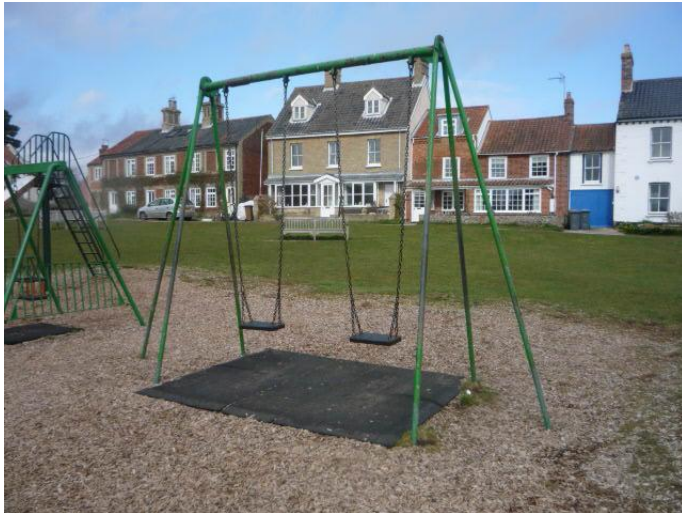
**Item: 1 Bay 2 Flat Seat Swing (2700mm)**

The distance between the seat side and the support is insufficient – Recommend Monitor – Low Risk.

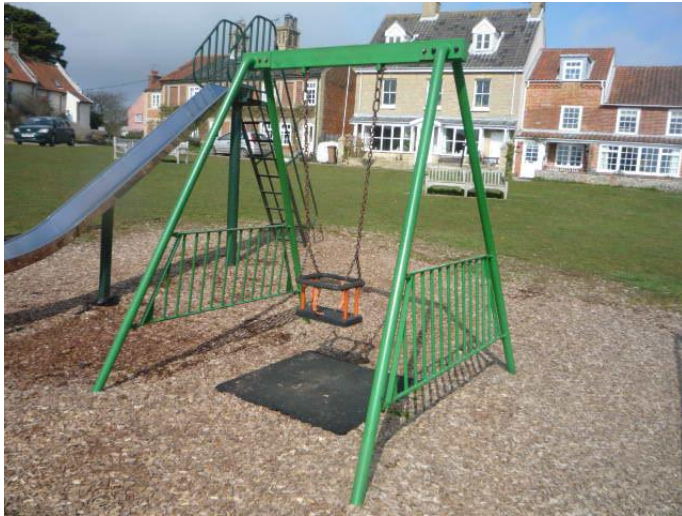
**Item: 1 Bay 1 Cradle Seat Swing (2000mm) - Playquip**

The item meets the requirements of EN1176 where this may be tested on site without dismantling or destruction.

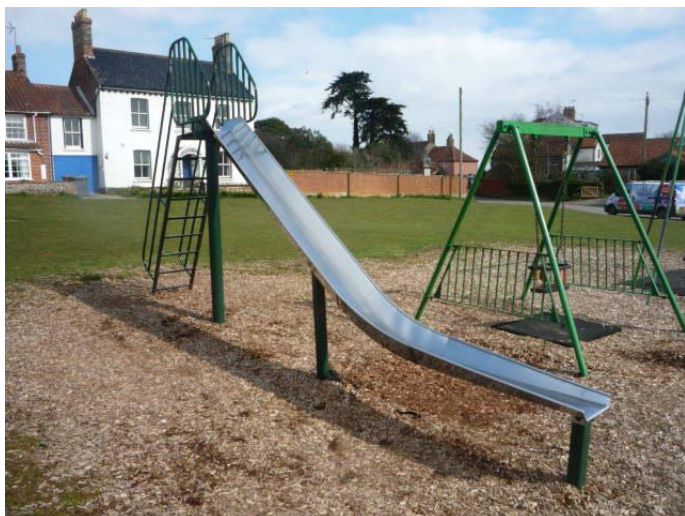
## **Item: Slide (2000mm) – Wicksteed Leisure**

The item fails to meet the requirements of EN1176 in the following respects:
