PLAY AREA SAFETY INSPECTION REPORT

For Walberswick Common Lands Charity/Walberswick PC

On 31st May 2017

Play Area, Common, Church Lane, Walberswick

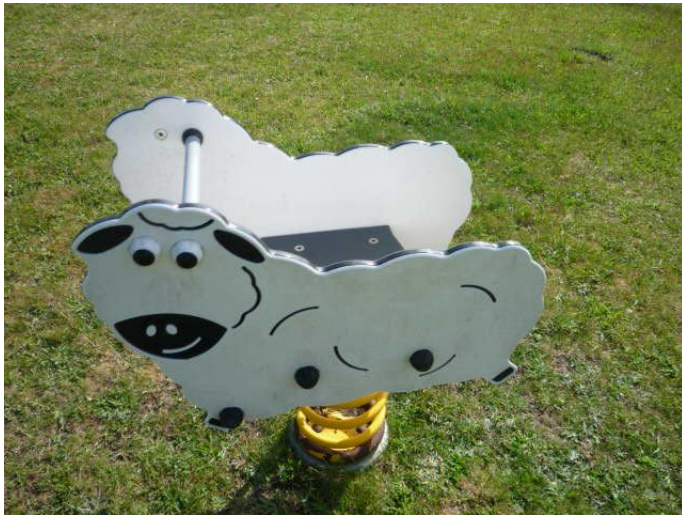
Item: Springy Sheep - Fahr

The item meets the requirements of EN1176 where this may be tested on site without dismantling or destruction.

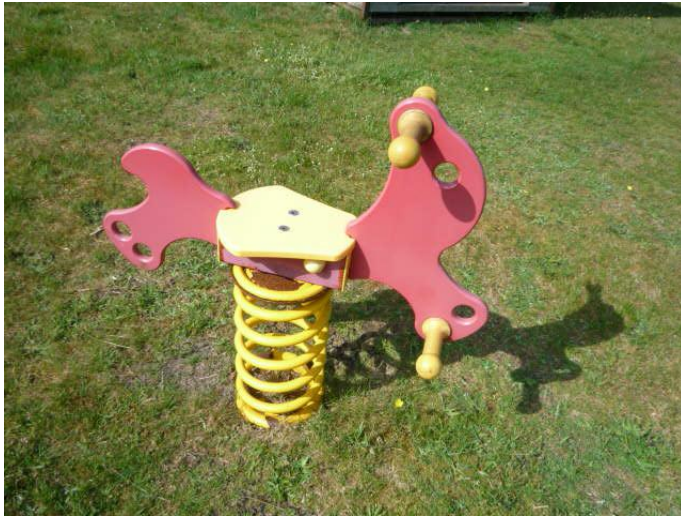
Item: Springy Racer - Playquip

The item meets the requirements of EN1176 where this may be tested on site without dismantling or destruction.

The surfacing is in satisfactory condition and no work is required at this time.

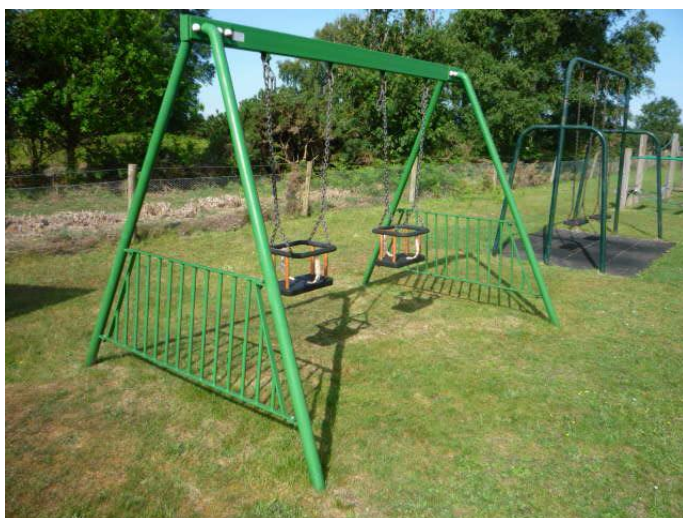
Item: 1 Bay 2 Cradle Seat Swing (2000mm) - Playquip

The item meets the requirements of EN1176 where this may be tested on site without dismantling or destruction.

The surfacing is in satisfactory condition and no work is required at this time.

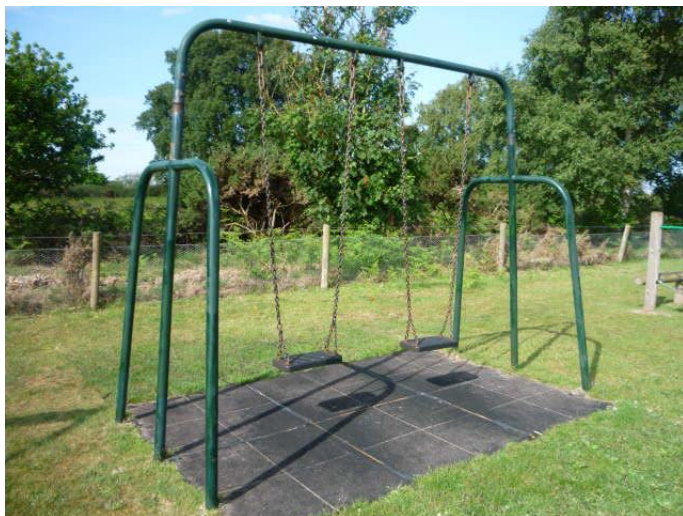
Item: 1 Bay 2 Flat Seat Swing (2400mm)– Sutcliffe Leisure

The item meets the requirements of EN1176 where this may be tested on site without dismantling or destruction.

The surfacing is in satisfactory condition and no work is required at this time.

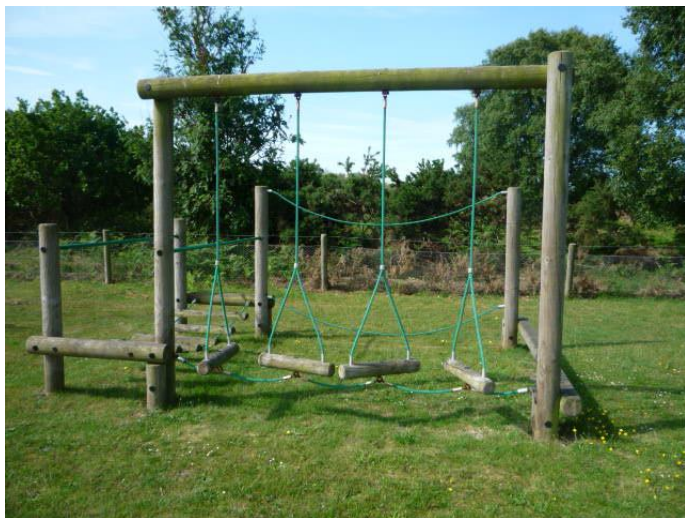
Adventure Cube – Evans

The item meets the requirements of EN1176 where this may be tested on site without dismantling or destruction.

The surfacing is in satisfactory condition and no work is required at this time.

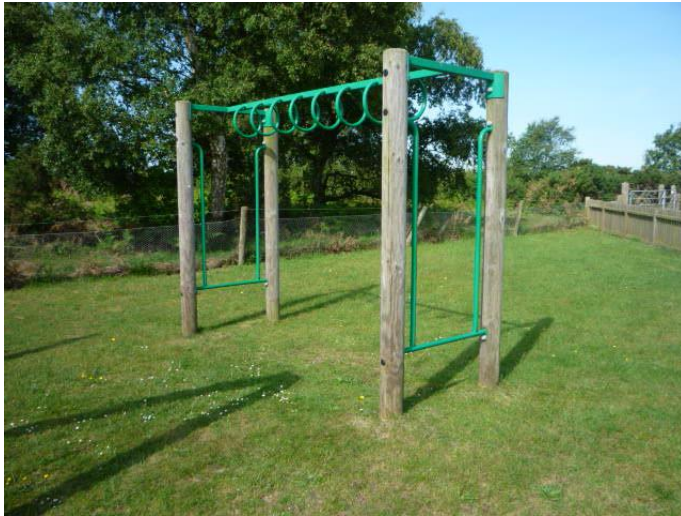
Item: Ring Ladder - Evans

The item meets the requirements of EN1176 where this may be tested on site without dismantling or destruction.

The surfacing is in satisfactory condition and no work is required at this time.

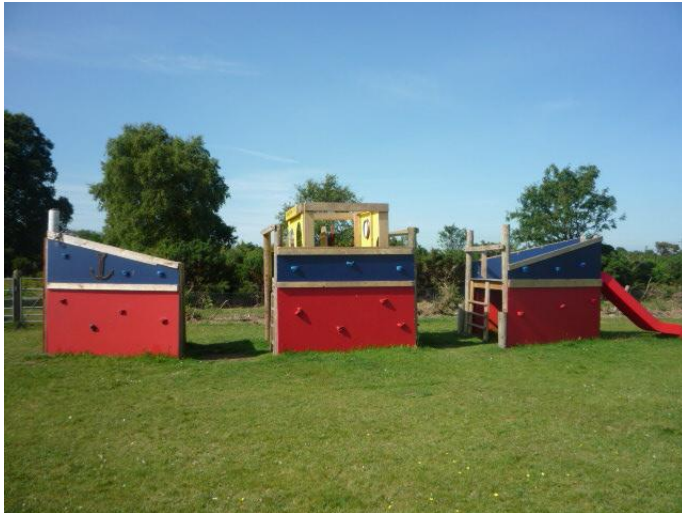
Large Boat – Marriot Play and Leisure

The item meets the requirements of EN1176 where this may be tested on site without dismantling or destruction.

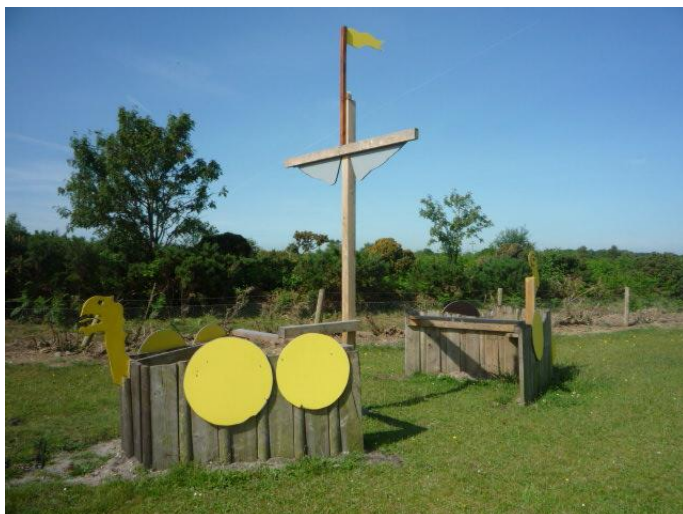
Small Boat – Marriot Play and Leisure

The item meets the requirements of EN1176 where this may be tested on site without dismantling or destruction.

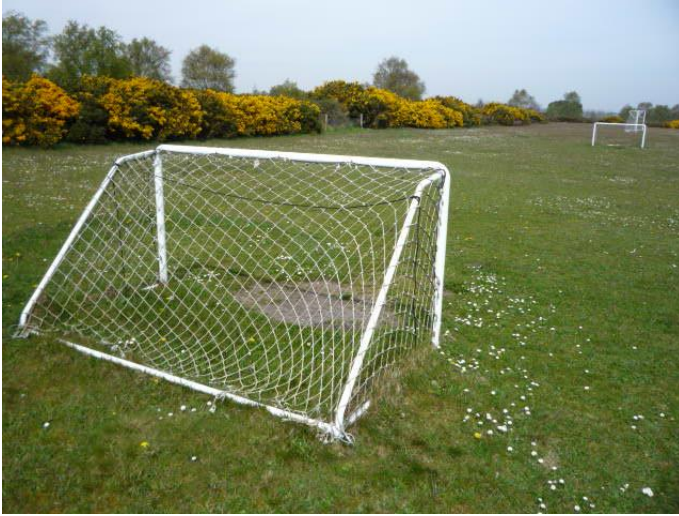
Small Goals

The item meets the requirements of BSEN 748 where this may be tested on site without dismantling or destruction.

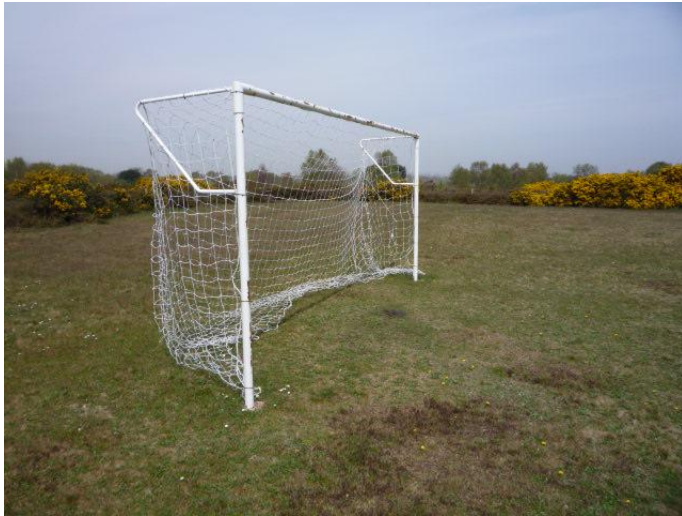
Item: Two Full Size Goals

Full size goals fail to conform to BSEN 748 in the following:

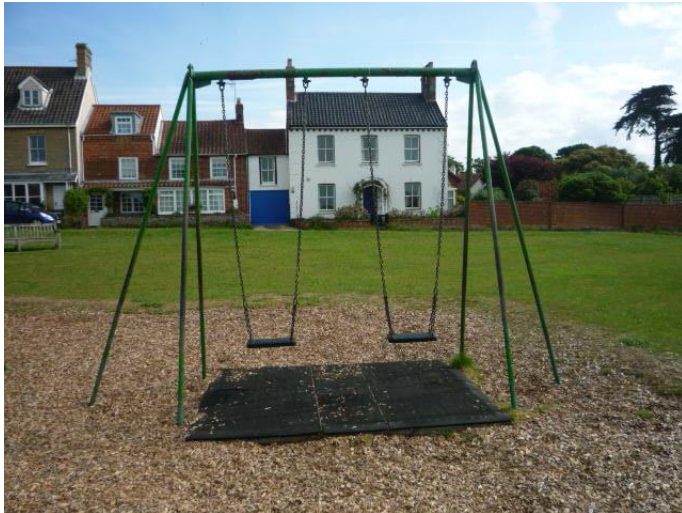
Item: 1 Bay 2 Flat Seat Swing (2700mm)

The distance between the seat side and the support is insufficient – Recommend Monitor – Low Risk.

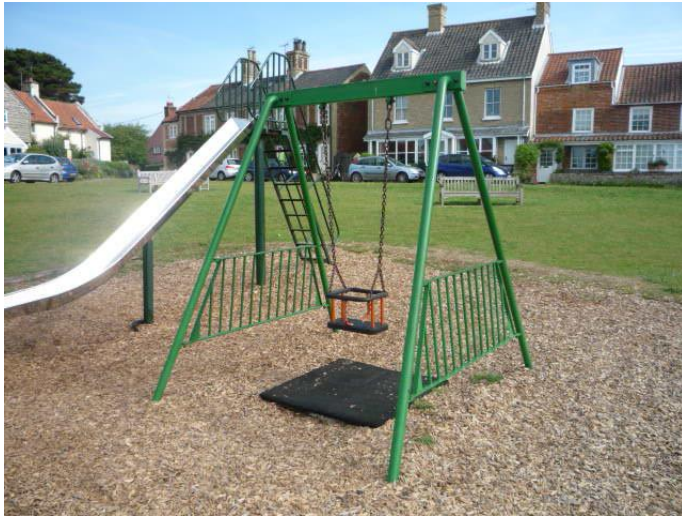
Item: 1 Bay 1 Cradle Seat Swing (2000mm) - Playquip

The item meets the requirements of EN1176 where this may be tested on site without dismantling or destruction.

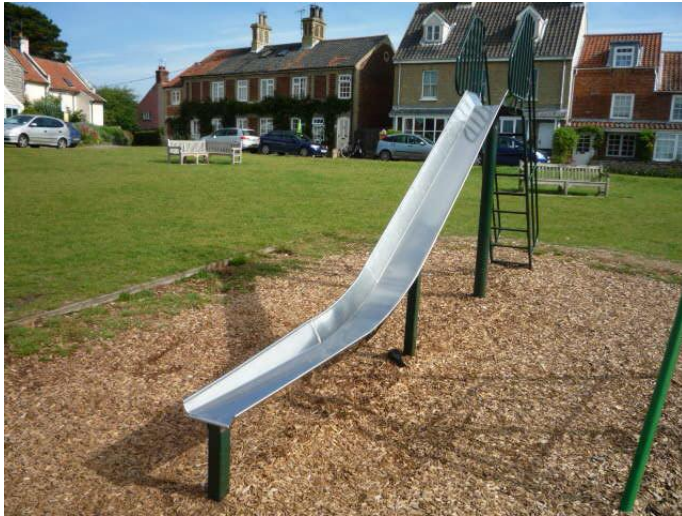
Item: Slide (2000mm) – Wicksteed Leisure

The item fails to meet the requirements of EN1176 in the following respects:
