Safety Inspection Report

Annual Inspection

Playing Fields

Walberswick Parish Council

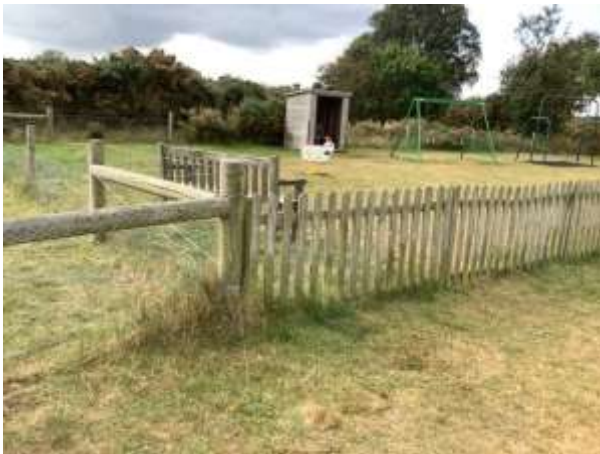
Fencing

Panel is damaged.

Several panel slats missing and damaged leaving nails projecting.

Repair.

Commented [AL1]: Will get Roberts Garden Services to quote for repair

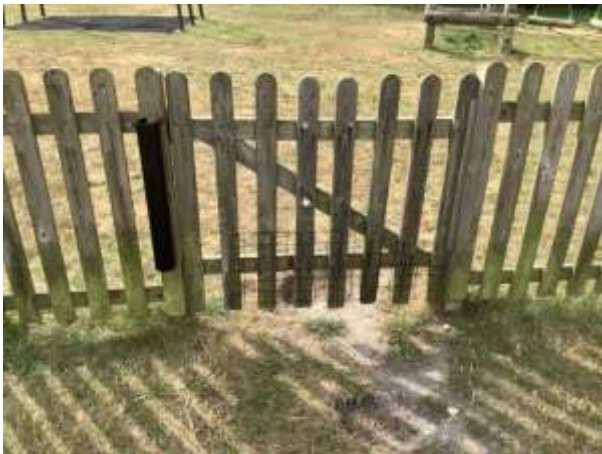
Gates

Ground erosion present.

Erosion at the entrance.

Entrapment on side(s) of the gate.

Hard or sharp projections.

Wire mesh damaged and projecting.

Repair the worn areas.

Commented [AL2]: Will get Roberts Garden Services to quote for repair. Same comment applies for all worn areas

Adjust gate / posts / fit new rubber buffer to ensure a spacing of at least 12 mm throughout the range of the gate to remove the entrapment. The 12 mm gap also should apply on the hinge side of the gate.

Commented [AL3]: Will get Roberts Garden Services to quote for repair

Remove hard, pointed and sharp projections.

Commented [AL4]: Will get Roberts Garden Services to quote for repair

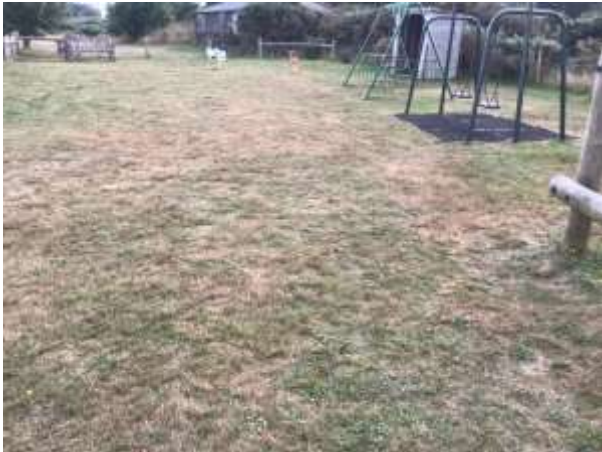
General Surface - Grass

Surface has holes in it.

Holes in the grass around the units.

Repair.

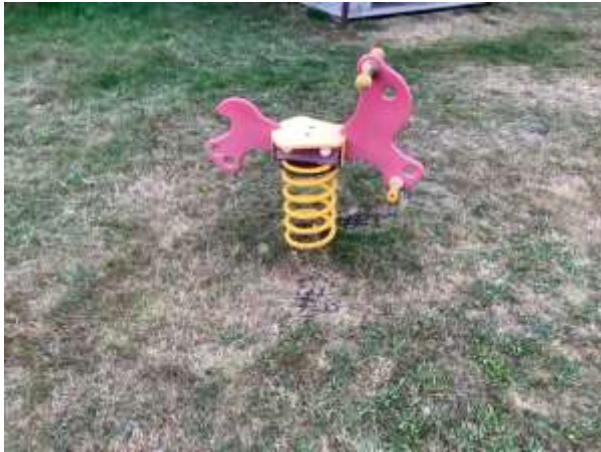
Rocker - Horse

Cap missing.

Foot hold caps missing.

There is significant corrosion on this item.

Replace.

Commented [AL5]: Will attempt to source replacement caps, if item is not replaced entirely (see comment below)

De-scale back to good metal and coat with lead free paint, using appropriate precautions. Repairs may be necessary where corrosion is severe.

Commented [AL6]: Corrosion under seat is significant...replacement to be considered

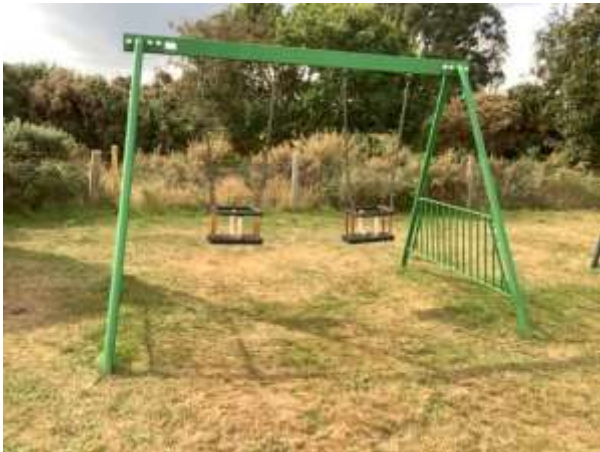
Swing - Toddler - 1 Bay 2 Seat

Swing seat rubber is deteriorating / degrading.

Seats degrading and frame is rusting. Consider replacing both seats.

Replace when metal is exposed.

Commented [AL7]: Safety Committee Agree and will propose replacement to WPC

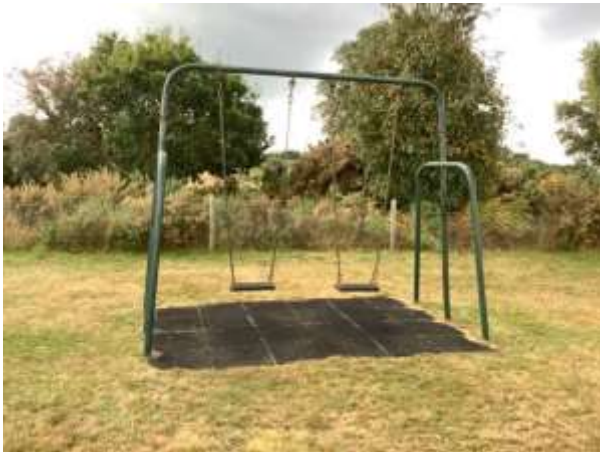
Swing - Junior - 1 Bay 2 Seat

Item is at the end of its useful working life.

The swing has corroded and split the tubing. Our inspector recommends that the unit is replaced.

Programme early replacement.

Commented [AL8]: Safety Committee will propose to WPC that replacement in 22/23 is budgeted

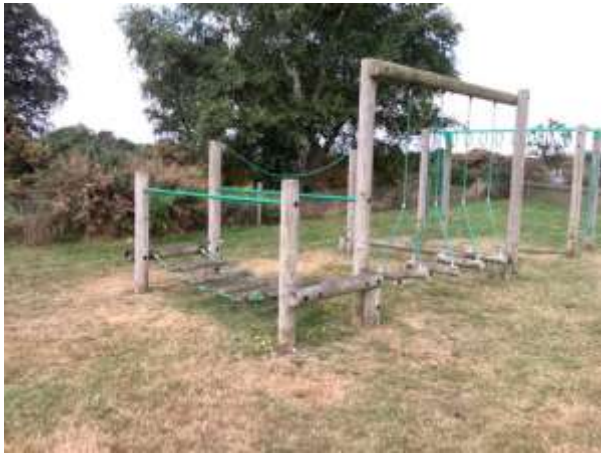
Climber - Frame - Square

Item has some parts missing.

Bottom rope missing on rope walk, leaving sharp wires projecting from connectors.

Strimmer damage to supports is likely to accelerate timber rot.

Timber is decayed.

The cross beam on the suspended bridge has decayed inside & one slat has started to decay. Replace.

Replace the missing parts.

Commented [AL9]: Replacement being ordered from supplier

Prevent further damage.

Replace affected parts.

Commented [AL11]: Supplier will be contacted for advice

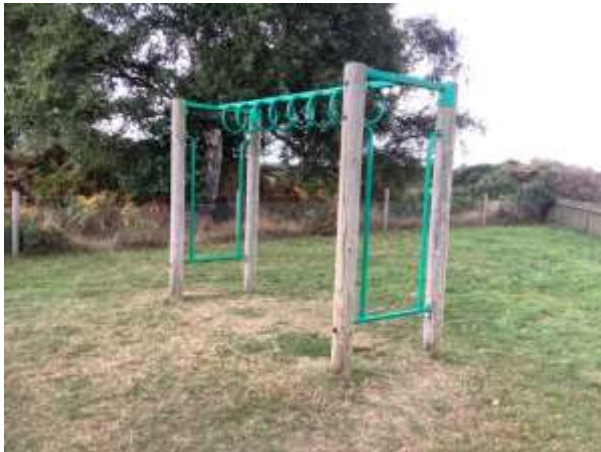
Agility - Ladder - Trapeze Rings

Strimmer damage to supports is likely to accelerate timber rot.

Prevent further damage.

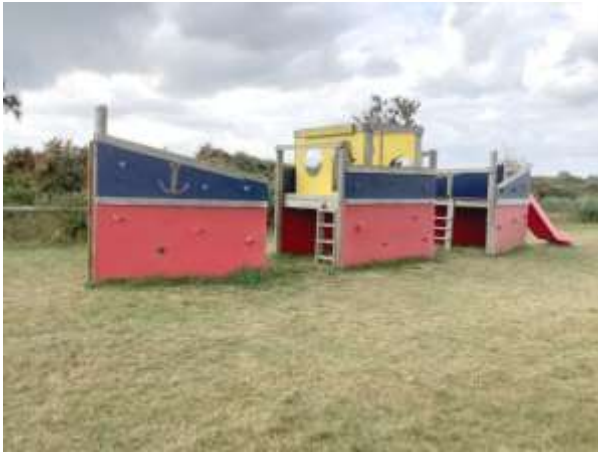
Multiplay - Junior - Large Boat

The item or its surfacing are not compliant with the requirements of the relevant standards.

There is decay to timber components which may affect structural integrity. We do not recommend replacing rotten supports with timber posts which are directly set in the ground due to the increased problem of timber rot, especially in posts in contact with the ground.

Posts decaying.

The circle barrier is damaged, leaving screws projecting.

Strimmer damage to supports is likely to accelerate timber rot.

The front section platform barriers are lower than 700 mm. However, they are part of the climbing wall. The platform also has no guard rail.

The rear section platform barriers are lower than 700 mm. However, they are part of the climbing wall.

Replace decayed components where possible and plan replacement of item. Check on a routine basis, especially at ground or foundation level.

Commented [AL12]: This item does not meet current standards – replacement to be considered by WPC – item has been closed to public in the meantime

Replace.

Prevent further damage.

Refer to manufacturer for comment.

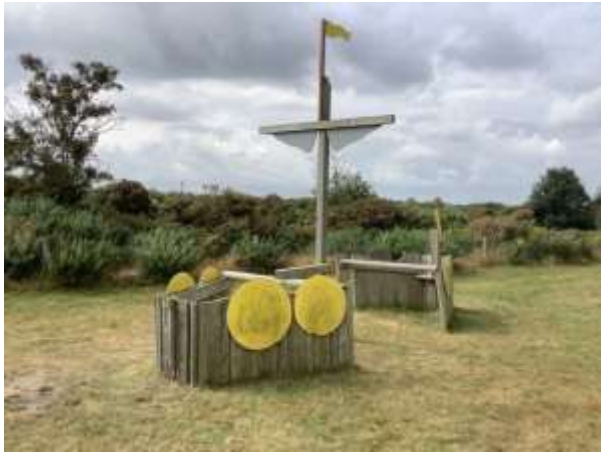
Play Boat - Small

Item is at the end of its useful working life.

The unit is decayed, leaning and is unstable. Remove.

Item is damaged.

Front section damaged leaving sharp edges. Remove and replace.

Remove immediately.

Commented [AL13]: Safety committee recommend removal – item has been closed to public in the meantime

Replace.

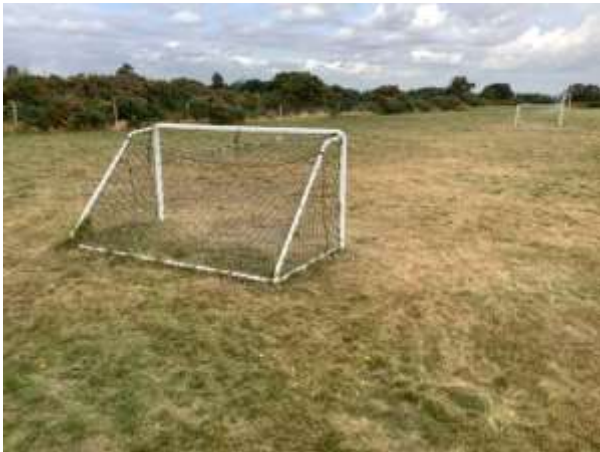
Goal Post - Football - 5-A-Side

Ground erosion present.

Goal mouth/s wearing. Either soil & seed affected area or re-turf affected area.

Item is not secure.

Secure the net to the frame.

Item has some parts missing.

Net missing. Replace and remove remnants of the old net.

Surface is uneven.

Holes in the playing surface.

Repair the worn areas.

Secure.

Commented [AL14]: New nets already budgeted and will be sourced – same comment applies to all mentions of net replacement

Replace the missing parts.

Make good.

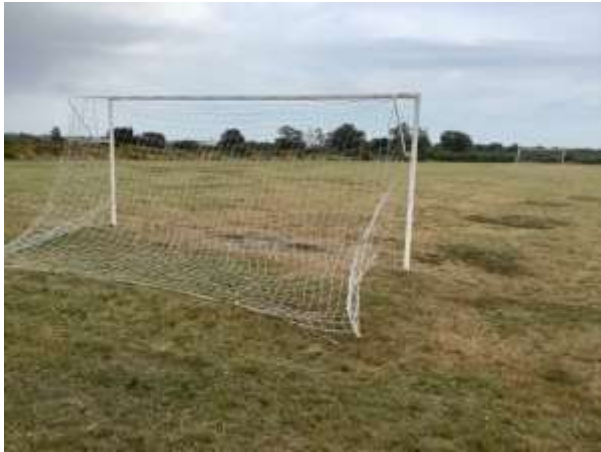
Goal Post - Football - Full Size

Ground erosion present.

Goal mouth/s wearing. Either soil & seed affected area or re-turf affected area.

Surface is uneven.

The playing surface has holes.

Repair the worn areas.

Make good.
