Safety Inspection Report

Annual Inspection

Playing Fields

Walberswick Parish Council

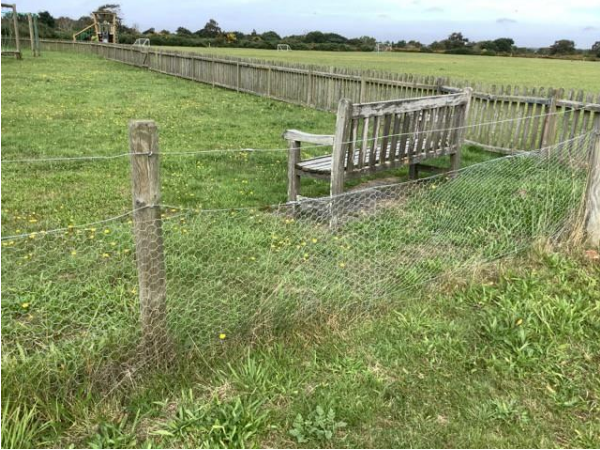
Fencing

A section of the fence is missing.

Slats missing leaving nails projecting.

Medium

Replace the missing parts.

Commented [AL1]: Find someone willing to repair and maintain ongoing

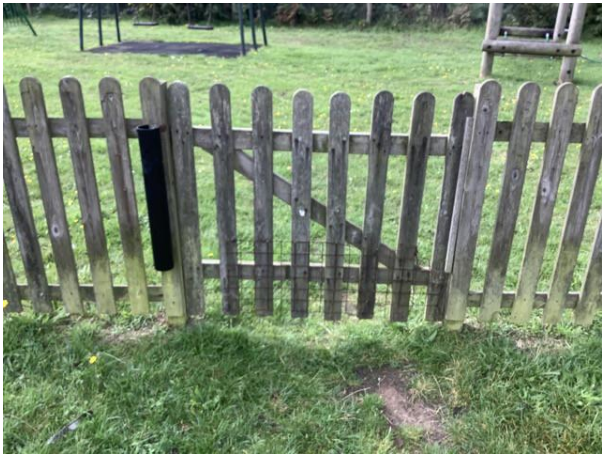
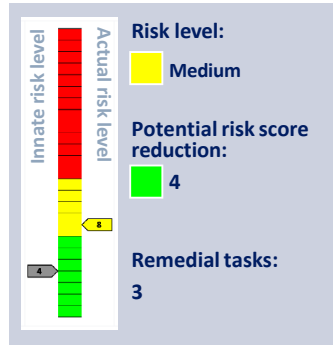
Gates

There is a crushing or shearing point on the side of the gate. Where the gaps reduce to less than 12 mm these have been known to cause serious, permanent injury to children, especially on the hinge side where the leverage forces are significant.

Medium

Adjust gate / posts / fit new rubber buffer to ensure a spacing of at least 12 mm throughout the range of the gate to remove the entrapment. The 12 mm gap also should apply on the hinge side of the gate.

Commented [AL3]: Inspect - new requirement

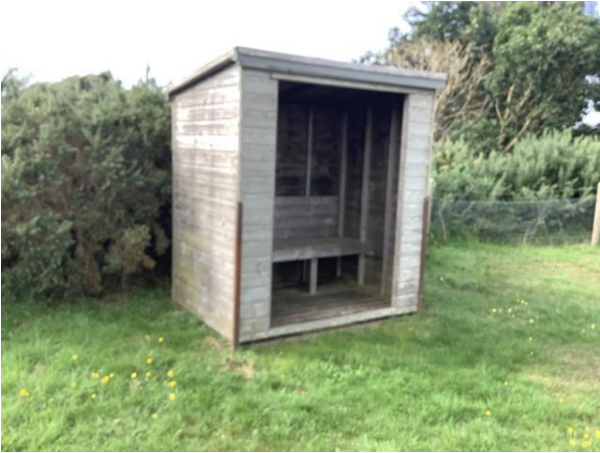
Shelter

Timber is decayed.

Floorboard decayed and missing leaving a large hole this could entrap feet etc.

Medium

Replace affected parts.

Commented [AL6]: WCLC owned/responsibility and aware - chase up repair

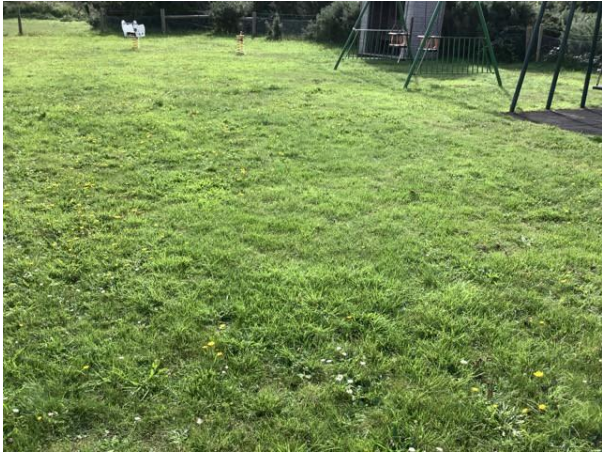
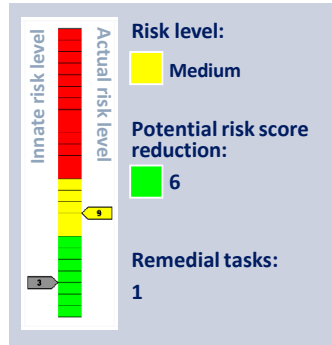
General Surface - Grass

Surface has holes in it.

Holes in the grass around the units could create potential trip hazards.

Medium

Repair.

Commented [AL7]: On going task done already done with rest of playing field

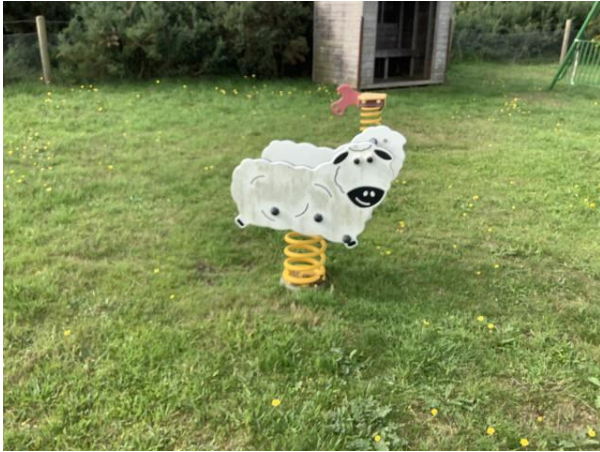
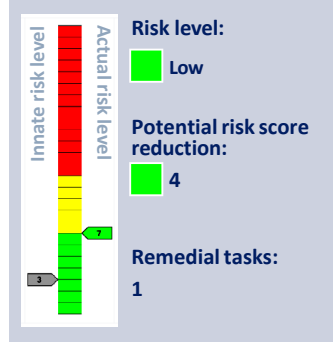
Rocker - Sheep

Loose in ground.

Unit working loose in the ground. Monitor and reset if the unit becomes unstable.

Low

Read the notes for further action.

Commented [AL8]: monitor

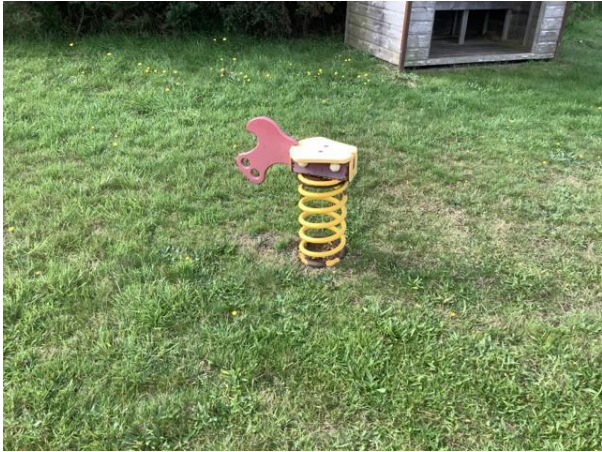
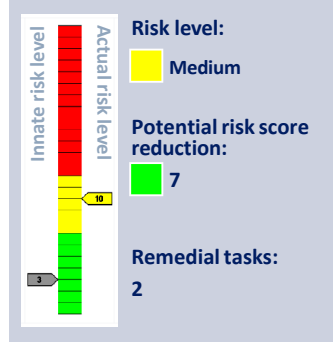
Rocker - Horse

Item has some parts missing.

Head and handles are missing.

Medium

Replace the missing parts.

Commented [AL9]: Suggest replace whole unit

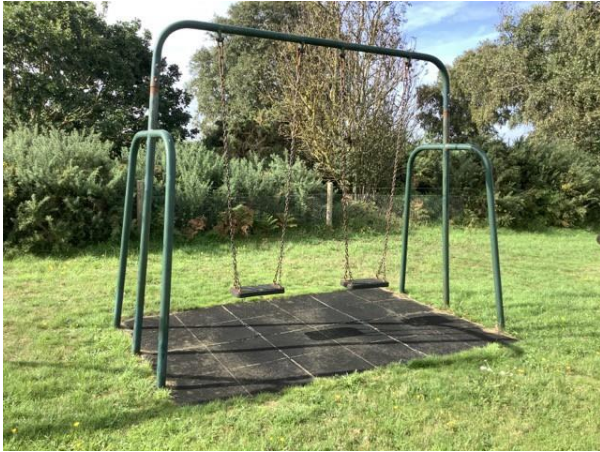
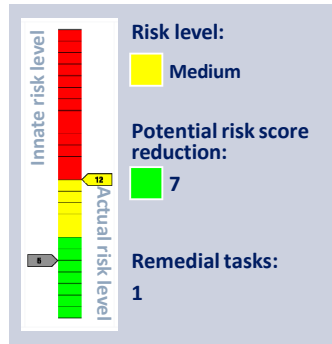
Swing - Junior - 1 Bay 2 Seat

Item is at the end of its useful working life.

The swing has corroded and split the tubing. Our inspector recommends that the unit is replaced.
Flat seats are split and chains starting to wear.

Medium

Programme early replacement.

Commented [AL11]: Get quotes and ask for use of CIL money

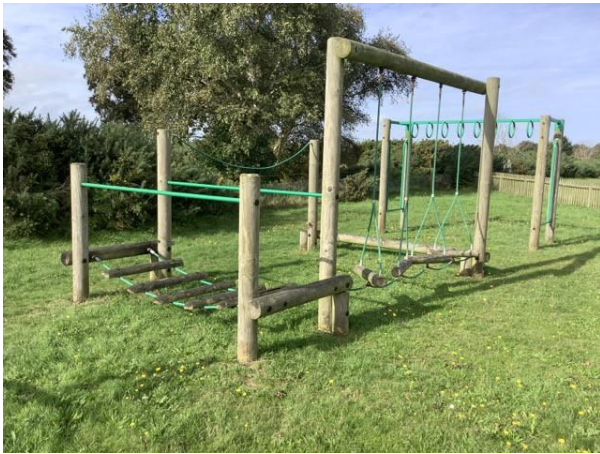
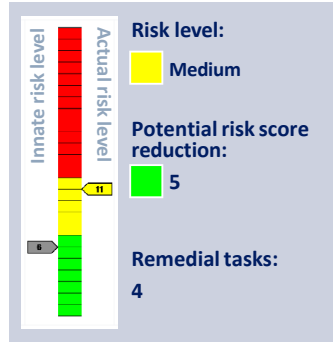
Climber - Frame - Square

Fixtures loose or missing.

Suspended log walk rope top bar fittings loose and moving. Secure in correct place.

Medium

Tighten.

Commented [AL12]: New requirement - inspect

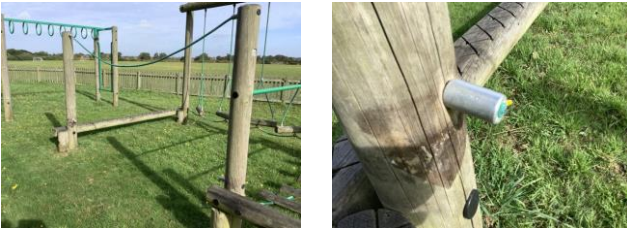
Bottom rope missing from rope walk, leaving sharp wires projecting from connectors.

Medium

Replace the missing parts.

Commented [AL13]: Re-order

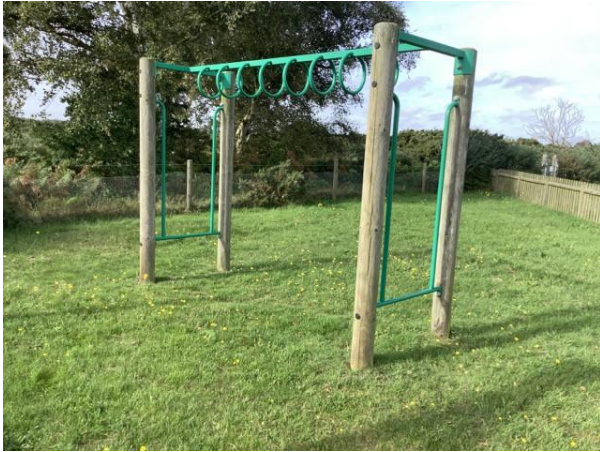
Agility - Ladder - Trapeze Rings

Strimmer damage is present on posts, allowing water to enter and timbers to soften. It can also remove the protective envelope around the timber. Prevent further damage and check timbers for decay throughout the year.

Low

Prevent further damage.

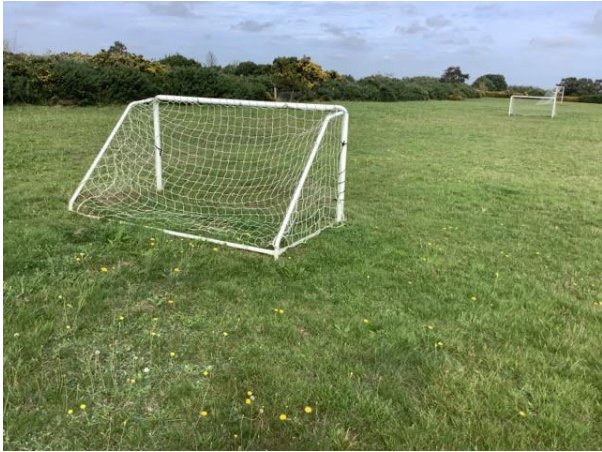
Goal Post - Football - 5-A-Side

Ground erosion present.

Goal mouth/s wearing. Either soil & seed affected area or re-turf affected area.

Low

Repair the worn areas.

Commented [AL15]: Consider using matting?

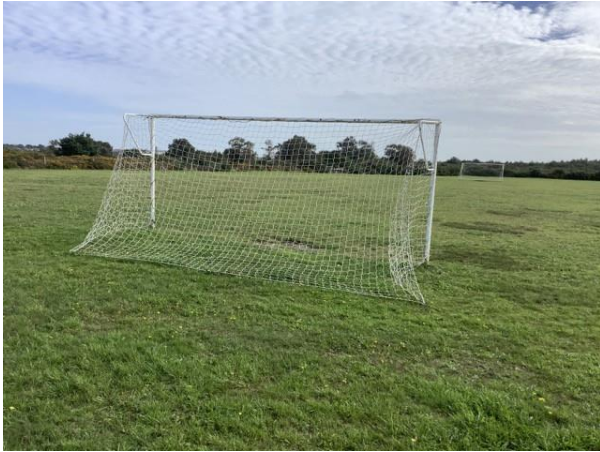
Goal Post - Football - Full Size

The structural tests within EN 748 / EN 16579 have not been done during this inspection. These can be conducted by separate arrangement.

Very low

Arrange to conduct the appropriate tests.

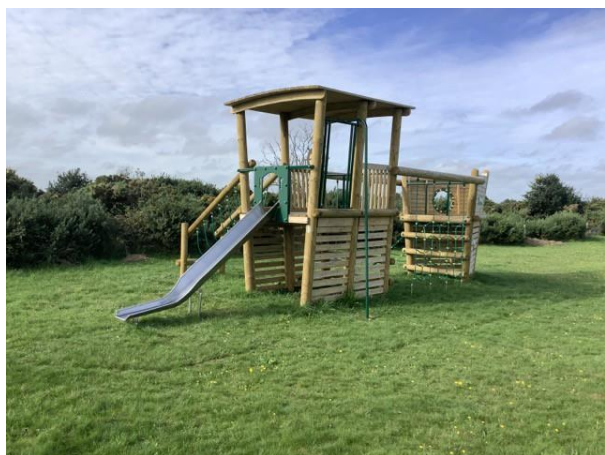
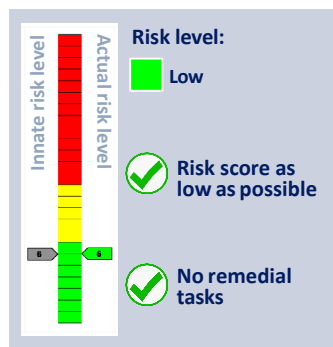
Multiplay - Junior - Pirate Ship

Paintwork is in poor condition.

Low

De-scale back to good base material and coat with lead free paint, using appropriate precautions. Repairs may be necessary where corrosion is severe.

Commented [AL17]: Re-paint (last done 3 years ago)
